POST COLLISION

Immediate Results and Actions

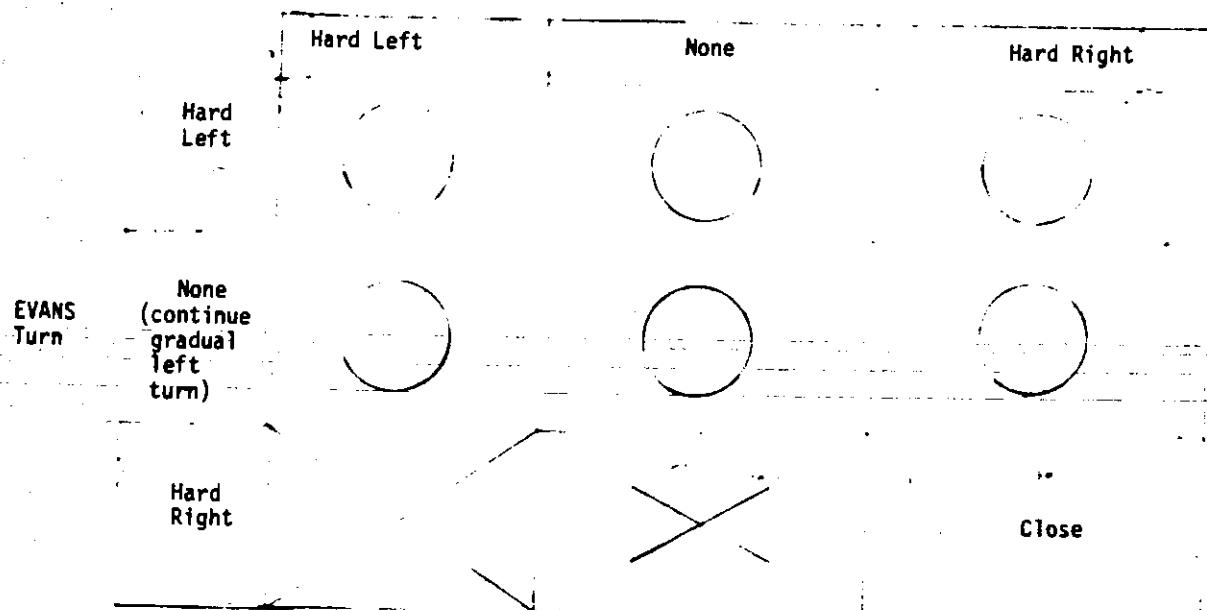
MELBOURNE Turn

98. (U) The following table displays the Board's best estimates of hypothetical alternative final turns by each ship based on reconstruction.

Note: 1. - miss; - hit; close - 100 yards or less.
2. Actions referred to are alternatives to be considered in lieu of and at the respective times of EVANS' "Right Full Rudder" and MELBOURNE's "Port 30 - Port 35"
3. Engine orders are a separate subject.
