First, I want to take this opportunity to thank you for giving us your time, insight and information in regard to the ongoing investigation of incident of the F-111A Aircraft (refno 1948), piloted by USAF Captain **RONALD D. STAFFORD** and EWO Captain **CHARLES J. CAFFARELLI**.

SUBJECT: Request for Information Regarding Loss of F-111A Piloted by Ronald D. Stafford (Your Ltr, 18 Oct 88)

- 2 Atch
1. SMAMA Service Engineering  
Report No. 73-511
  2. Operation Sequence Times

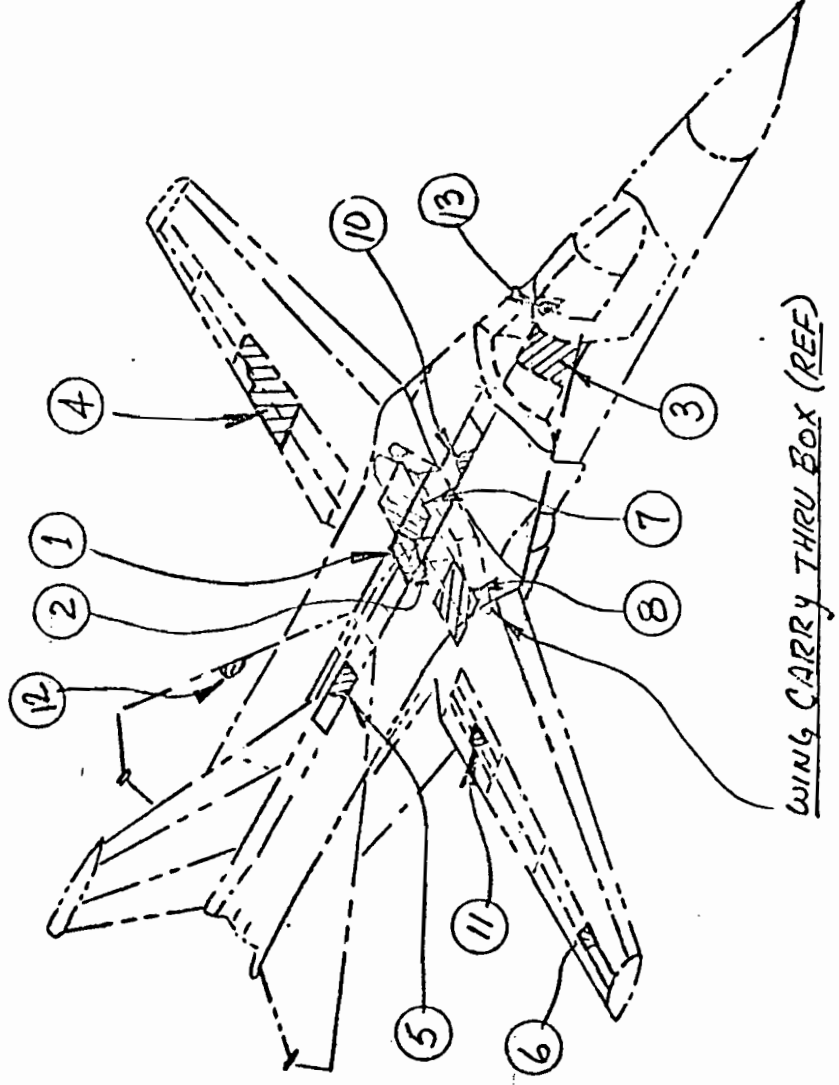
FIGURE 1. LOCATION OF IDENTIFIABLE PARTS

of these design features are outside F-111 design specifications. A review of photographs received from SEA indicates that this part was not included in the on-scene analysis. It is therefore assumed that the part was inadvertently shipped with the F-111 parts. It is not included in this analysis. Figure 1 shows the orientation of the identifiable parts on the aircraft.

A. Location of parts on aircraft planform in Figure 1 indicates aircraft was intact prior to impact. This assumes all parts noted are from the same aircraft. The crew module was an integral part of the airframe. From the pieces investigated, there is no evidence of pre-impact fire or battle damage.

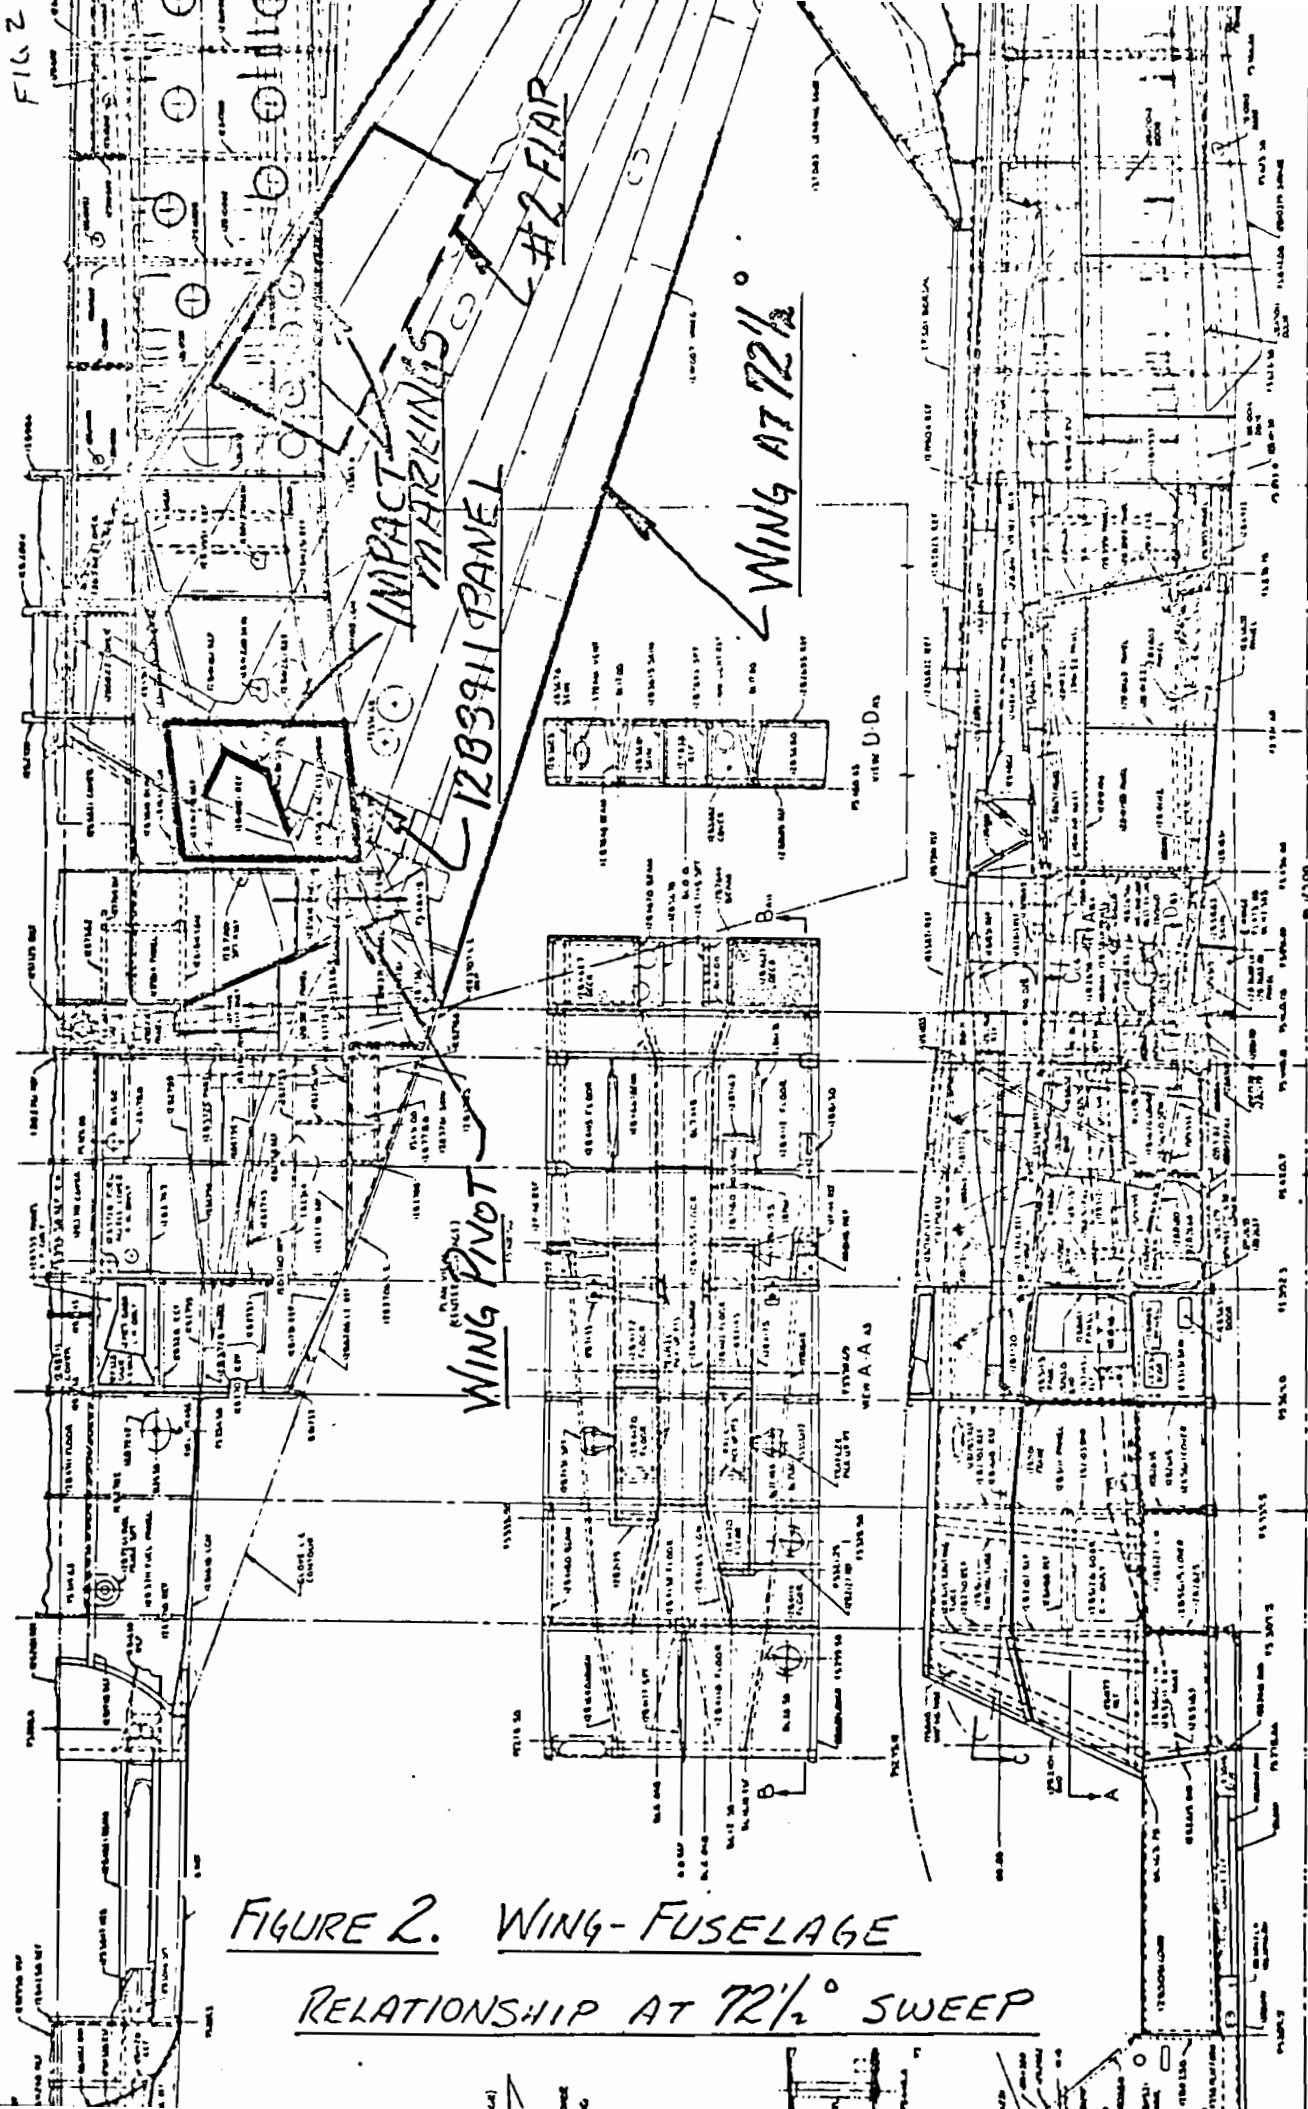
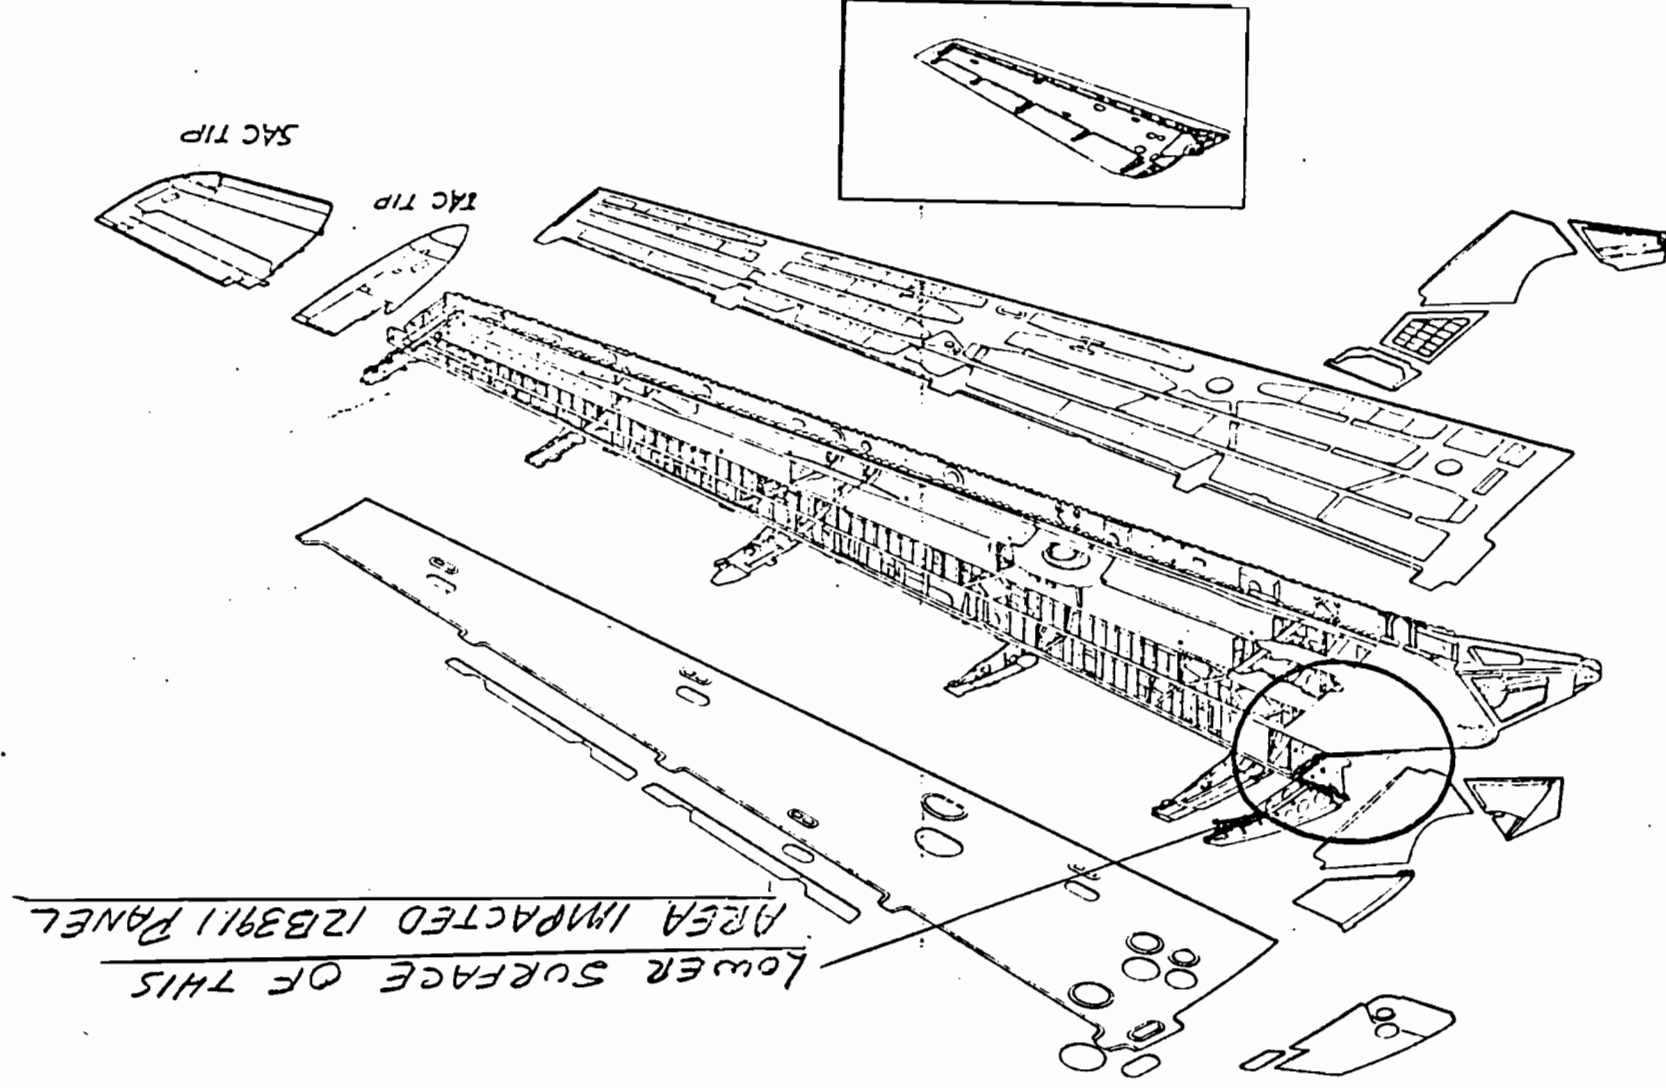
FIGURE 3. WING AREA IMPACTED INTO  
12B3911 LH PANEL

B. The LH 12B3911 panel (identification #7) has markings on its upper surface caused by impact with the lower surface of the wing. The markings are very distinctively caused by the wing rear spar, bulkhead No. 0, and the rear spar of the wing pivot fitting. For the marks to be made at this location on the 12B3911 panel, the wing would be in aft sweep, at or very near 72°.

C. Figure 2 includes a layout of the wing-fuselage relationship with the wing at 72-1/2°. The 12B3911 panel, #2 flap, and impact markings are shown in bold outline. Figure 3 is a blow-up of the wing showing the parts which impacted the 12B3911 panel.

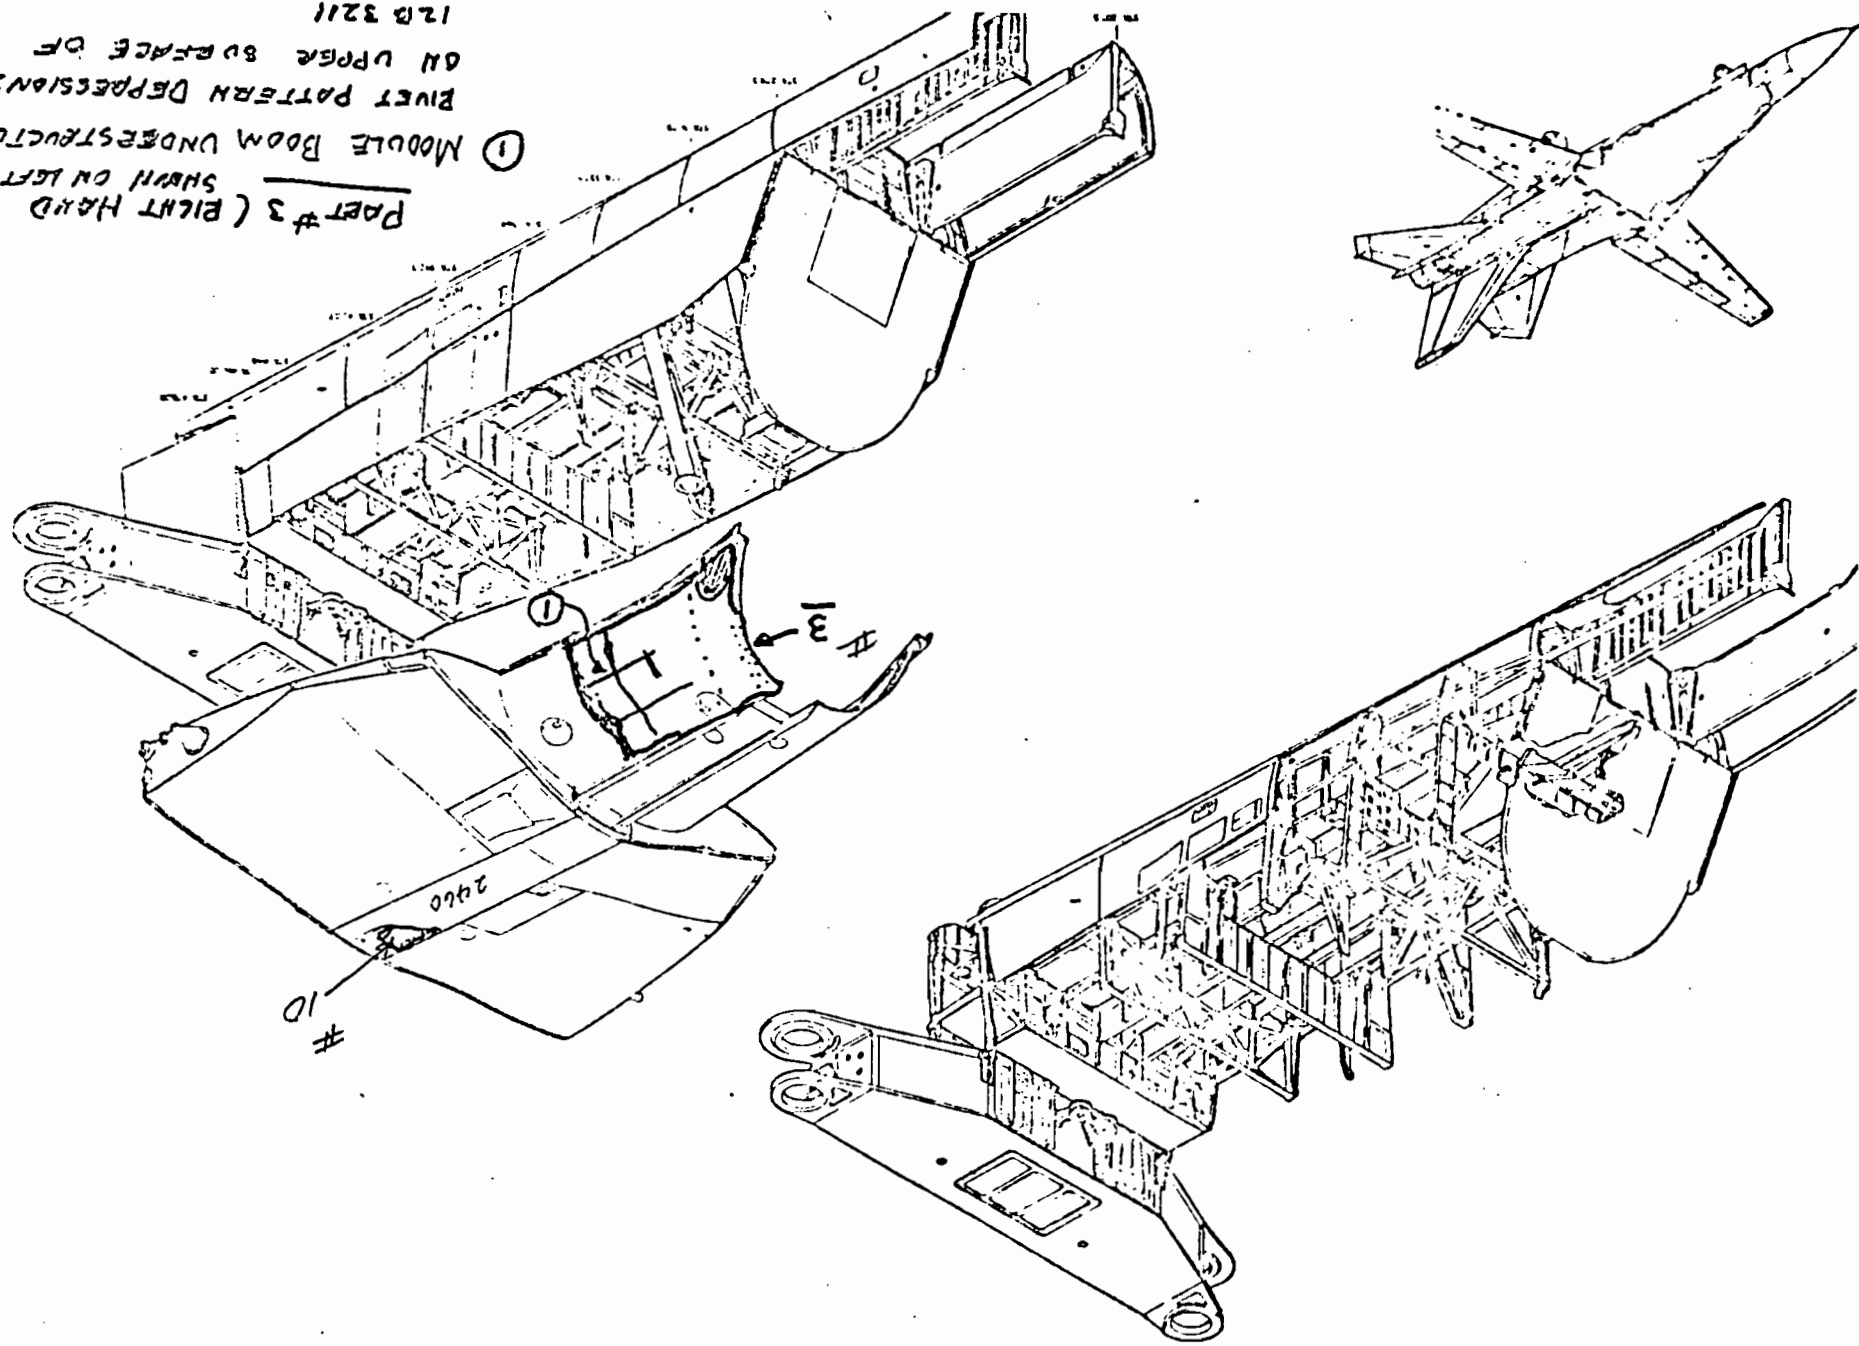
FIGURE 4. LOCATION OF 12B3211 PANEL

B. The 12B3211 panel is located directly beneath the stabilization glove of the crew module. Part #3 is the forward two-thirds of the right hand fuel tank panel. It contained distinctive rivet impact markings in three lateral lines on its rear half. These rivet patterns match the rivet patterns on the underside of a crew module stabilization glove almost exactly. Further, the failure mode of the 12B3211 panel is that it was forced upward into the glove with significant pressure. This is positive evidence that the crew module was structurally intact on the aircraft at the time of break up.

C. Negative evidence that the crew module did not functionally separate was the lack of exhaust or burning on the 12B3211 panel. The panel lies directly in the rocket path during liftoff.

D. Figure 4 illustrates the position of the 12B3211 panel and the location of the rivet impact markings.

① MODULE BOOM UNDERSTRUCTURE  
 SHOWN ON LEFT SIDE  
 PART # 3 (RIGHT HAND)  
 RIVET PATTERN DEPRESSIONS  
 ON UPPER SURFACE OF  
 12B 3211

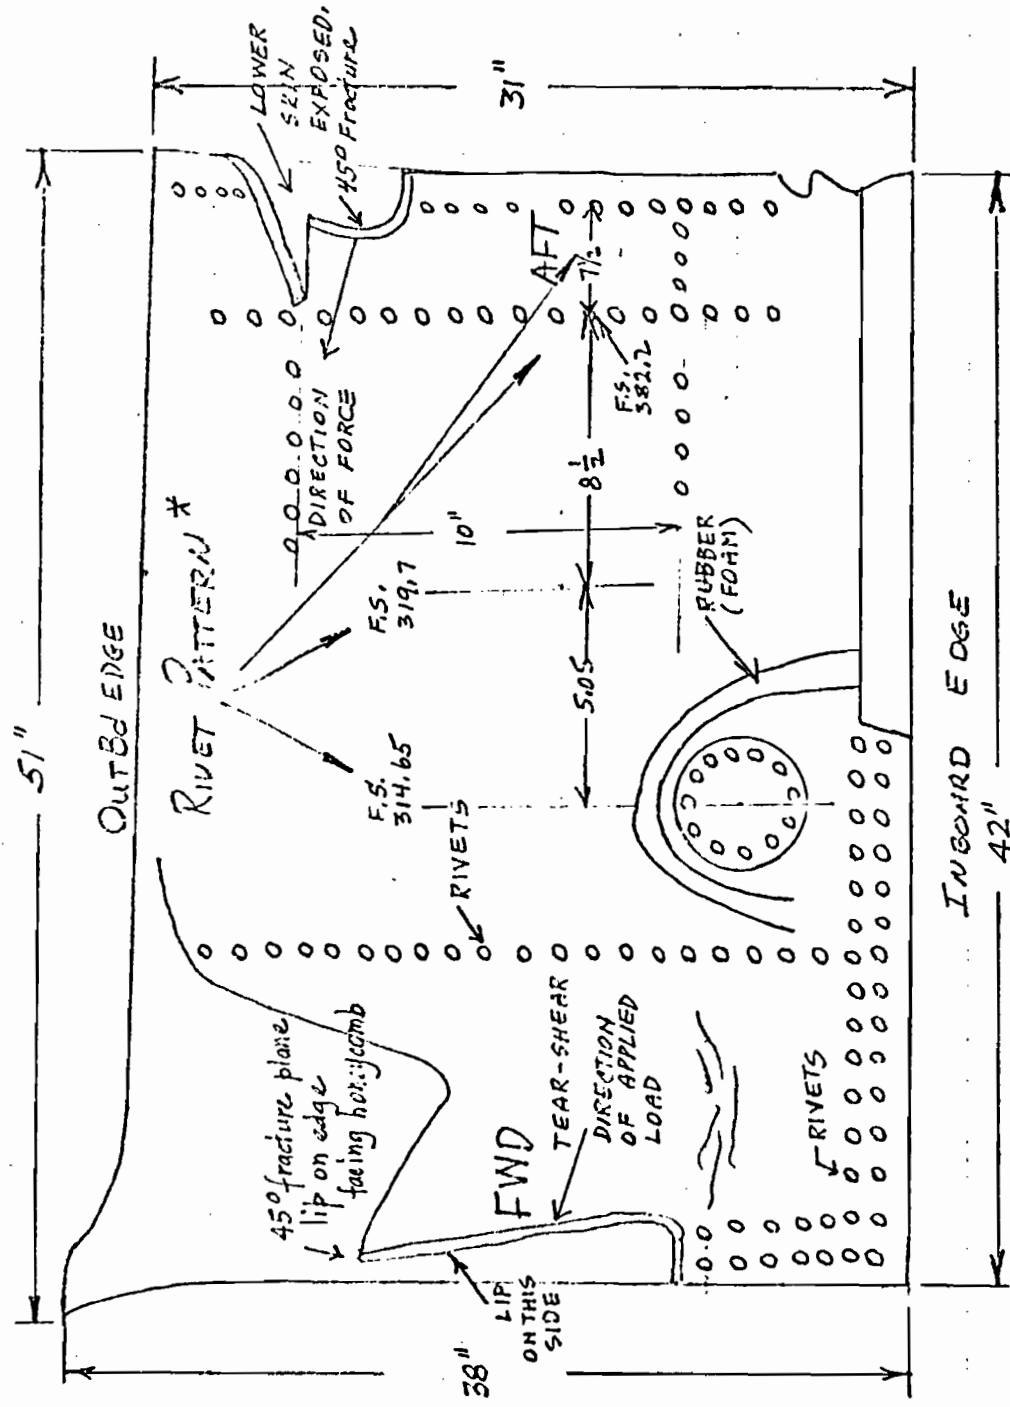
FIGURE 7. FAILURE DESCRIPTION - UPPER SURFACE, PART 3.

1. A line of core shear exists 2 to 3 inches forward of station 307.5 indicating high internal pressure prior to separation from the attach frame. Failure of the attach frame was basically a tensile-bending loading failure propagating from the outboard end. The shear direction of the inboard rivets indicate a lateral outboard movement of the panel. The only other significant mark on the lower surface was a raised ridge caused by impact with the module stabilization beam on the opposite side.

4. The cause or failure is believed to be high uniform internal pressure causing panel section to be blown upward into lower surface of crew module stabilization glove while module glove was solidly attached to fuselage structure.

PART marked #3. P/N 12B3211.  
Fwd Fuel Tank Upper R.H. side. TOP VIEW.

Honeycomb between two aluminum skins (.036" thick, approx.)  
No fire or heat damage.

Direction of load AFT to FWD direction (see the sketch).

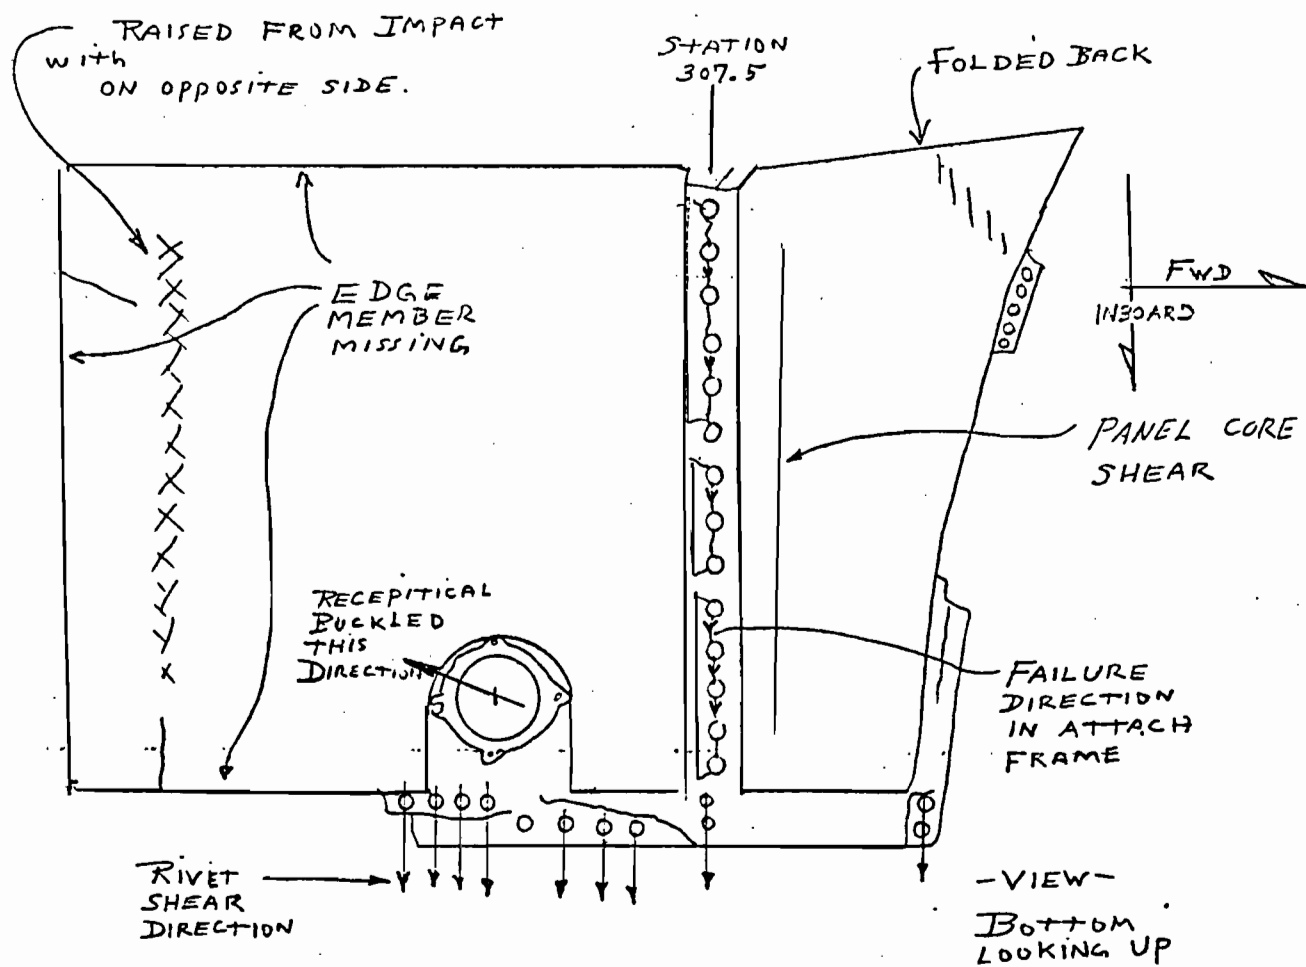
FIGURE 8. FAILURE DESCRIPTION - LOWER SURFACE, PART 3.

PART #3 P/N 12B3211

FWD. FUEL TANK UPPER RIGHT HAND SIDE - BOTTOM VIEW

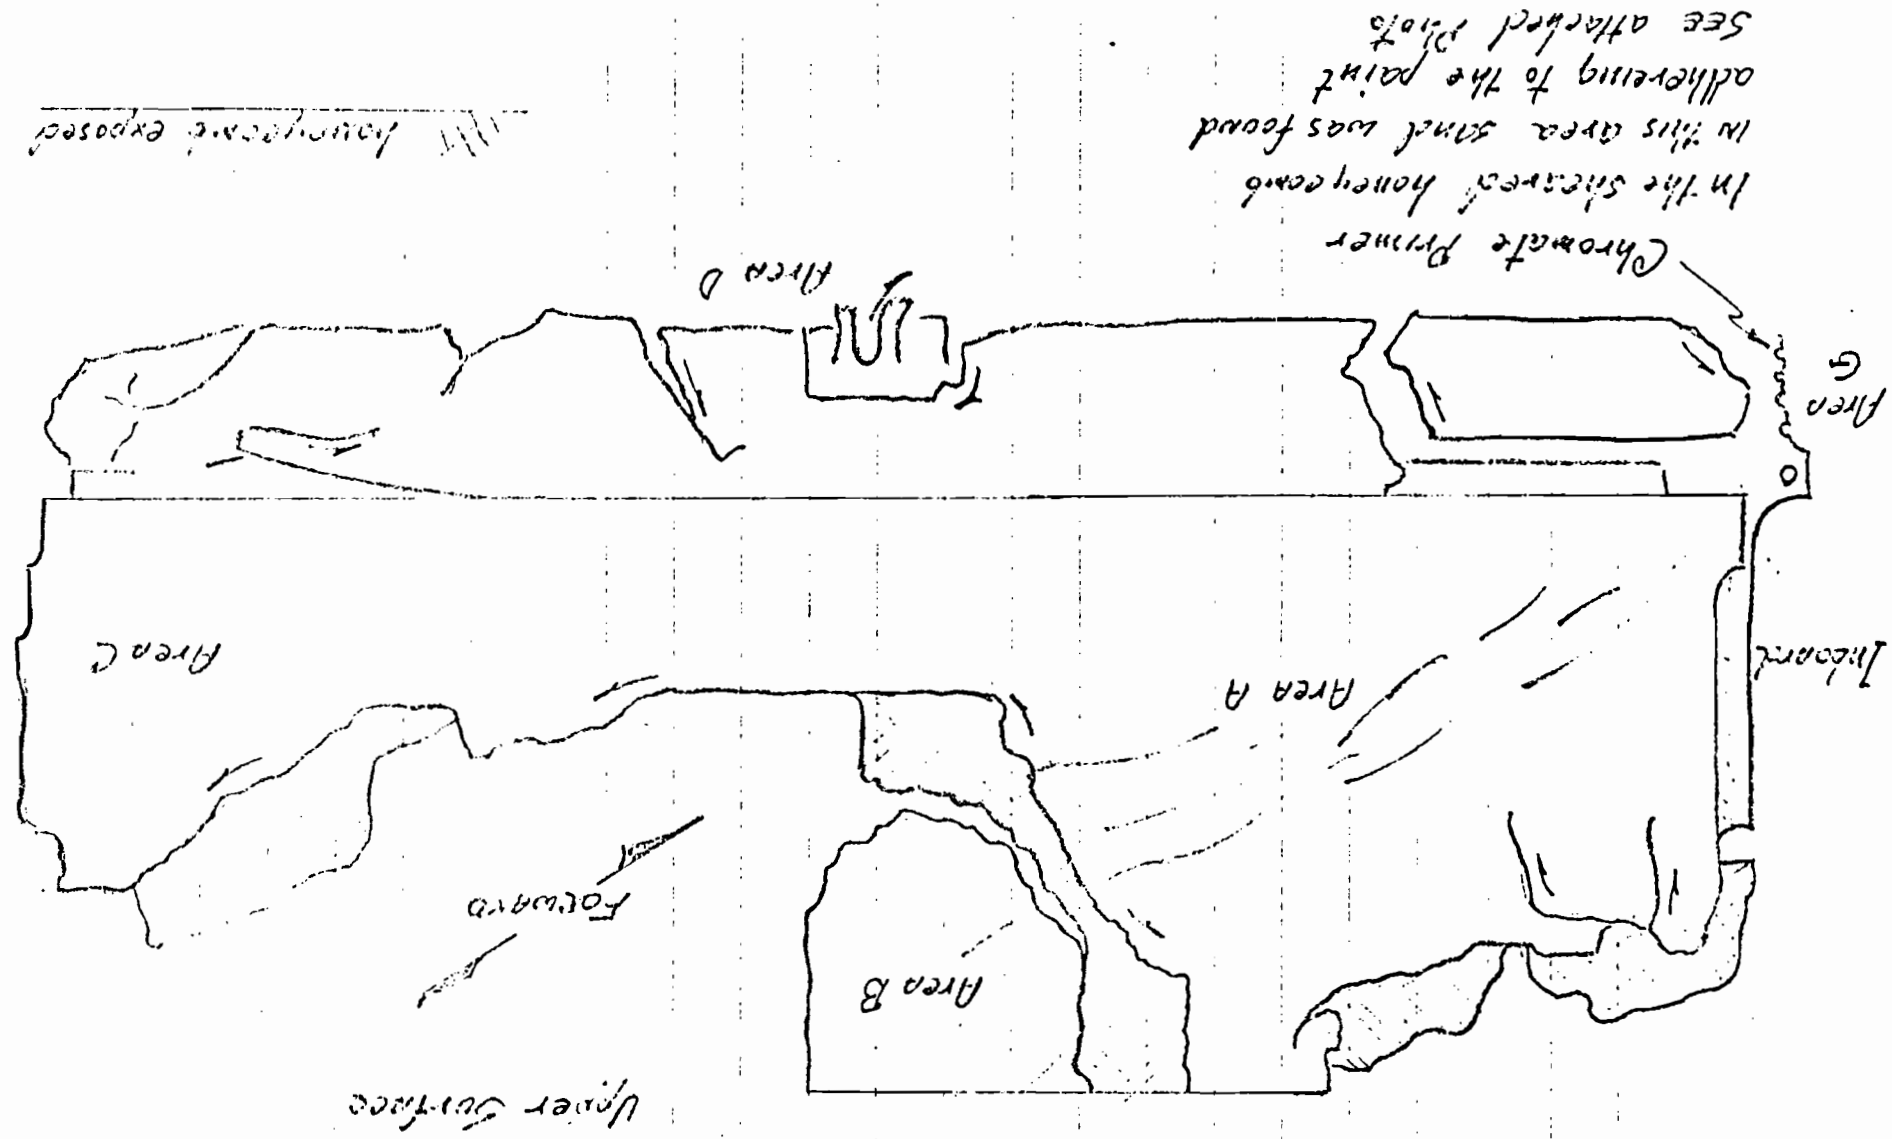
FIGURE 10. FAILURE DESCRIPTION - UPPER SURFACE, PART 4

a. Area A - The flap appears to have been thrust upward into the overwing fairing. The abrasions show a gray residue from the non metallic sealing material. The area coincident to this area on the lower skin (E) shows very severe damage from the lower fuselage being thrust into the flap.

c. At impact the flap was torn loose in a direction outward along the length of the wing failing in tension at area G and bending in area D.

4. It is believed that the fuselage crushed into the flap from below at the same time that a relatively uniform high pressure hit the lower surface of the flap portion which was not inside the fuselage. The upper surface marks from the overwing fairing are believed to be caused as a reaction to the upward forces.

PART # 4 - #2 FLAP

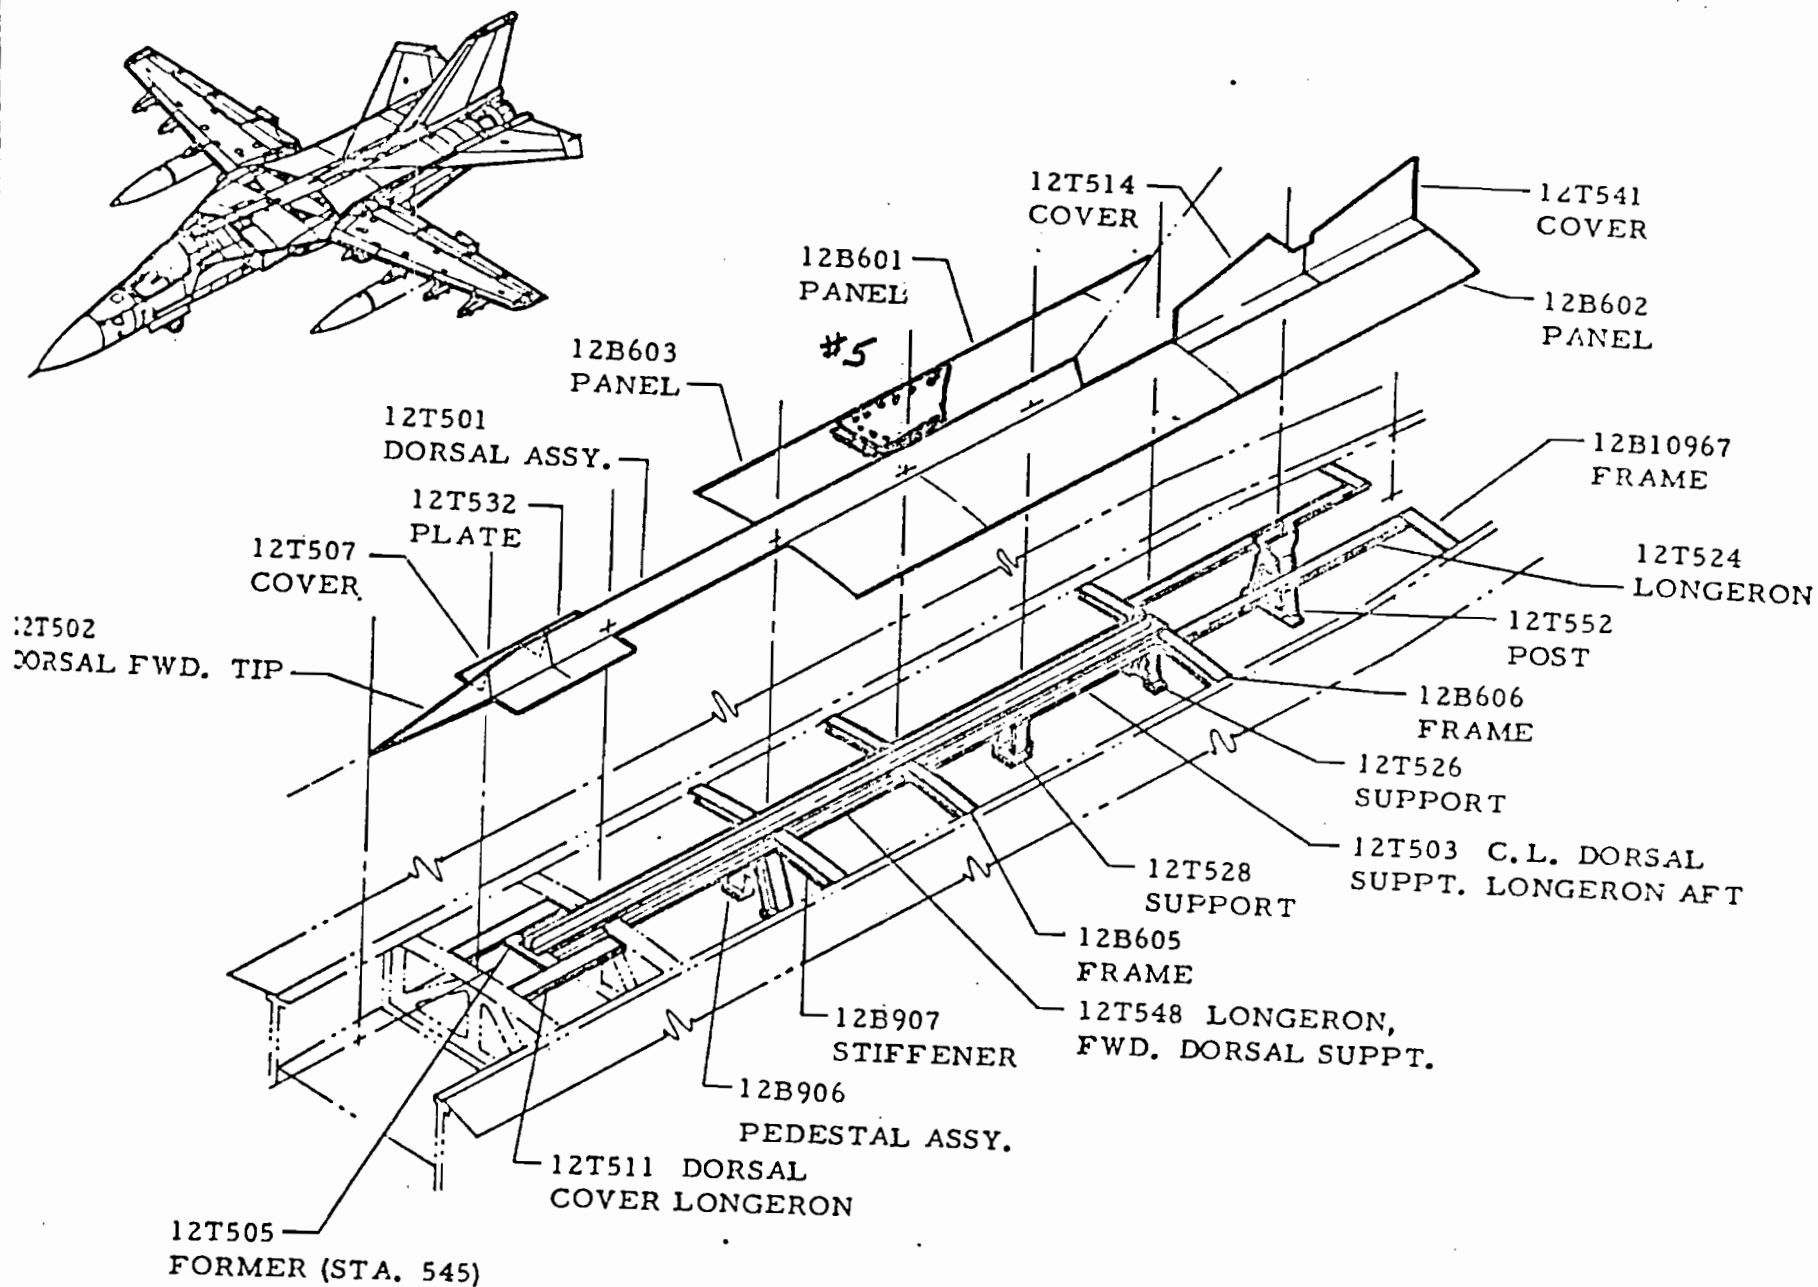
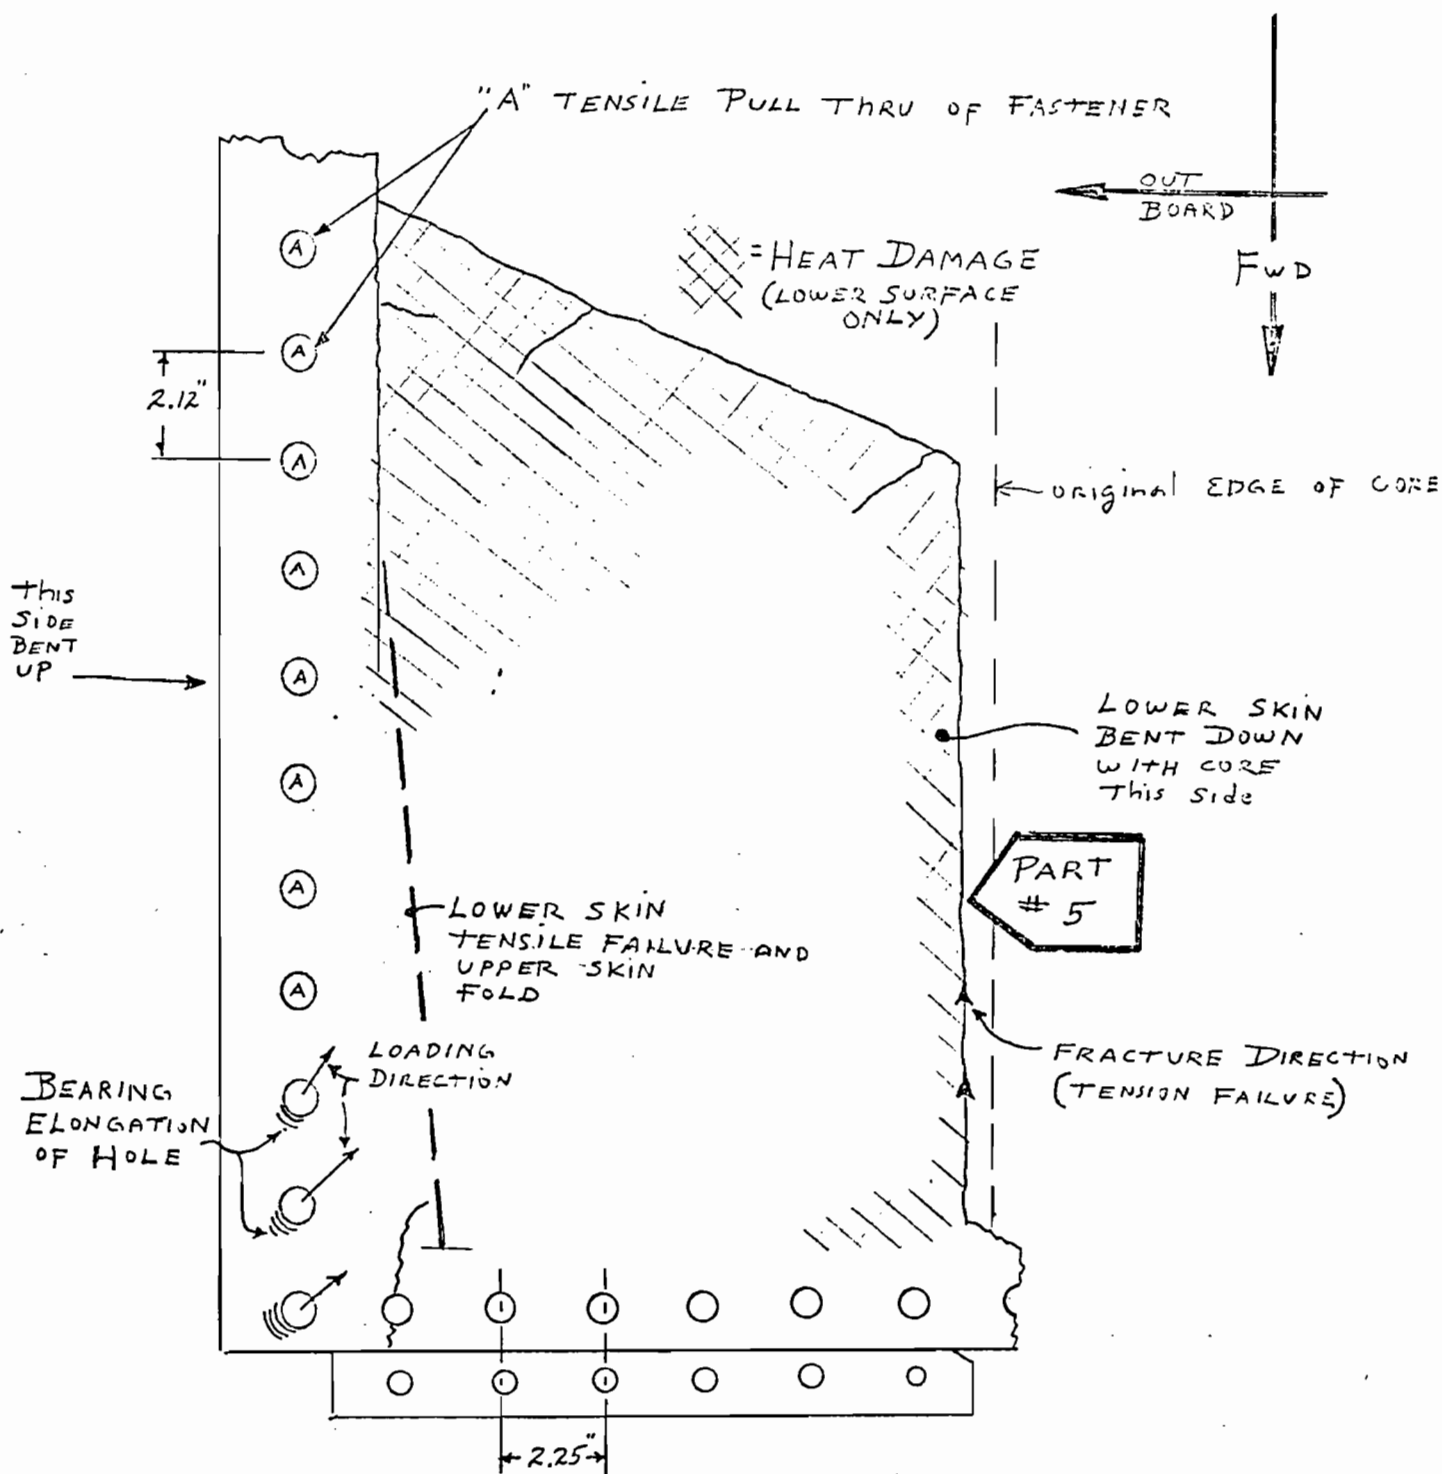
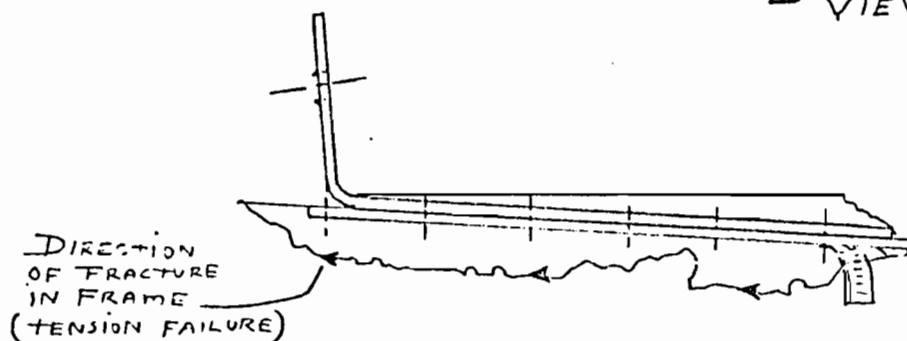
FIGURE 13. FAILURE DESCRIPTION - PART 5. (74)

1. Examination of fracture patterns, folds and hole deformations indicate this panel failed from an upward force. Failure started on the inboard forward corner and propagated both aft and outboard. Except for the forward three holes in the outboard hole pattern, no deformation was present to indicate other than an upward load. The outboard fold occurred prior to separation of the panel from the outboard structure.

2. Evidence of heat or fire damage is present on the lower surface of this panel, mainly on the inboard and aft end of the remaining section. Where separation of the core from the skin occurred, both the adhesive remaining on the core and on the skin show the same heat or fire damage. No evidence of heat is present on the top skin. The presence of fire damage on the delaminated section indicates the damage occurred after break up.

4. Cause of failure is believed to be from a high uniform pressure on the internal side of the panel blowing the panel upward.

- VIEW - Top Side  
LOOKING DOWN.

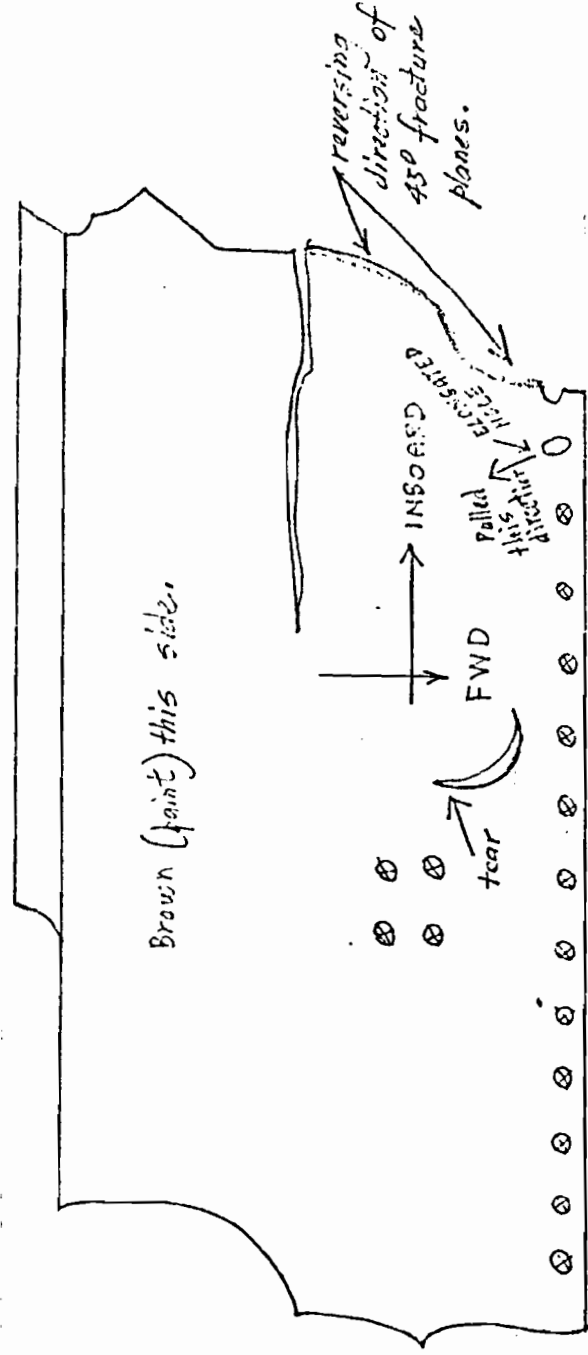
FIGURE 15. FAILURE DESCRIPTION OF PART 6.

# PART MARKED #6

R/H 6436 panel, DWG 12W7620.

Panel is severely bent (damaged) in multiple directions

No fire damage observed.

Fracture is overload (tear). 45° fracture planes were reversing directions.

Cause of failure is impact damage.

6. 6436 Panel - RH upper False Spoiler measure approx 22" span. Both the inbd and outbd section is missing. The section has the support link and fitting was attached. Lower end was broken at the clevis. Panel is severely bent in several directions with the inner skin is peeled and buckled in a down and aft direction.

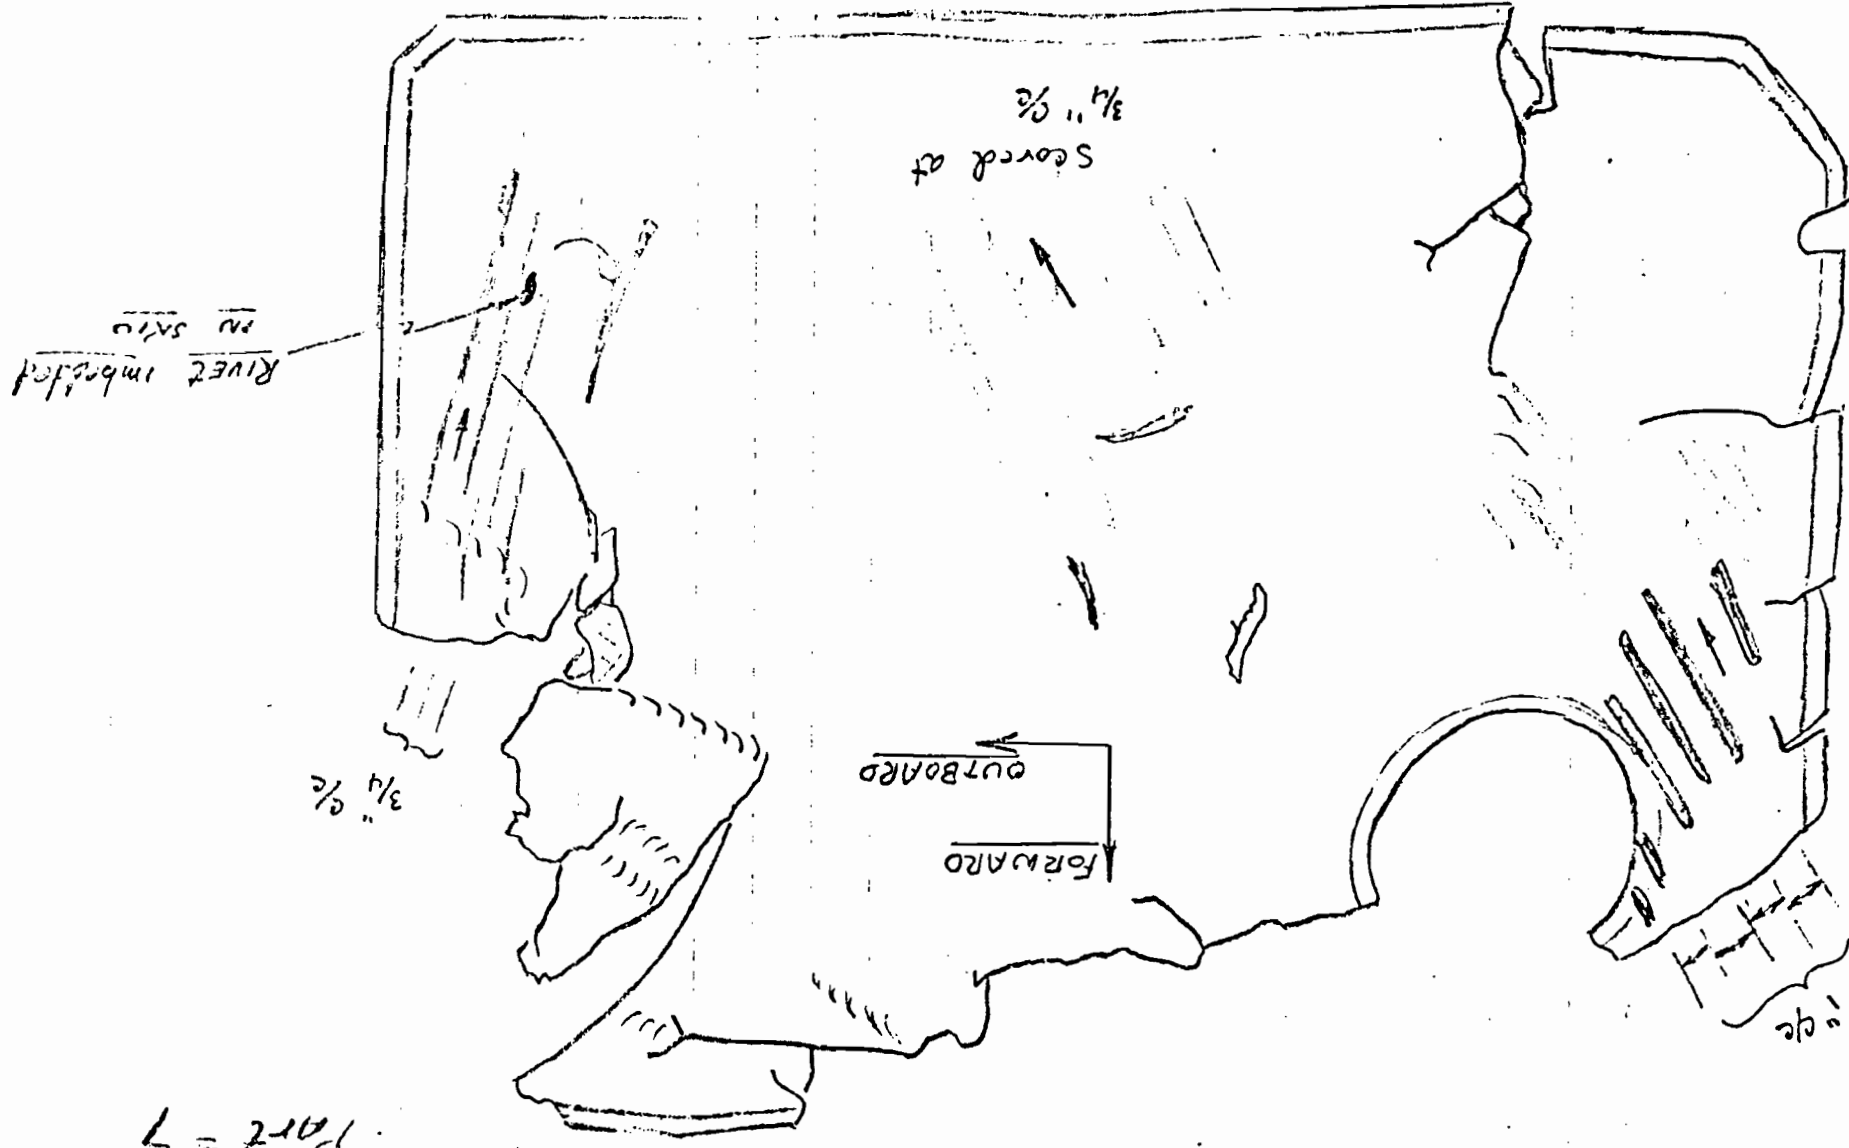
FIGURE 16. FAILURE DESCRIPTION - LOWER SURFACE, PART 7

1. On the upper surface of the panel, the only section of skin remaining was that which impacted the lower surface of the wing rear spar, pivot fitting and bulkhead zero. The skin beyond this area was missing with the core showing relatively little damage from subsequent impact with other pieces. The section of the top skin remaining showed no other impact damage.

The lower skin contained score marks similar to those found on the lower skin of part no. 8, except to a lesser extent. The uniformity of the depth and width of these score marks indicate the panel was relatively flat at the time they were made. The score marks are caused by a rivet pattern.

4. Cause of failure is believed to be from the nacelle structure and high pressure blasting upward into the bottom of the panel. The panel broke loose from the edge members and hit the lower wing surface with high force.

Bonded Assy

P/S 1283911-189
