First, I want to take this opportunity to thank you for giving us your time, insight and information in regard to the ongoing investigation of incident of the F-111A Aircraft (refno 1948), piloted by USAF Captain **RONALD D. STAFFORD** and EWO Captain **CHARLES J. CAFFARELLI**.

SUBJECT: Request for Information Regarding Loss of F-111A Piloted by Ronald D. Stafford (Your Ltr, 18 Oct 88)

- 2 Atch
1. SMAMA Service Engineering  
Report No. 73-511
  2. Operation Sequence Times

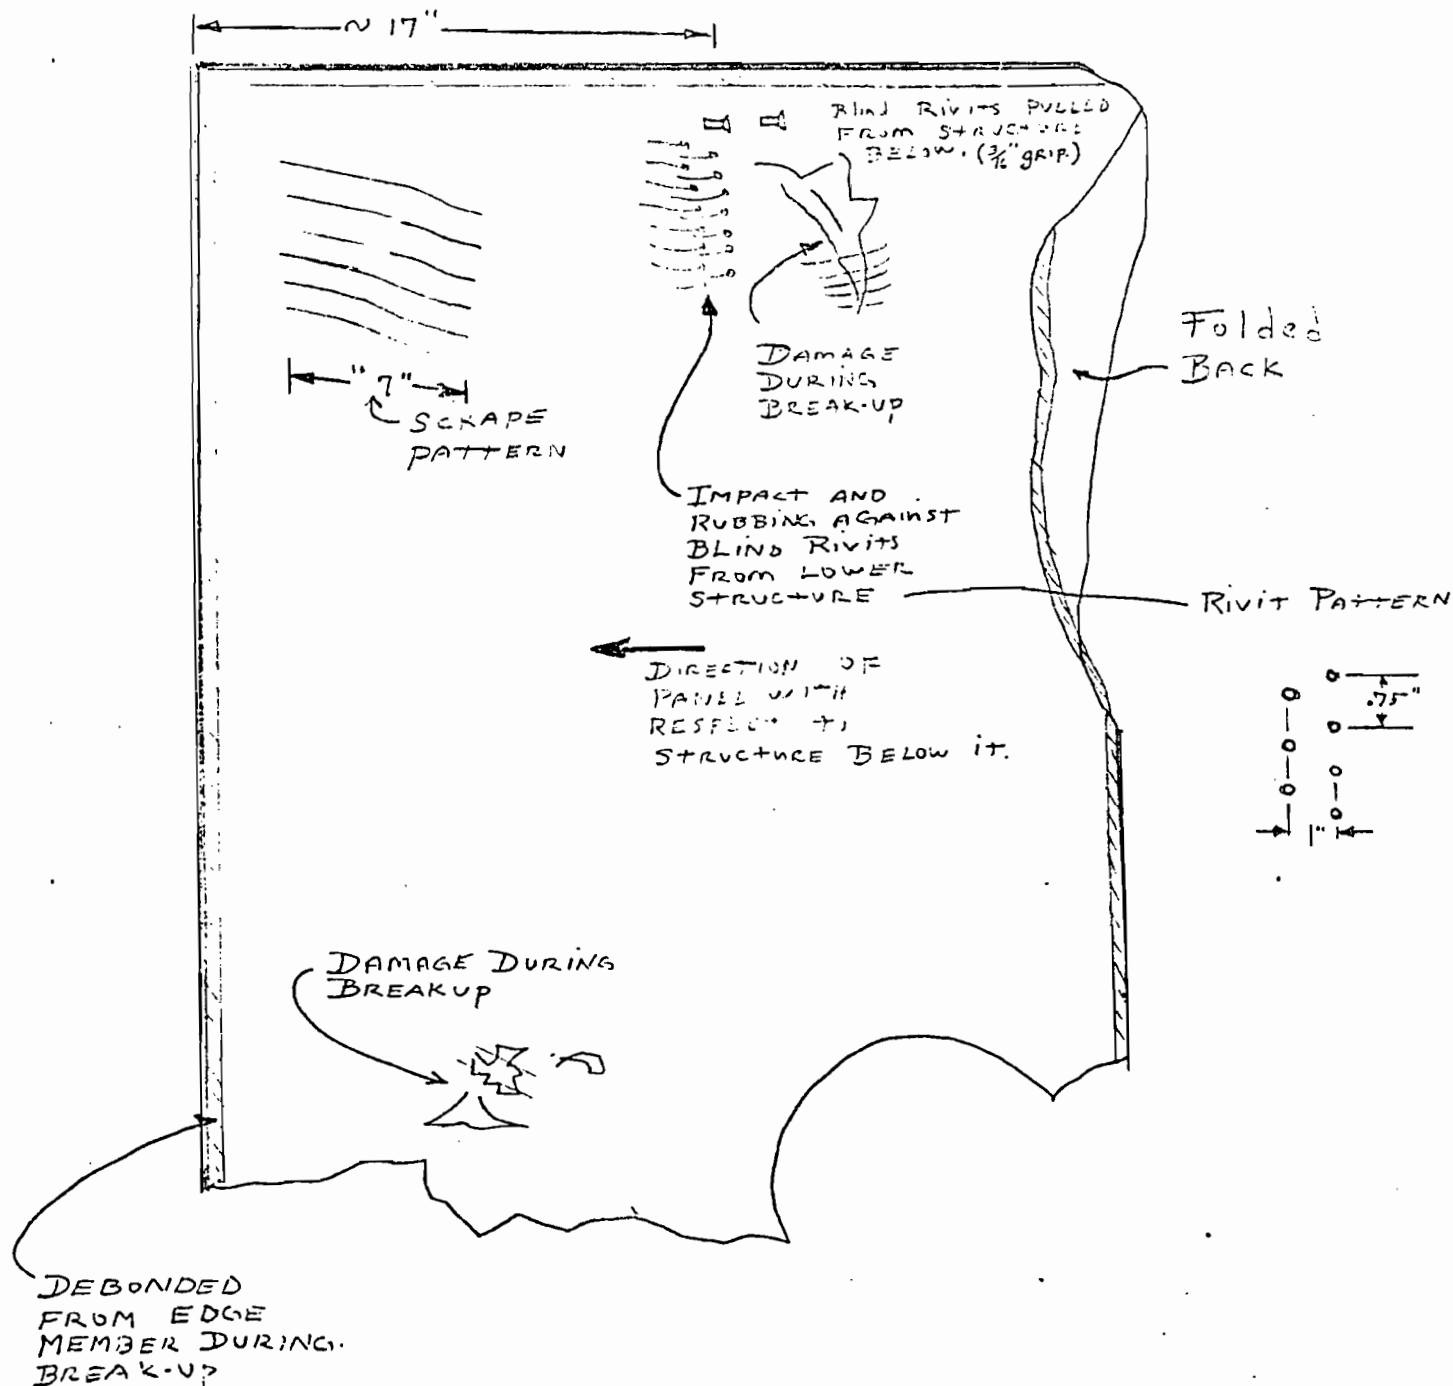
FIGURE 18. FAILURE DESCRIPTION -  
LOWER SURFACE - PART 8.

1. During initial break up, panel was relatively flat and free of folds as scrape marks from rivets in lower structure are continuous. Damage in the form of torn holes and indentations was caused during break up.

4. Cause of failure is believed to be the same as for part No. 7. The nacelle structure and high pressure hit the lower surface. The main difference from Part No. 7 is that the impact with the wing is not as clearly indicated on the upper surface. The panel is deformed, but positive impact evidence is lacking.

BOTTOM SURFACE  
LOOKING UP

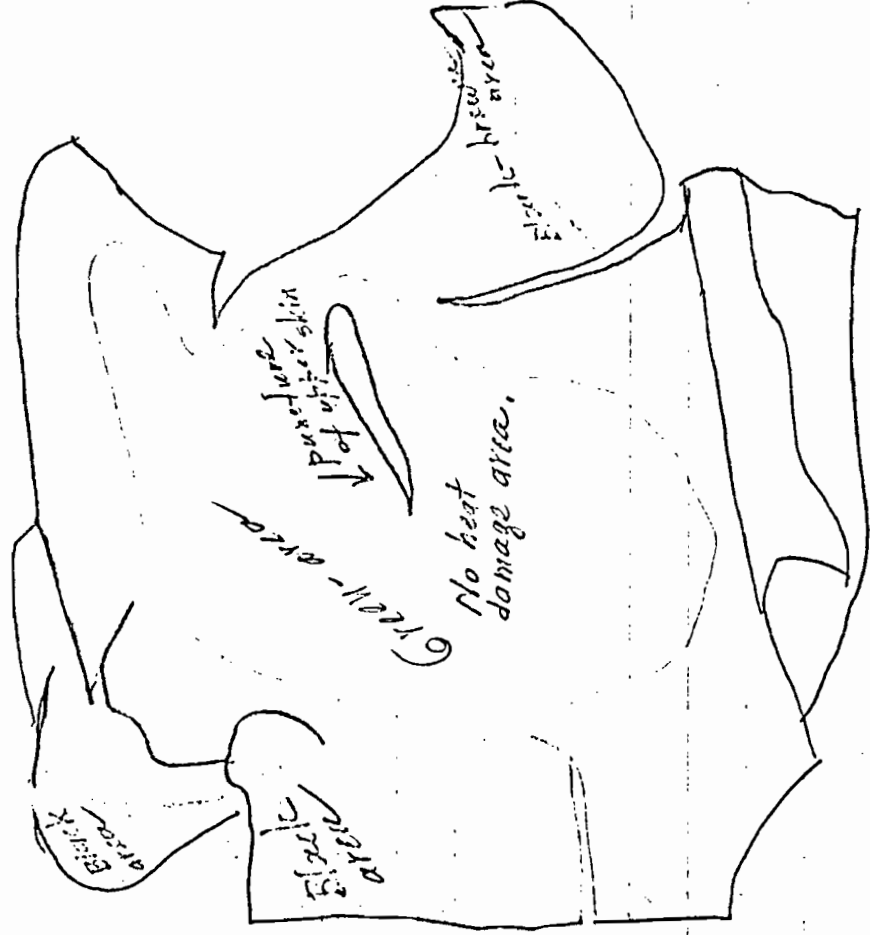
FIGURE 19. FAILURE DESCRIPTION - PART 9

3. Part Number 9 - This part showed the greatest amount of heat damage with the primer paint on the inner surface blistered and the paint on two edges was discolored indicating temperatures in excess of 600°F. Penetration of heat on the two edges was the greatest of any of the above parts. All damage to this part due to heat occurred after disintegration of the aircraft.

# PART #9

NOTES: Fire damage, yellow green paint turned black,  
size: 7"x8" approx., core = honeycomb

Fire damage both sides.

Temp.  $\approx 600^{\circ}\text{F}$  or GREATER.

TEARS AND BLISTERS ON OPPOSITE SIDE.

This part was squashed (impact-compression).

Fractures @  $45^{\circ}$  (vertical).

9. Unidentified - Burned honeycomb piece. Size approx 7" x 8" with core-panel-thickness estimated to be at least 1". Item is torn segment with crushed torn edges on all four sides. One side is primer color with fire predominately on the edges. i.e., predominately free of heat/fire damage. Other side shows significant heat damage over the entire surface. Fire on fractured edges, core, and both inside and outside of skins.

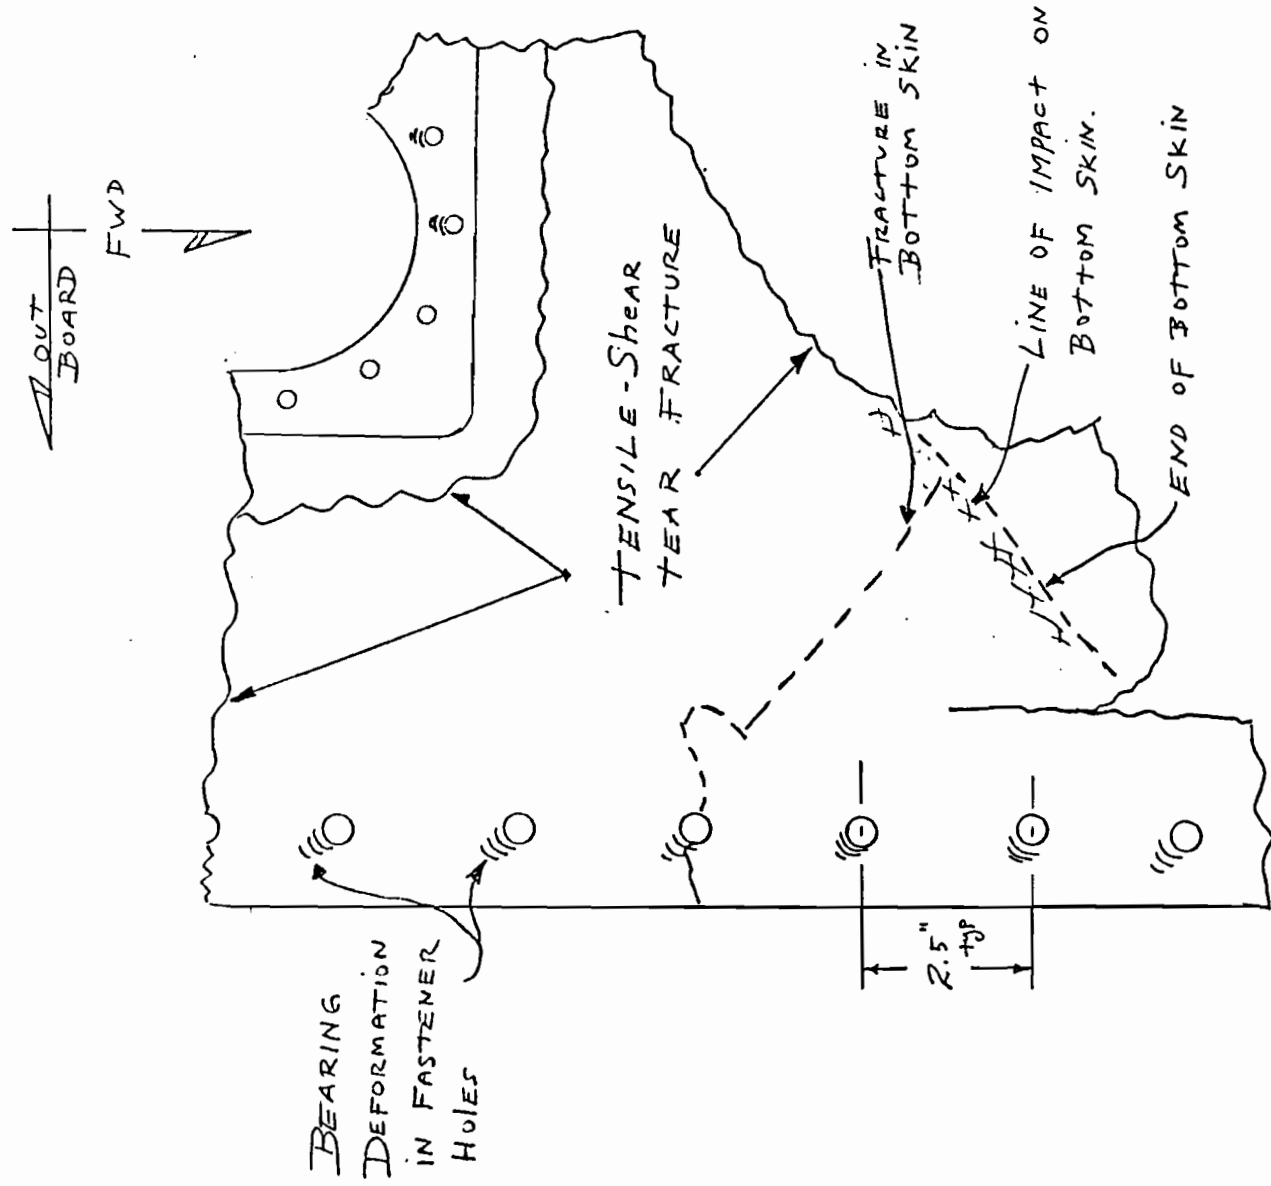
FIGURE 20. FAILURE DESCRIPTION - PART 10.

VIEW  
TOP OF PANEL  
LOOKING DOWN

External skin - brown color with prime inner color.  
3/8" core. Irregular shaped part 12" x 15". No evidence of  
heat or fire damage.
