COMMUNICATIONS**NAVSHIPS****900,000.1****SERVICE NOTES****AN/SYA-1(V); AN/SYA-4(V); MAINTENANCE INSTRUCTION—DATA DISPLAY CONSOLES, CATHODE RAY TUBE (CRT) VARIANCE**

SERVICE NOTES

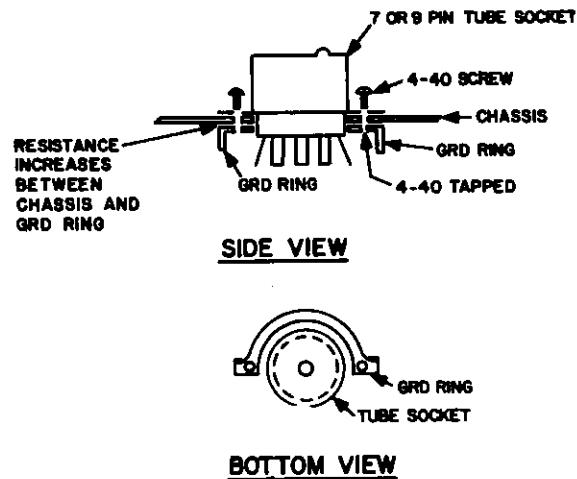
Figure 1.

This article describes the possibility of unusual problems that can be encountered and caused by faulty ground connections. The types of equipment in which ground problems are most likely to be encountered are those whose chassis have been anodized and which employ the half-ring ground tube socket mountings (see figure 1).

The d-c resistance between the half-ring ground and the chassis increase after the equipments, aboard ships, have been operational for several years. The problems are unusual in that the symptoms caused by this condition are never the same, although the units are in the same series.

4. Remove the ground rings causing this faulty condition, and clean the area under ring and chassis. Reinstall the ring and check to see if the condition has been corrected. Use the same method used in step 1 through 3. (668)

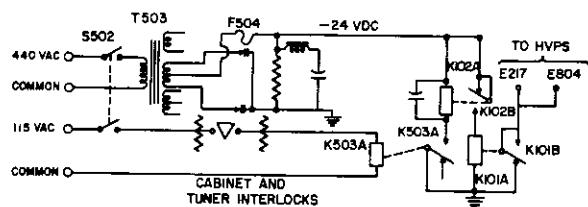
Figure 1.

It can be seen from Figure 1 that, upon start up, relay K503A is energized from 115 VAC through the Equipment Cabinet and Tuner interlocks. Contact K503B then closes to energize K102A from the -24-volt power supply. The normally open contact of K102B then is closed, completing the circuit from -24 volts through K101A coil to ground. When K101A is energized, one of the normally closed contacts on this relay removes the ground from the high-voltage lead which runs between E217 in the Power Supply drawer and E804 in the Radio Frequency Amplifier drawer through the cabinet harness.

Note that relays K101 and K102 are operated from the -24-volt supply. The loss of this supply voltage either from failure of F504 (-24-volt control fuse) or any other reason will result in the cabinet **high voltage bus being grounded continuously**. This could lead to an erroneous conclusion that the high voltage lead in the cabinet harness had arced or otherwise acquired an **Unwanted ground**. Again, any attempt to energize the high-voltage power supply with the transmitter in this condition will result in blowing two or more of the main-line fuses F201, F202, or F203.

On AN/WRT-2 Transmitters, Serial 1 through 263 an indicating type fuse is used at F504. It is important that exact replacement fuses be used and that they be installed in the fuseholder properly (red plunger visible through the clear plastic cap). On AN/WRT-2, serials B1 through B151 and serials C1 through C458, a fuseholder with a built-in neon indicator lamp is used. These indicators should largely eliminate the possibility of overlooking a blown F504 fuse. (656)
