**NAVSHIPS 0967-000-0030**

**ELECTRONICS  
INSTALLATION  
AND  
MAINTENANCE BOOK**

**SONAR**

**Change 5: February 1967 (0967-000-0035)**

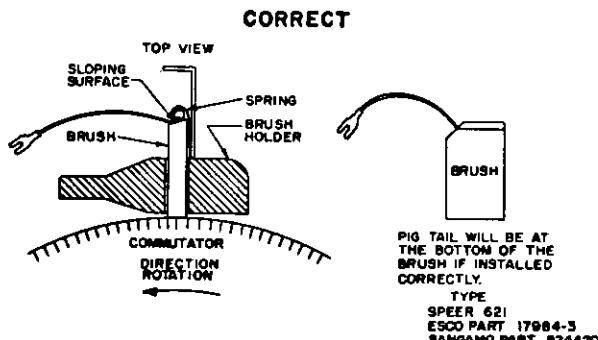
Figure 1.

as shown in figure 1. Figure 2 shows improper mounting.

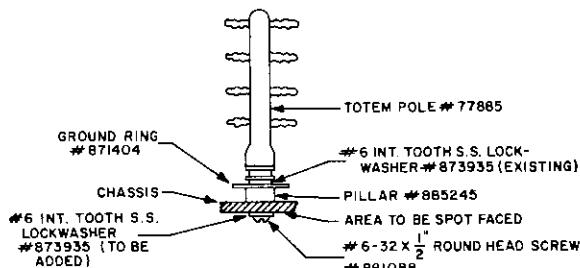
Figure 1

Several recent instances of "double keying", "short transmission sector", "keying lockout", etc., have been traced to an improper connection between the JP terminal post ground ring and chassis ground in the keying chassis.

The No. 6-32 X 1/2" mounting screw must be removed while holding the JP terminal post firmly against the chassis so that the "pillar" and "ground ring" lockwasher will not be disturbed. Remove all paint from the area under the screwhead. The added lockwasher is installed directly under the head of the mounting screw and the entire assembly should be firmly secured.
