COMSTSINST 3541.5B
13 Sep 1965

Section 7.4

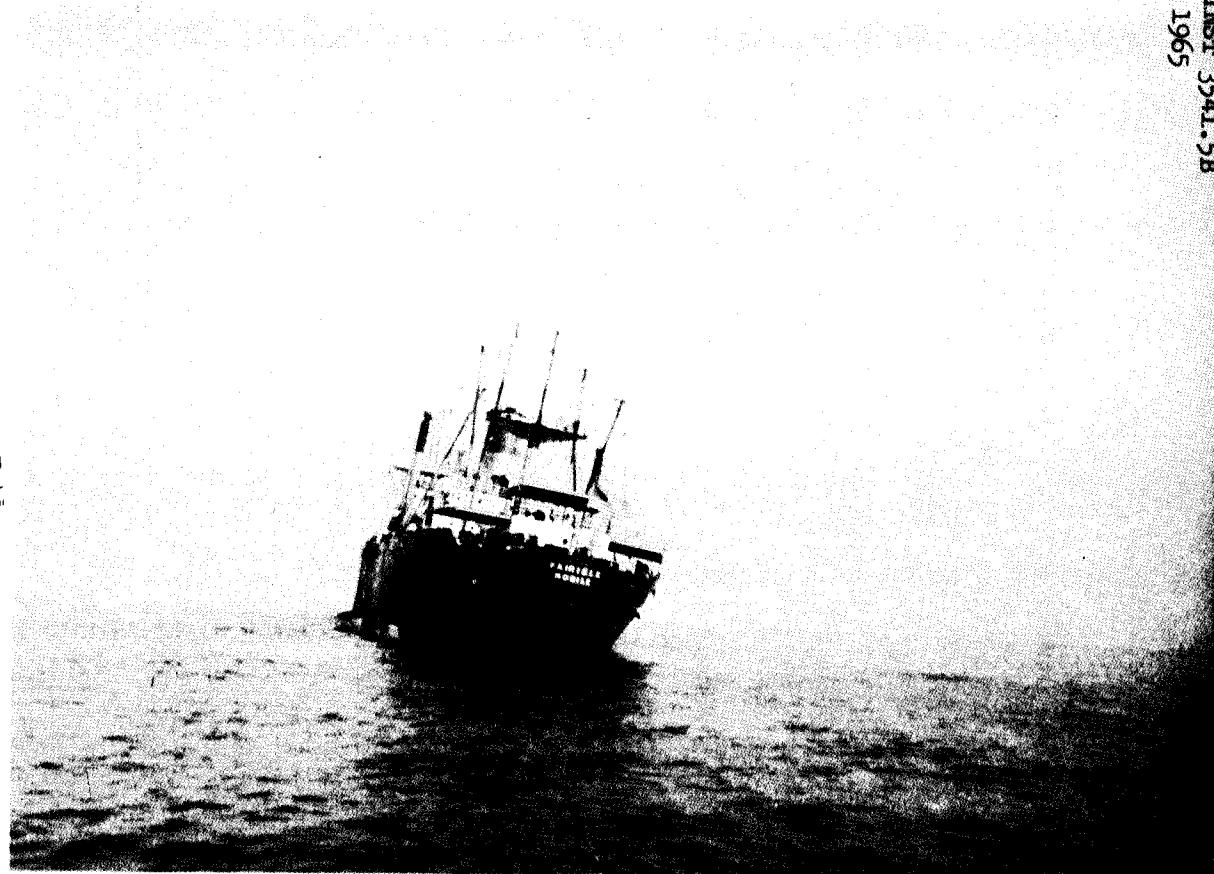
FAIRISLE lists sharply to starboard 23rd July 1956, after collision with SAN JOSE II under almost identical conditions to the DORIA'S two days earlier and in the same area. She limped into N.Y. harbor and was beached in Gravesend Bay.

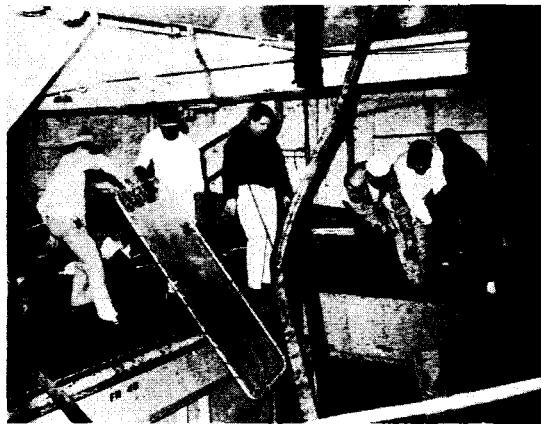
DEBRIS REMOVAL is supervised by Chief Steward John McLoughlin (dark jacket, center). Lower area of number 2 hold was flooded when *Marine Carp* was damaged by an ice floe.

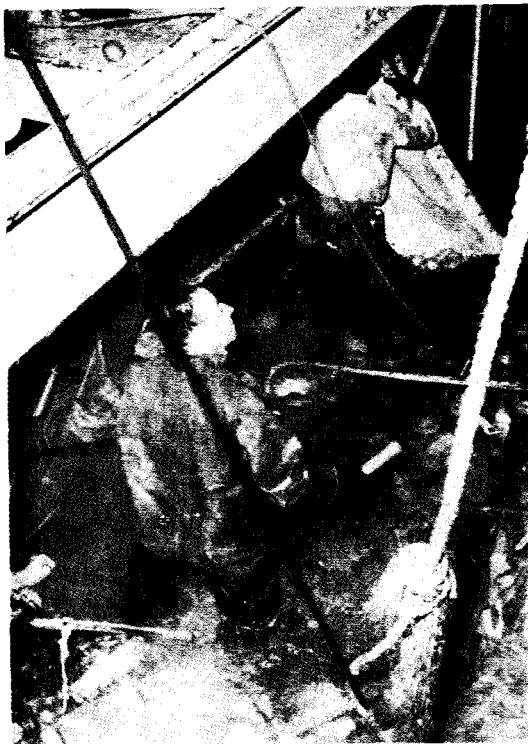
CAREFUL SEARCH for submerged debris which could clog the eductors is made by USNS *Marine Carp*'s master, Capt. W. J. Patnaude. Incoming water washed bedding from above spaces.

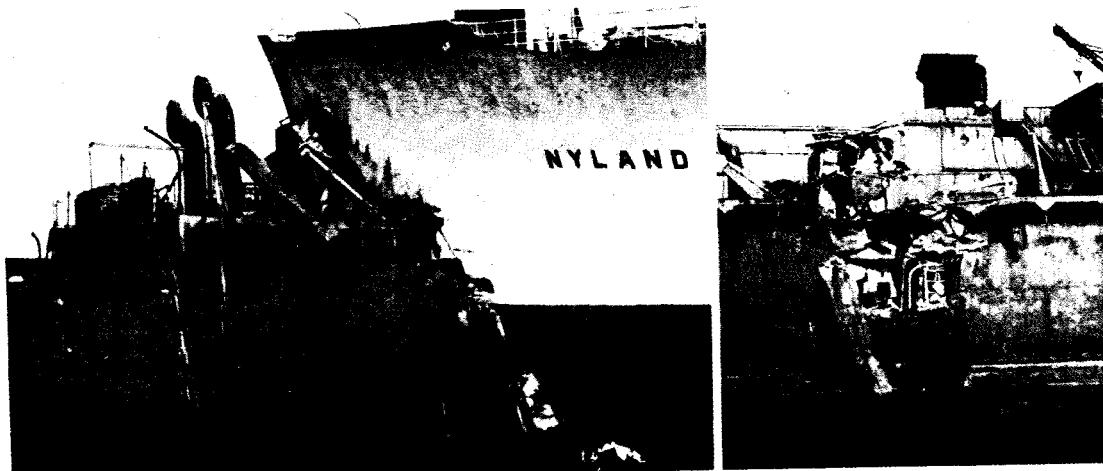
BATTERED grain hulk, laid up in a Maritime Commission reserve fleet, was opened up on the starboard side by a cargo ship (left). After the ships were separated, the gaping hole revealed damage to living spaces and engine room (right).

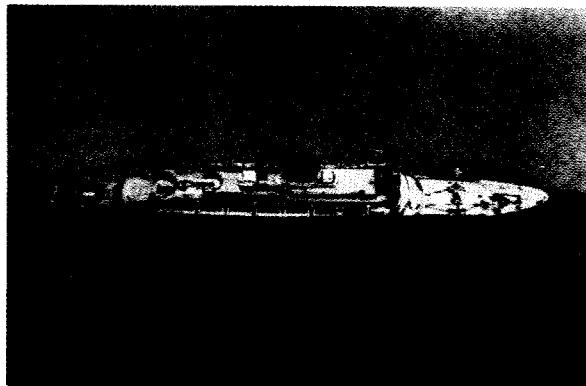
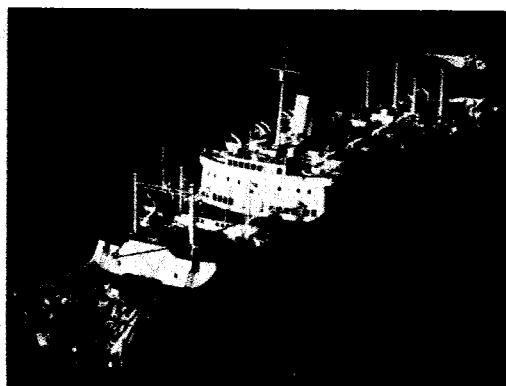
MAIN DECK AWASH, the ill-fated Italian liner *Andrea Doria* (left) settles into the sea off Nantucket following a collision with the Swedish liner *Stockholm* (right). The accident occurred in the open sea despite the fact that both ships had radar systems.

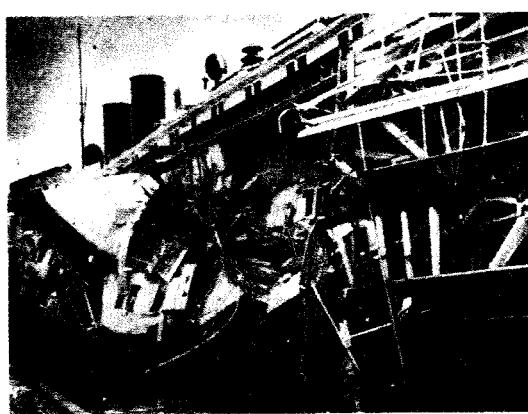
IMPACT of collision in fog opened up the port side of this Great Lakes steamer. A collision can never be blamed solely on fog.
