COMSTSINST 3541.5B  
13 Sep 1965

## Section 7.12

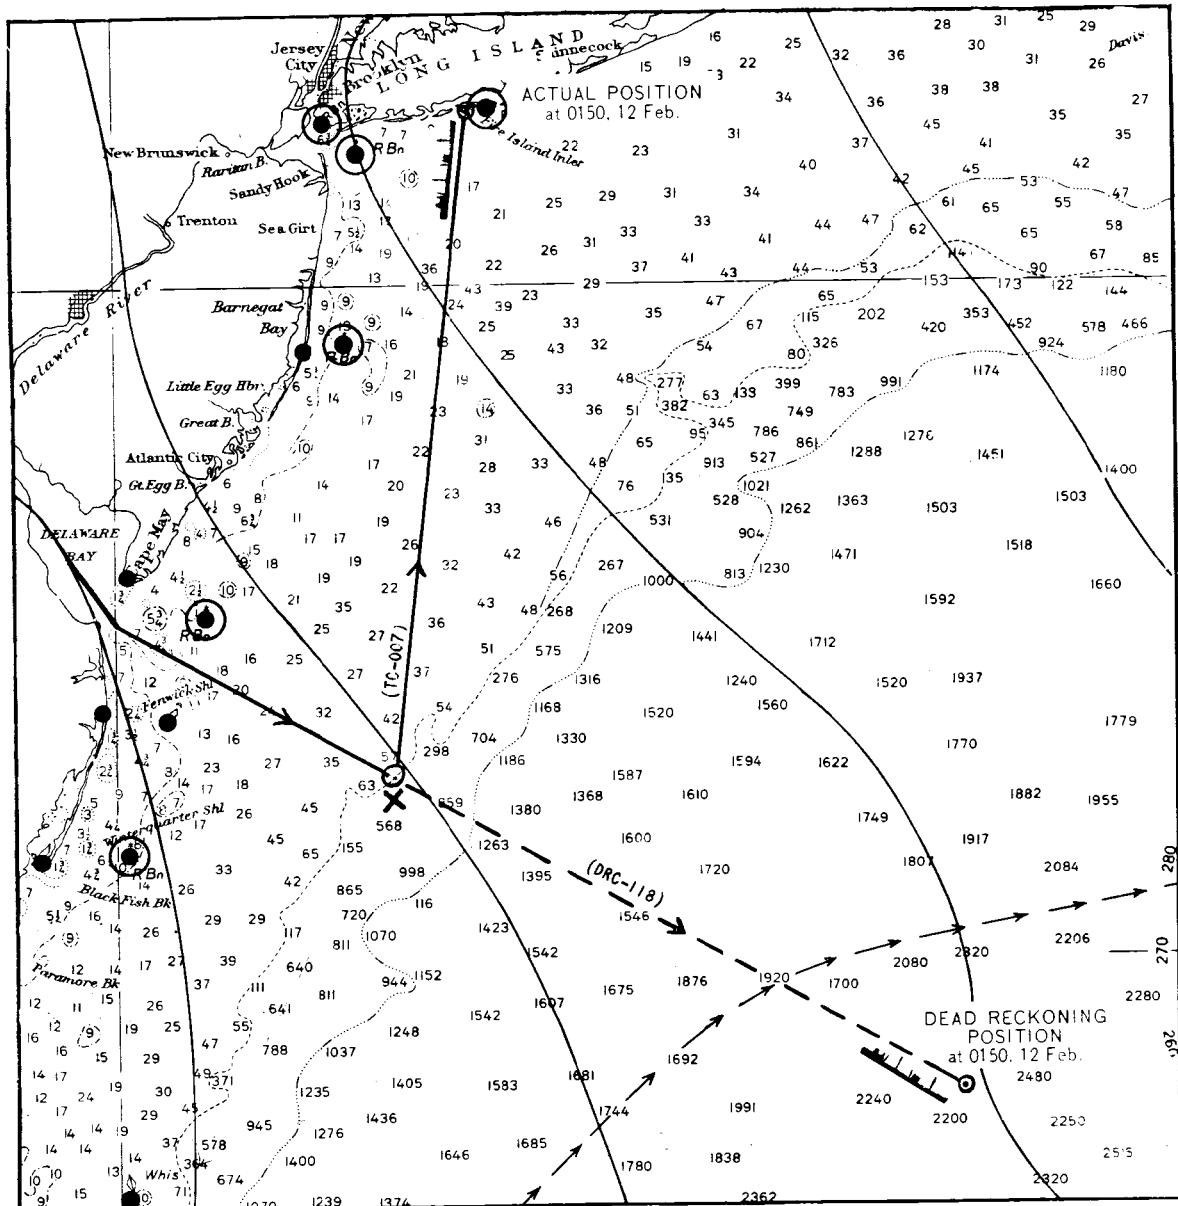
Ten minutes after the correct course was set by gyro compass, the repeater system failed and the repeaters froze on  $118^\circ$ . Fifteen minutes later, the derangement corrected itself. The repeaters, however, were out of synchronization with the master gyro. Although the repeaters indicated a heading of  $118^\circ$ , the ship had swung left to a course of  $007^\circ$  true.

ACTUAL AND DEAD RECKONING COURSES OF THE TANKER. Chart furnished by *Proceedings of the Merchant Marine Council*.

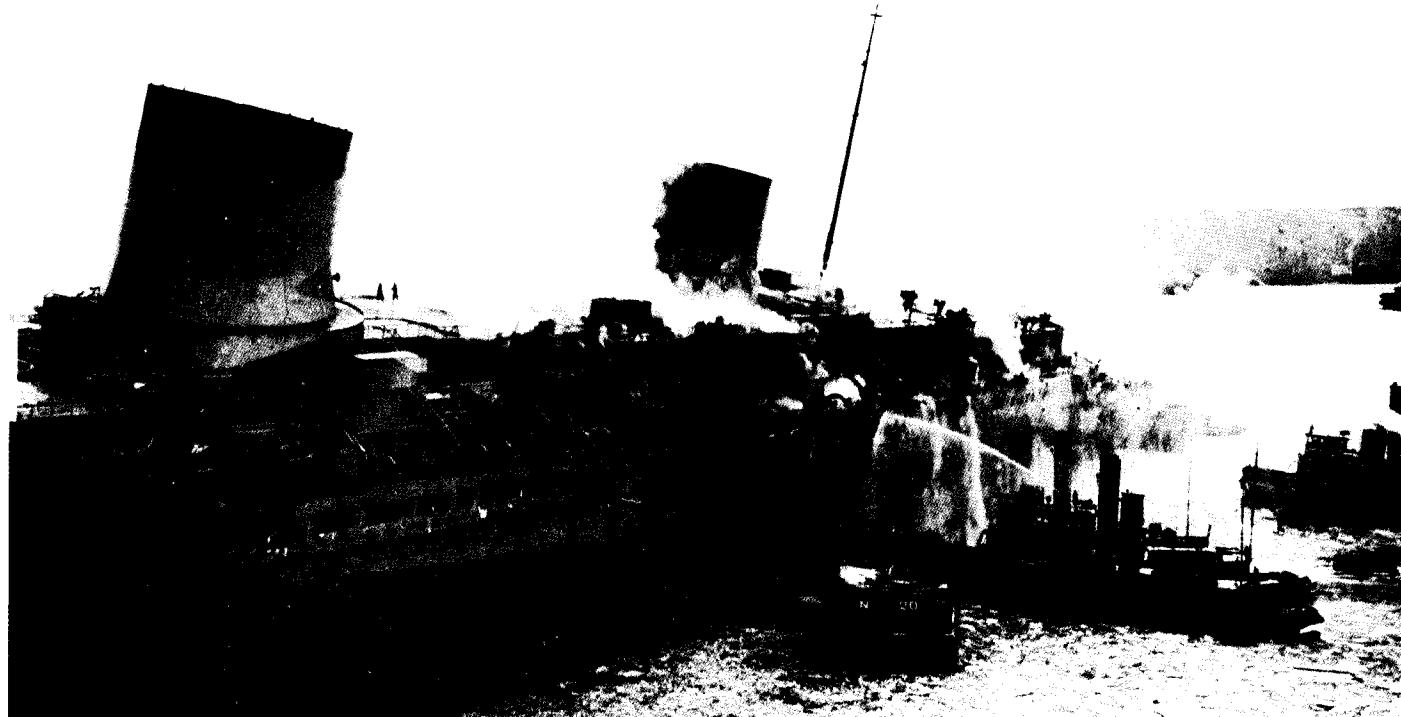
NORMANDIE afire at Pier 88 New York, 9 February 1942. Her fire  
and capsizing prevented completion of her conversion as a troop transport.  
(USCG Photo).

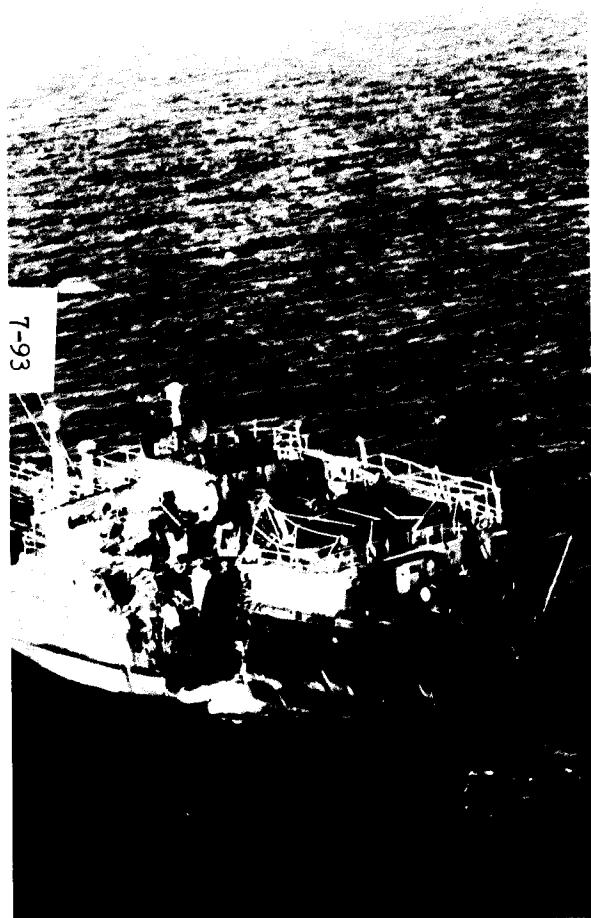
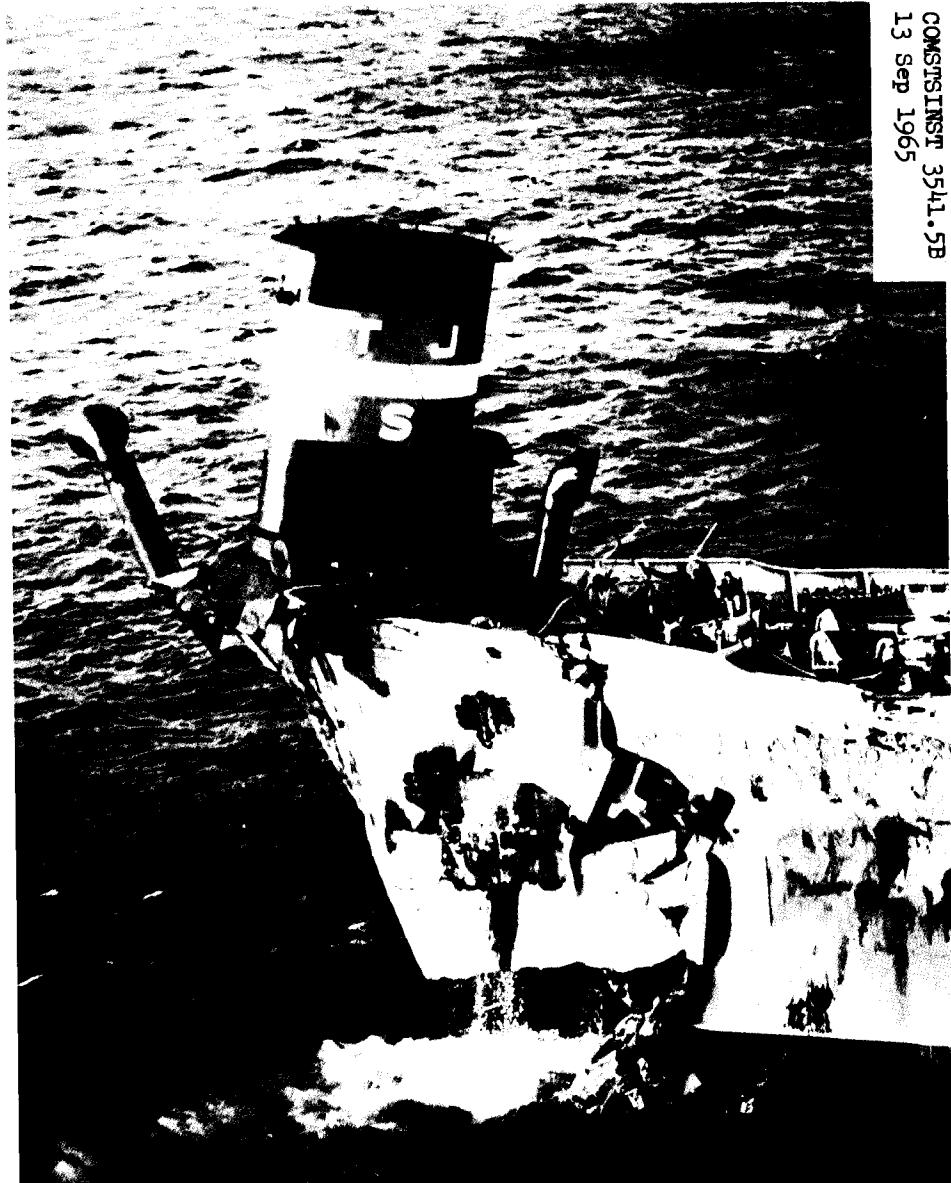
VALCHEM & SANTA ROSA AFTER  
COLLISION IN FOG, MARCH 26, 1959,  
OFF ATLANTIC CITY. FOUR DEAD  
SIXTEEN INJURED ON TANKER.

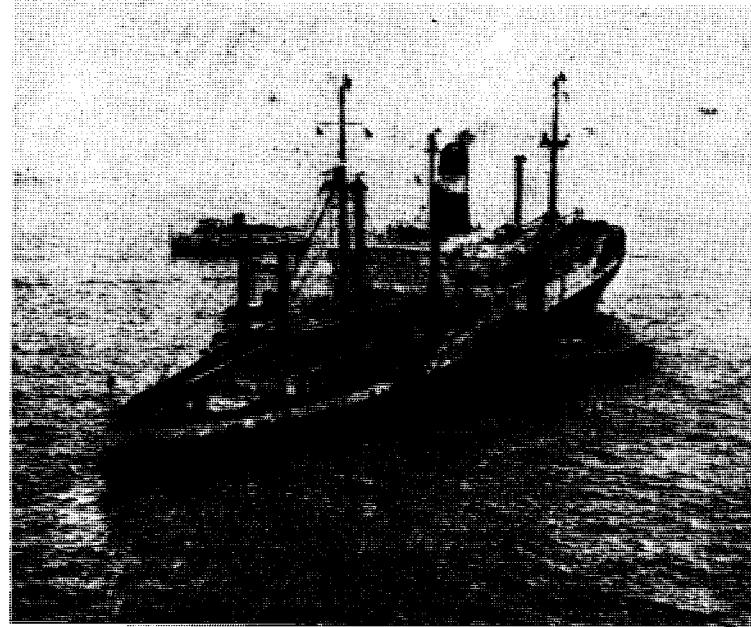
BEACHED: Shortly after the collision the SS *Excalibur* was put ashore on Bay Ridge Flats where she stayed for 10 days preparing for shift to a nearby New York shipyard.

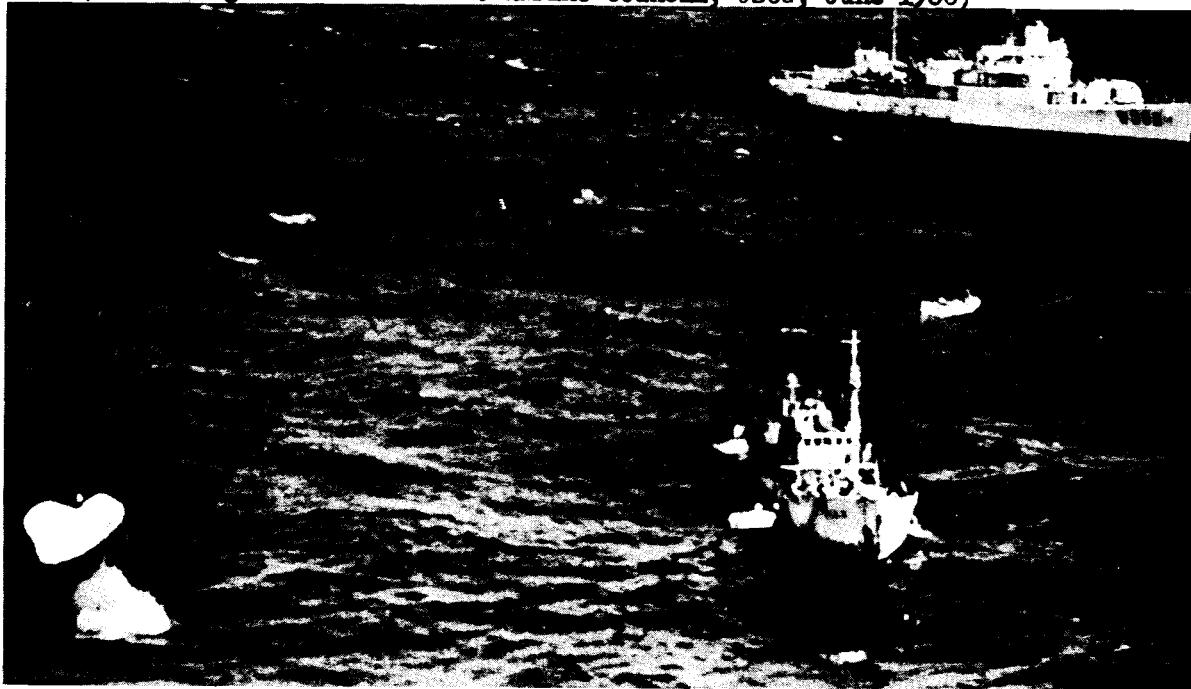
SUCCESSFUL air-drops of 2,500 pounds of cement, gravel, sand, pump and other equipment from a new Coast Guard "Hercules" plane to assist the disabled vessel *Toyama Maru* (foreground). A work boat from the Cutter *Bering Strait* (background) retrieved the material and the cutter's damage control crew boarded the *Toyama Maru* to make temporary repairs.

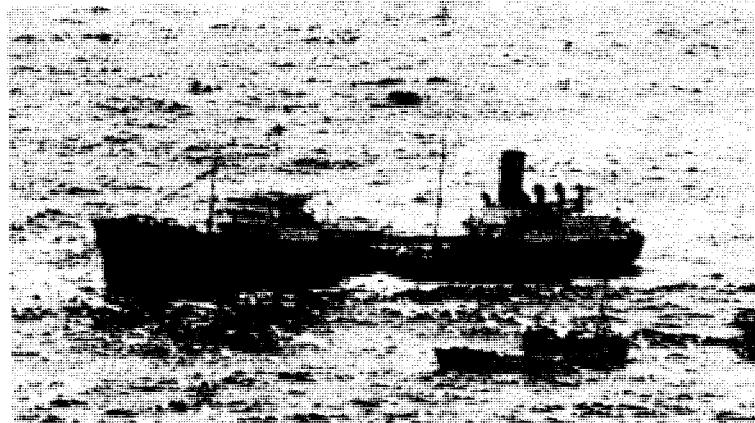
PICTURED is the tanker M. E. *Lombardi* maneuvering along side the disabled Japanese fishing-training vessel *Toyama Maru*.
