COMSTSINST 3541.5B  
13 Sep 1965

# CASUALTY REVIEW

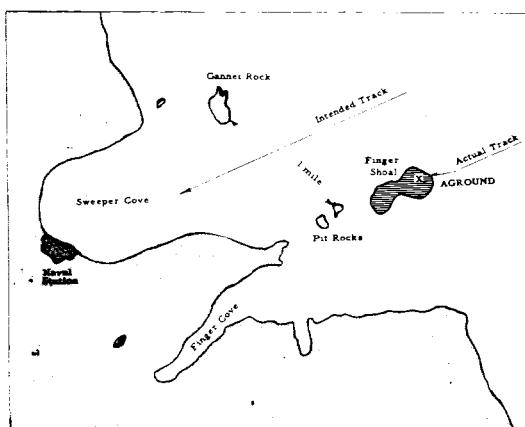
DIAGRAM OF USNS MANN GROUNDING ON FINGER SHOAL.

Under unfavorable conditions of weather and visibility with known dangers in close proximity, *Mann* was navigated at excessive speed with insufficient personnel posted for adequate navigational and lookout duties. Accurate plotting of the ship's track was not performed nor were complete records of navigational data kept in logs or bell and bearing books. There

is evidence of inadequate study by the navigational personnel of pertinent charts, light lists, sailing directions, and other navigational aids and, also that these aids were not corrected to conform to latest available information. Anchors were not manned on entering port. It was developed that the master possessed very little knowledge of the maneuvering characteristics of his ship nor did he know where such data could be found. The report of the investigating officer lists 40 such departures from good seamanship and navigation practices in the opinions section. COMSTS and the administrative commander's instructions were not followed, were improperly maintained, and were not fully disseminated to subordinate personnel by the master.

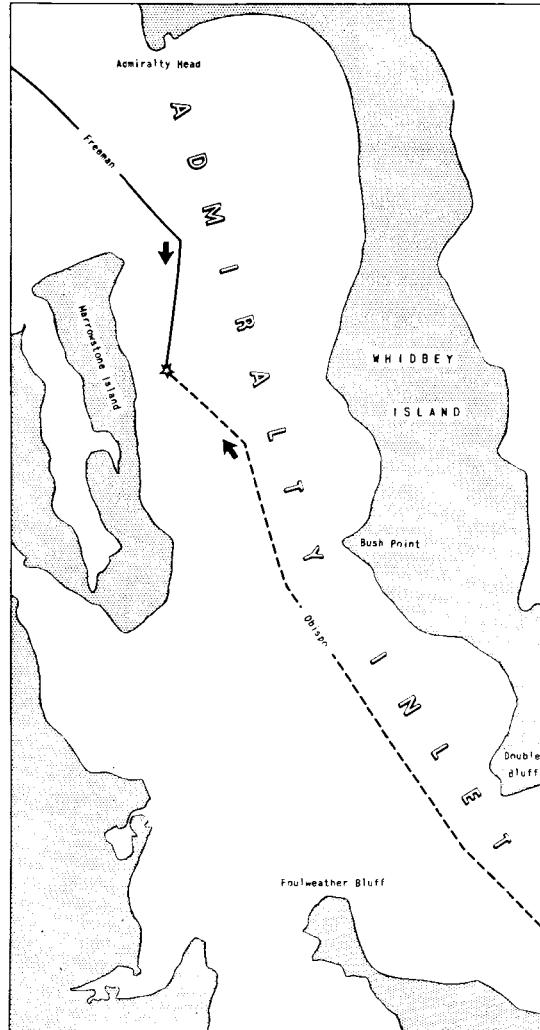
CHART SHOWS FREEMAN AND OBISPO TRACKS TO COLLISION

- **USE RADAR PROPERLY AND ACCURATELY**—In order to use radar as it should be used, its information should be plotted and interpreted accurately and a track maintained of the other vessel. This includes converting relative radar observations to true before any conclusions can be made on the true course and speed of another vessel.
