MILITARY SEA TRANSPORTATION SERVICE, PACIFIC
NAVAL SUPPLY CENTER
OAKLAND, CALIFORNIA 94625

SPECIFICATION NUMBER: MSTSP 70-11

REGULAR OVERHAUL

USNS GEN. JOHN POPE (T-AP 110)

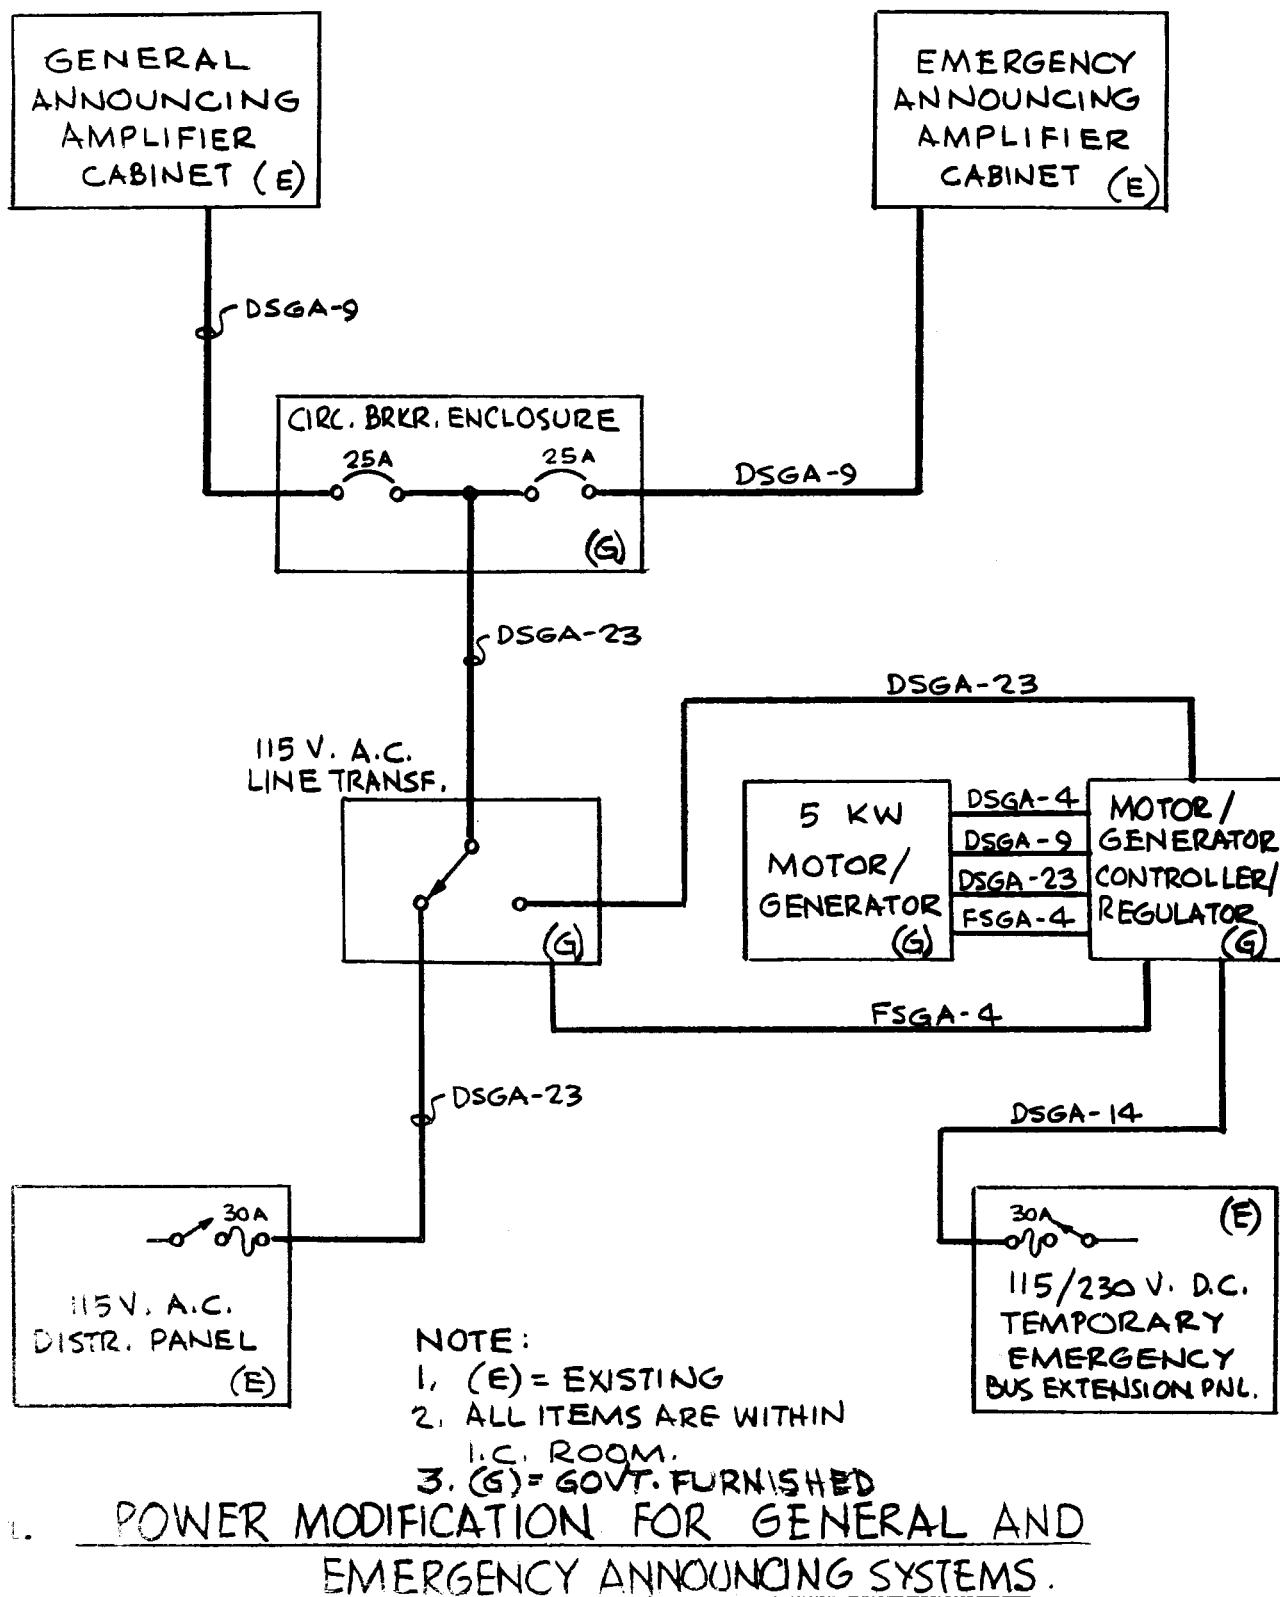
FIGURE 1. POWER MODIFICATION FOR GENERAL AND EMERGENCY ANNOUNCING SYSTEMS.
