USNS GENERAL EDWIN B. PATRICK (T-AP 124)
c/o Fleet Post Office
San Francisco, California

A-D-D-E-N-D-U-N

ANNUAL OVERHAUL REPAIR LIST

VOYAGE No. 156

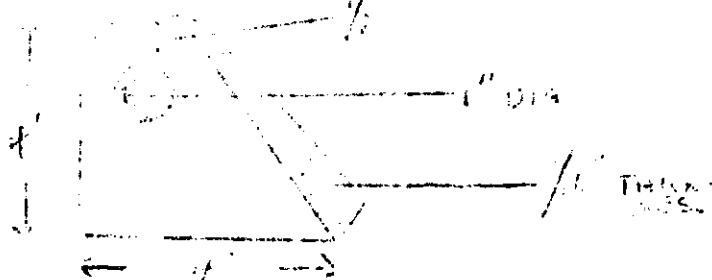
HINGE PADS - NO.5 HATCH - REPLACEMENT

Eight (8) pads as per accompanying sketch.

Burn off existing pads and replace with new.

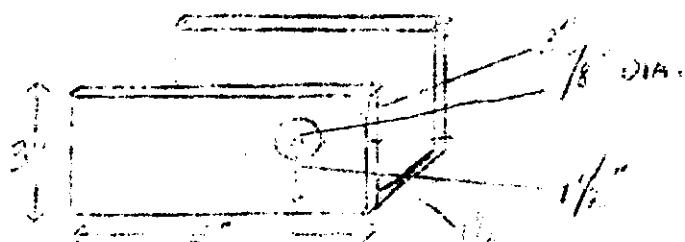
RETAINER CHANNELS FOR DOGS ON HATCH
NO.5 COAMING

Broken and bent by stovedores continually securing cargo hook under coaming.

Two (2) - Size as per accompanying sketch.

Crop out remainder of channels, repair and fair up bent sections of coaming on each side of hatch and weld new channels into place so that dogs will line up with lips on hatch cover. Crop out wasted section of stiffeners and build up with new material extending up to coaming.

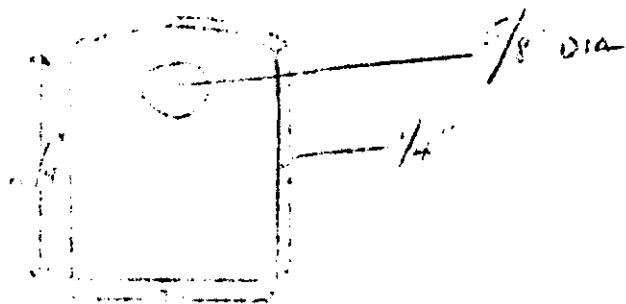
On forward and after side of Hatch No.5 the coaming is part of the ladderwells leading down into the trunk of the hatch. At present there exist five (5) inch channels in these coamings for the dogs. Due to debris collecting in these channels dogs are inoperative & also the channels form a constant leaking source into the ladderwells.

Eight (8) ears for four (4) dogs

Burn off the existing channels under the coaming. Close the resulting holes & substitute dogs ears on top of coaming. Now dogs will have to be five & one-half inches in length ($5\frac{1}{2}$ "').
