USNS GENERAL EDWIN D. PATRICK (T-AP 124)  
c/o Fleet Post Office  
San Francisco, California

A-D-D-E-N-D-U-M

ANNUAL OVERHAUL REPAIR LIST

VOYAGE No.156

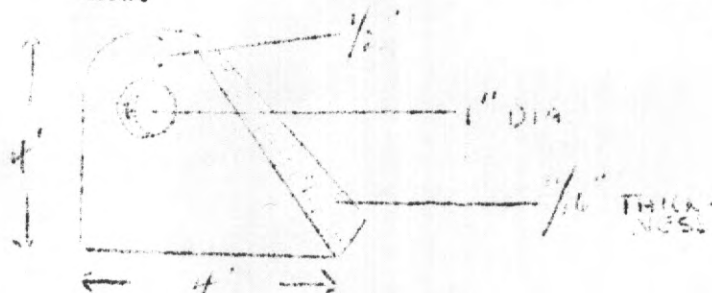
101 (Contd from Page No.43)

| ITEM No. | PRIORITY | SUBJECT & DESCRIPTION |
|---|---|---|
| 101 | 3 | SUBJECT: <u>HINGE PADS - No.5 HATCHCOVER -REPLACEMENT</u><br>DATA: N/A<br>LOCATION: Forward coaming No.5 Hatch - 01 Level<br>CONDITION: Hinge pads were originally made to fit a one inch (1") diameter pin. Eyes are elongated to approx. one & one half (1½) inches. |

Eight (8) pads as per accompanying sketch.

Burn off existing pads and replace with new.

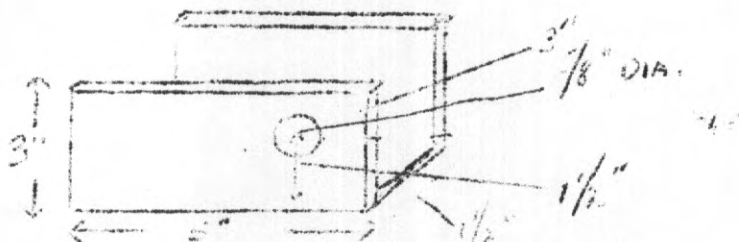
102

Broken and bent by stevedores continually securing cargo hook under coaming.

Two (2) - Size as per accompanying sketch.

Crop out remainder of channels, repair and fair up bent sections of coaming on each side of hatch and weld new channels into place so that dogs will line up with lips on hatch cover. Crop out wasted section of stiffeners and build up with new material extending up to coaming.

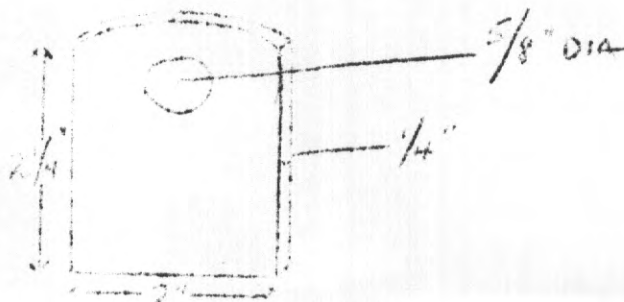
103 (Contd from Page No.44)

On forward and after side of Hatch No.5 the coaming is part of the ladderwells leading down into the trunk of the hatch. At present there exist five (5) inch channels in these coamings for the dogs. Due to debris collecting in these channels dogs are inoperative & also the channels form a constant leaking source into the ladderwells.

Eight (8) ears for four (4) dogs

Burn off the existing channels under the coaming. Close the resulting holes & substitute dogs ears on top of coaming. New dogs will have to be five & one-half inches in length (5½").
