MANC (Metallurgical Laboratory)

Right #4 Bellcrank (ASA 7075 T-6 Aluminum Alloy Forging)

Task #1128, Attachment #7

Metallurgical Analysis

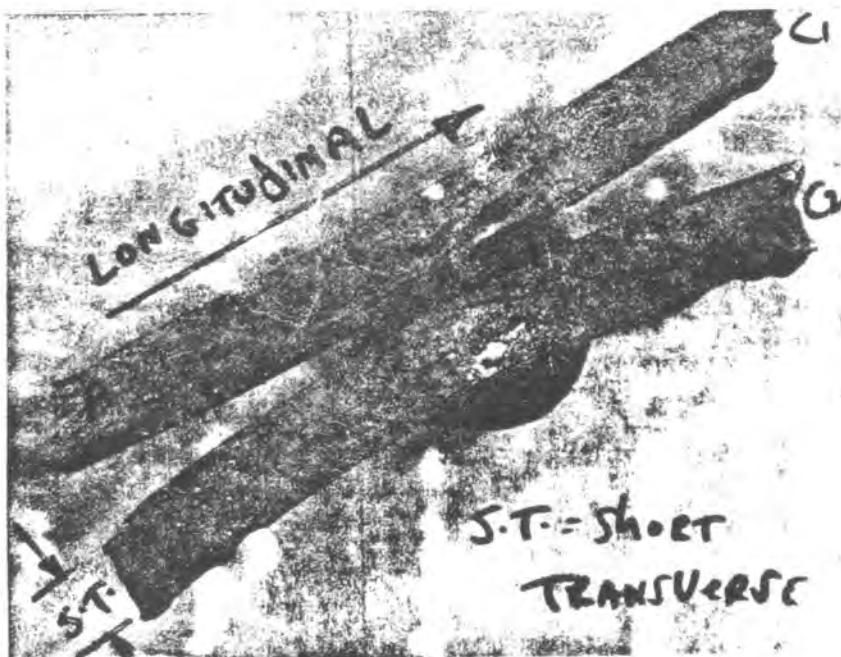
Photo 3

Flange segments C1 & C2 separated at the laboratory. Areas marked "A" are fresh lab fractures. Both segments appeared discolored & exhibited considerable corrosion on old fractures, similar to crack surfaces previously examined in this analysis.

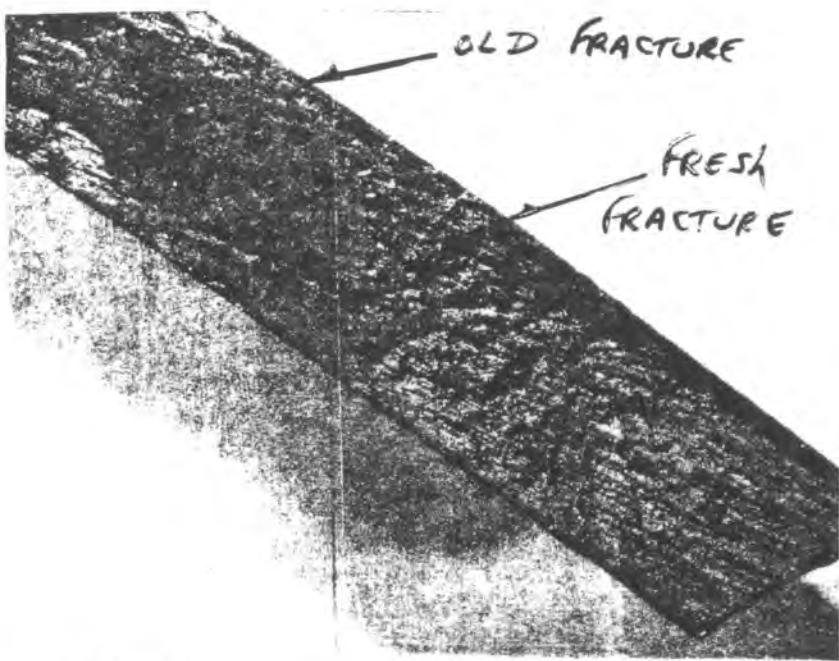
Photo 4

Difference in texture between fresh lab fracture and old fracture on C1 segment. "A", "B", & "C" indicate corresponding areas where fractographs shown in Photos 5-7 were taken.

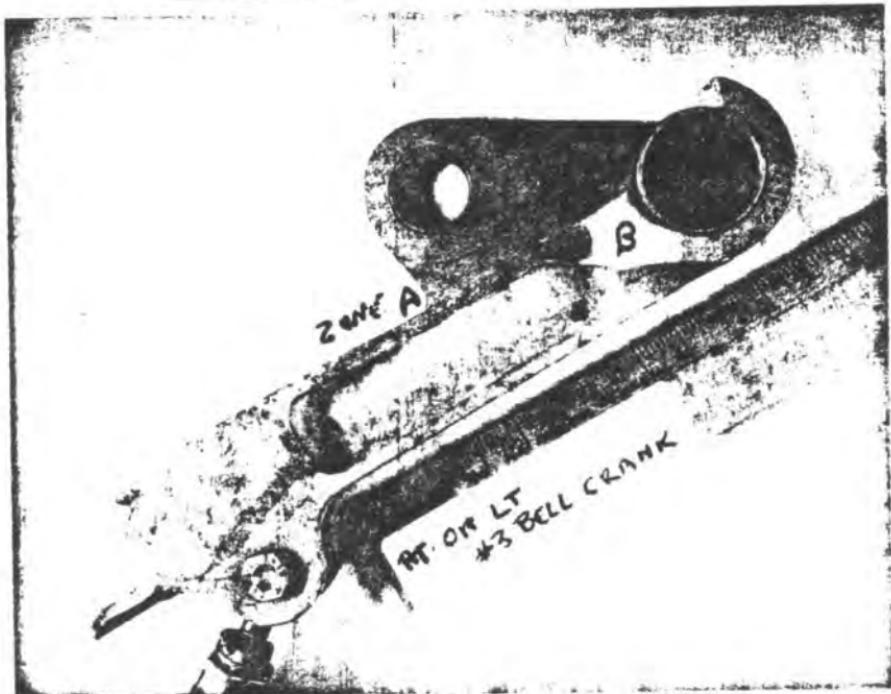
Photo 4. Separated Crack Surface on #3 Bellcrank. 5/8X
On This Examination, Crack Appears Progressive,
Emanating from Edge of Flange, Point "A", and Along
Full Length of Recess to Point "B". Light Area
is Area of Final Separation, Where Crack was Separated
at Laboratory.

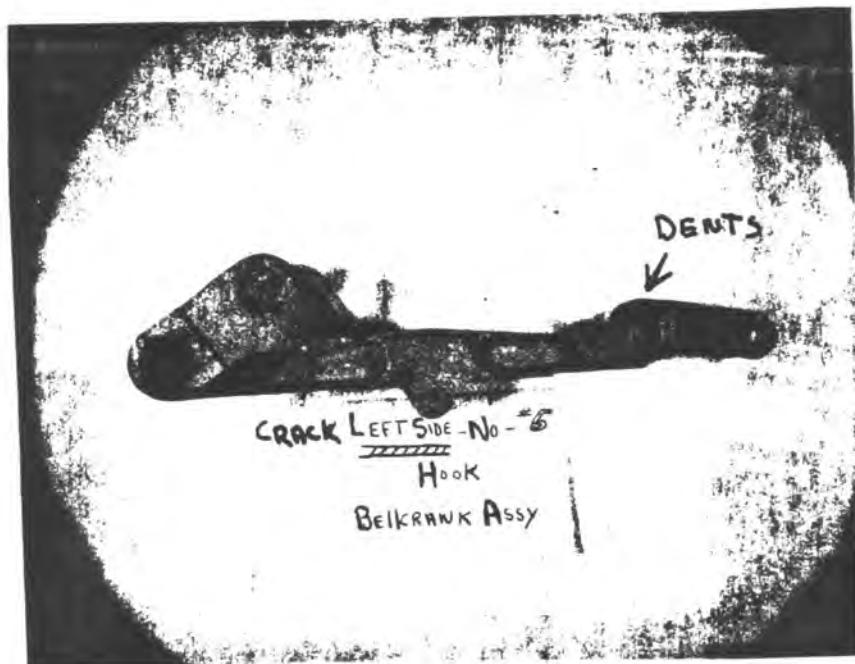
Photo #2 exhibits crack and two dents located on the same side of the bellcrank.

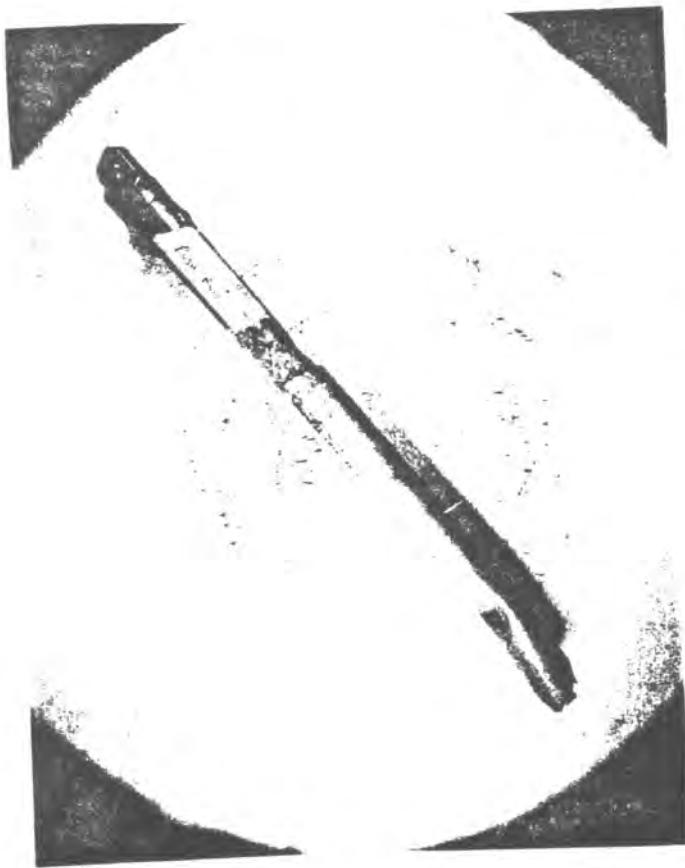
Photo #4

Matching fractured surfaces fitted together. Arrows point to the fracture and also to a dent noted exhibit "B".

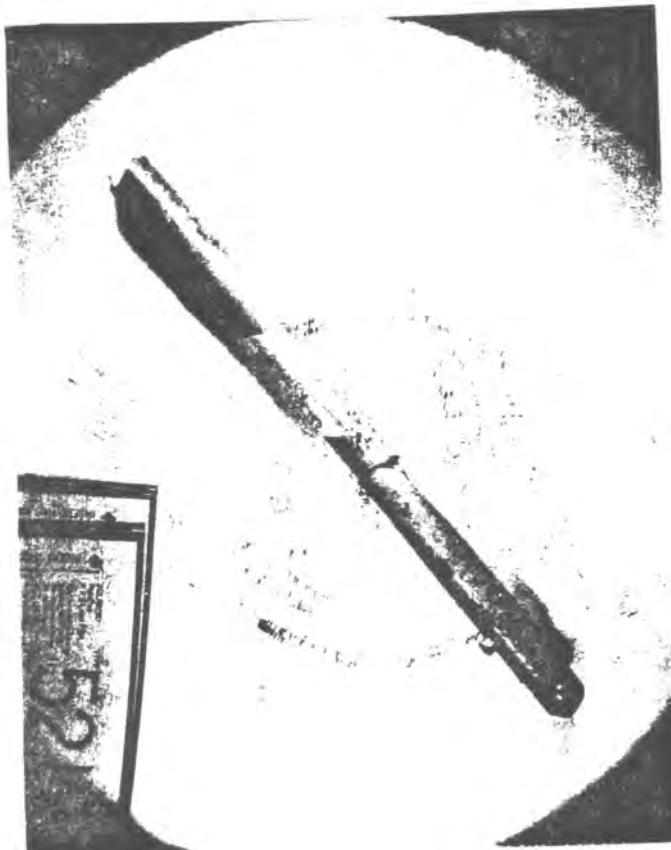
Photo #5

Same as photo #4 except viewed from a different angle. Note that exhibit "A" was also dented.

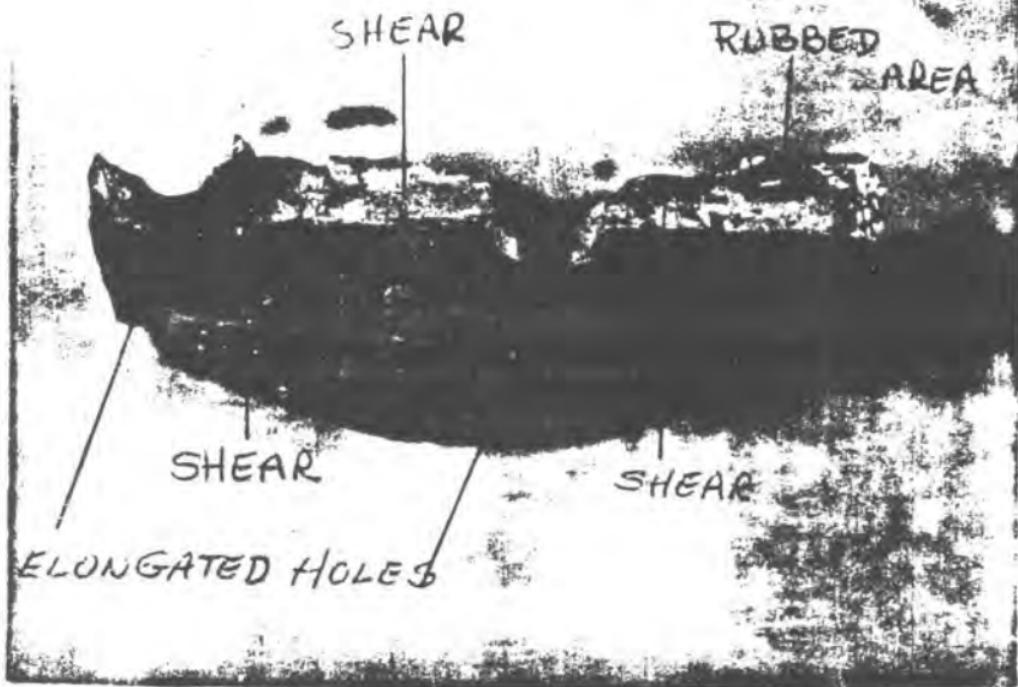
Photo 9. Mode and direction of fracture failure.
Fracture - tensile shear by overload.
Elongated holes and rubbed area.

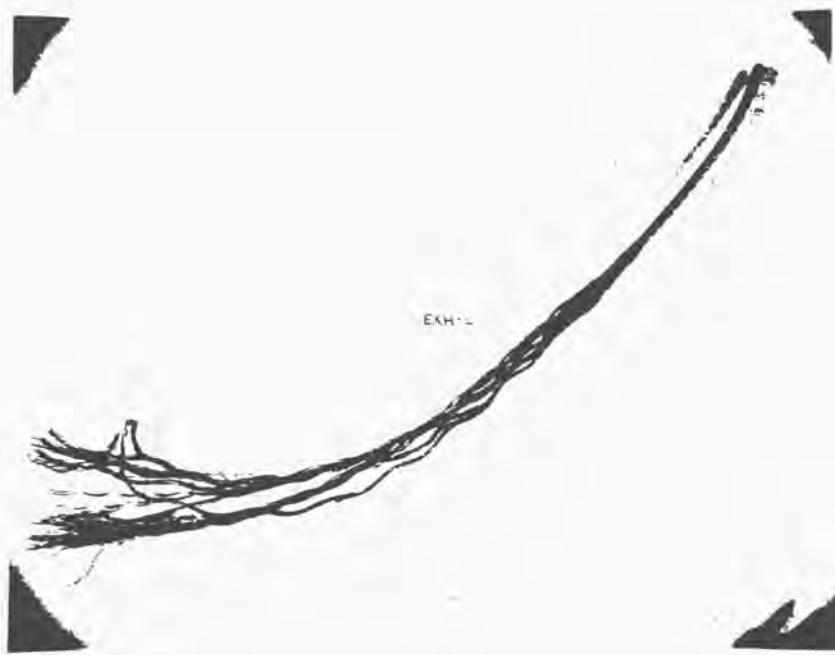
Photos #3 and #3A. Exhibit 2 taken at two magnifications revealed necking down of the fractured cables as well as some minor impact damage.

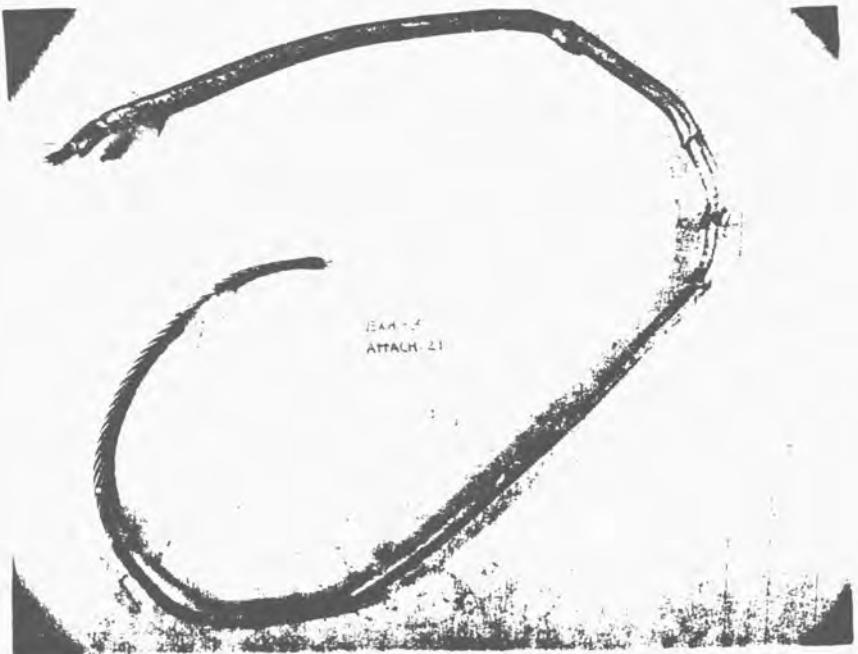
Photos #4 and #4A. Exhibit 3 taken at two magnifications revealed excessive bending and fracturing of the cable outer cover (arrows). Necking down of the fractured cables can also be seen.

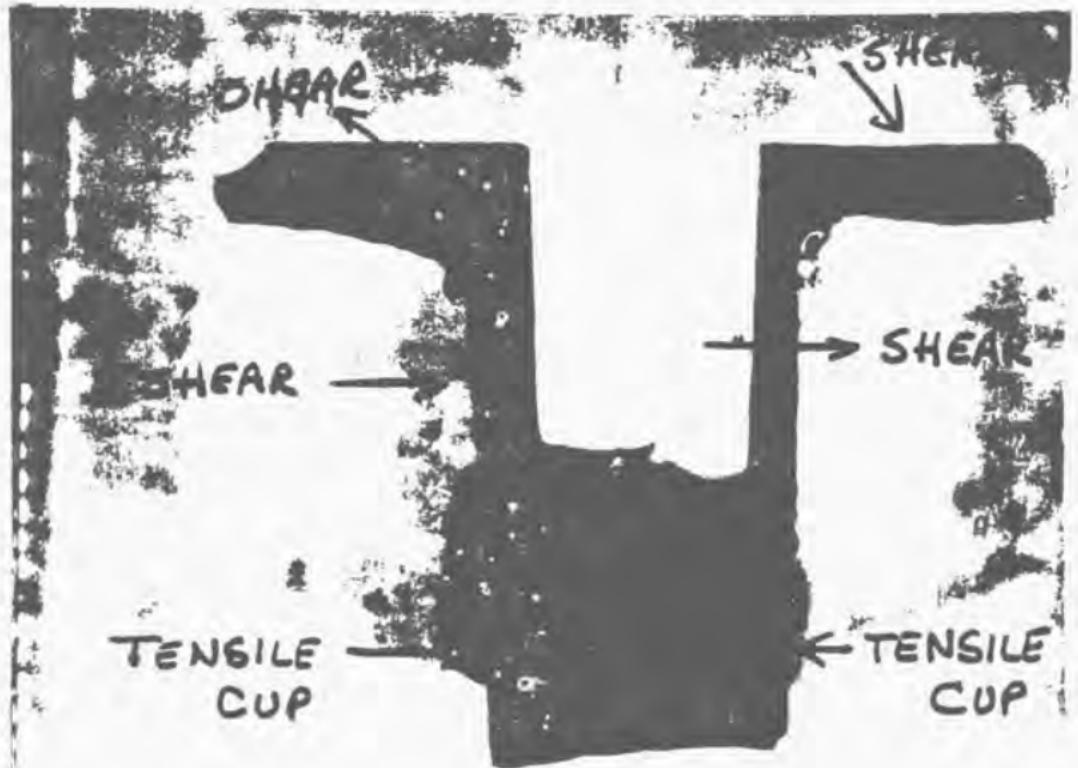
Mode of Failure - Tensile shear by overload.

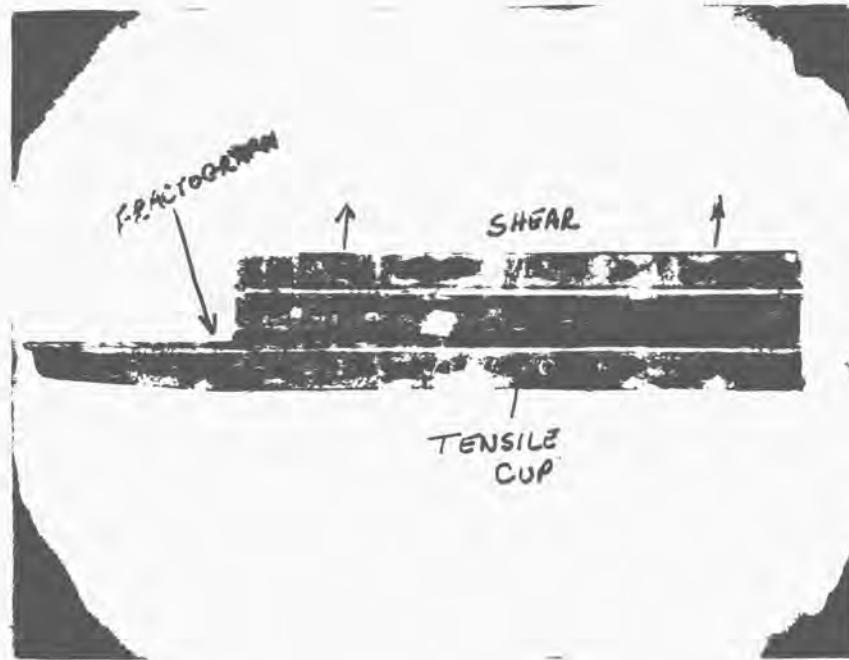
Mode of Failure: Fracture exhibited tensile shear, tearing, buckling, compression by impact.
