Task #1128, Attachment 34

Metallurgical Analysis

Subject: SwRI Project 02-4082-037
"Fractographic Examination of Failed Bell Crank Fittings"
FINAL REPORT

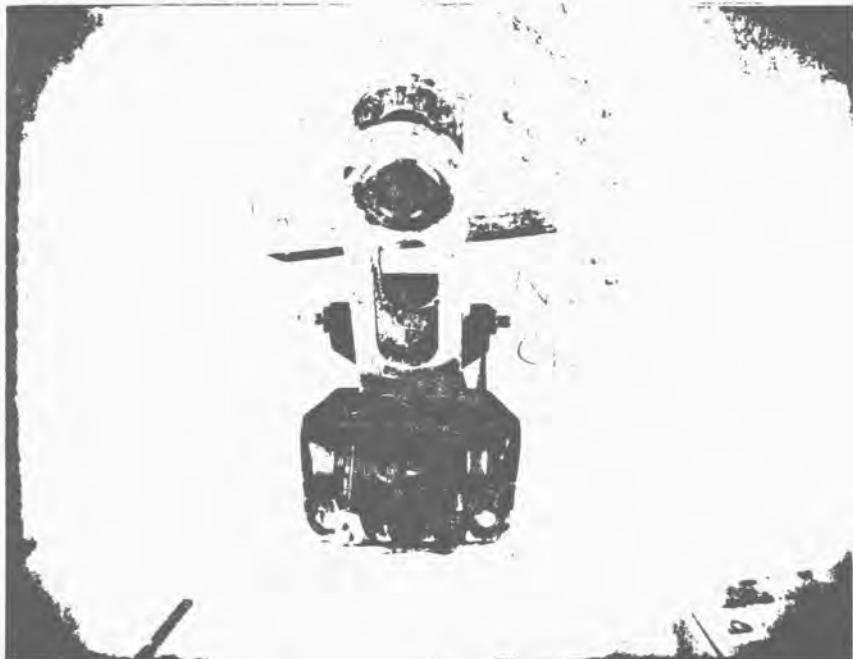
Photo #1 Good Yoke - No cracks.

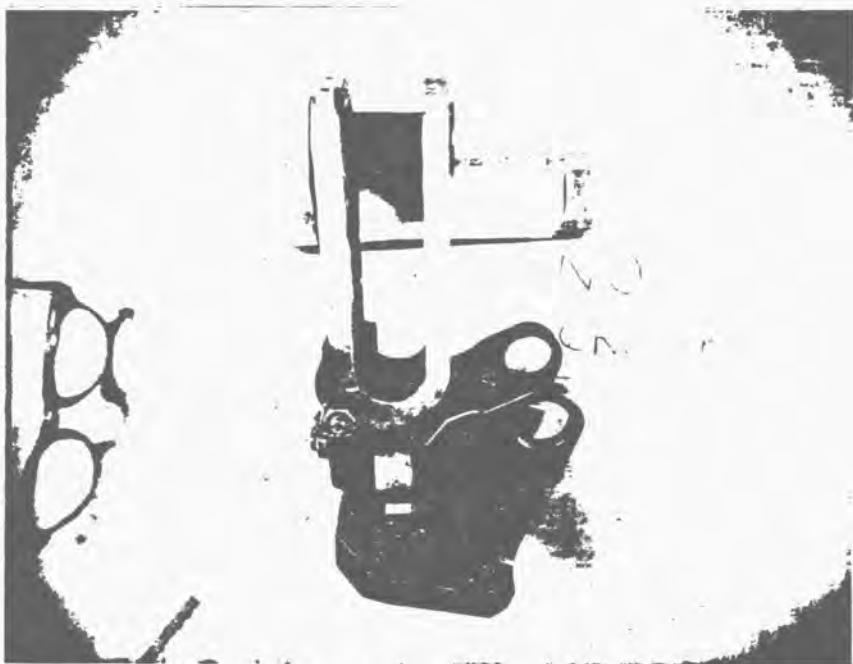
Photo #2 Good Yoke, no cracks.

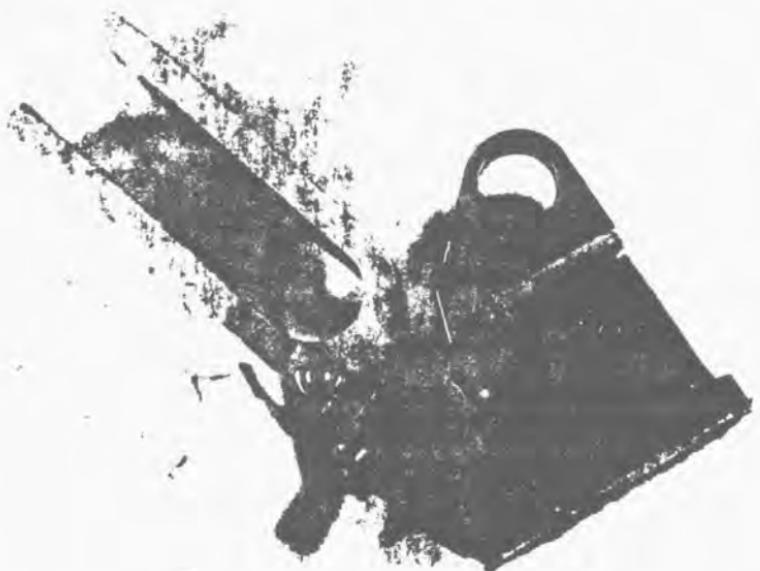
Photo #3 Yoke failed at 83,000psi.

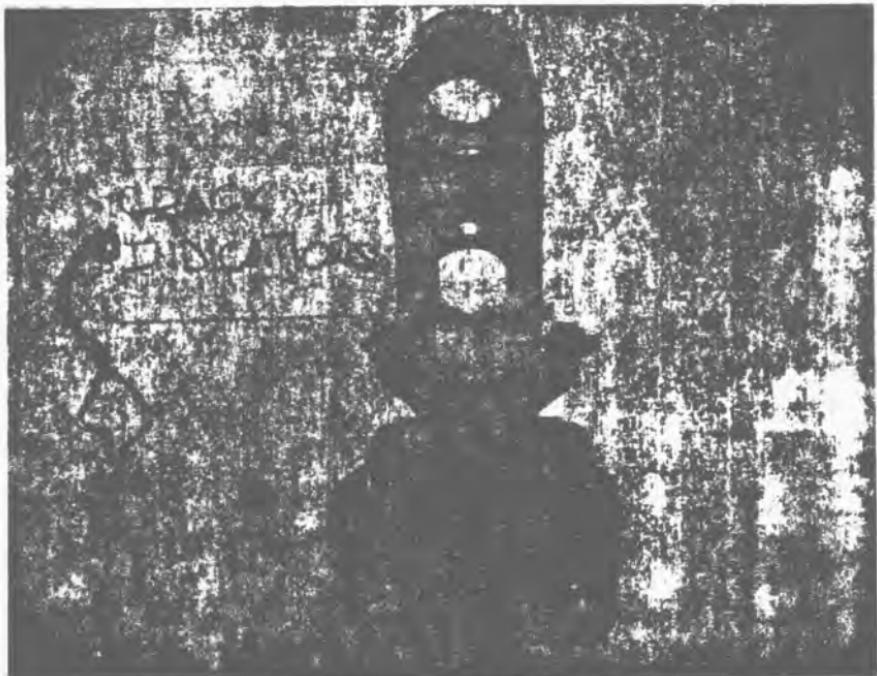
Photo #4 Crack indication on the monoball.

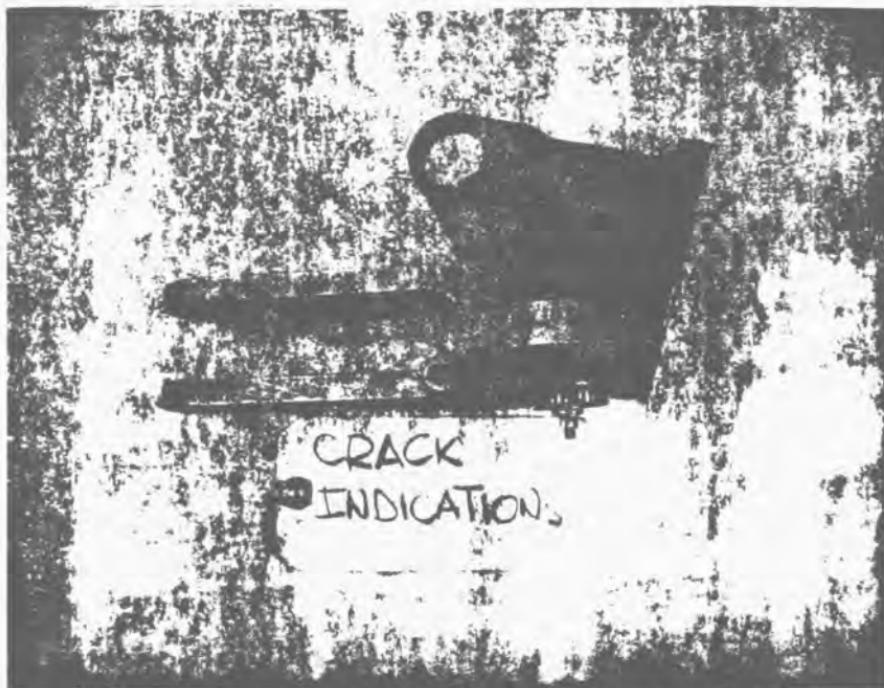
PHOTO #5 Crack indication of the monoball.

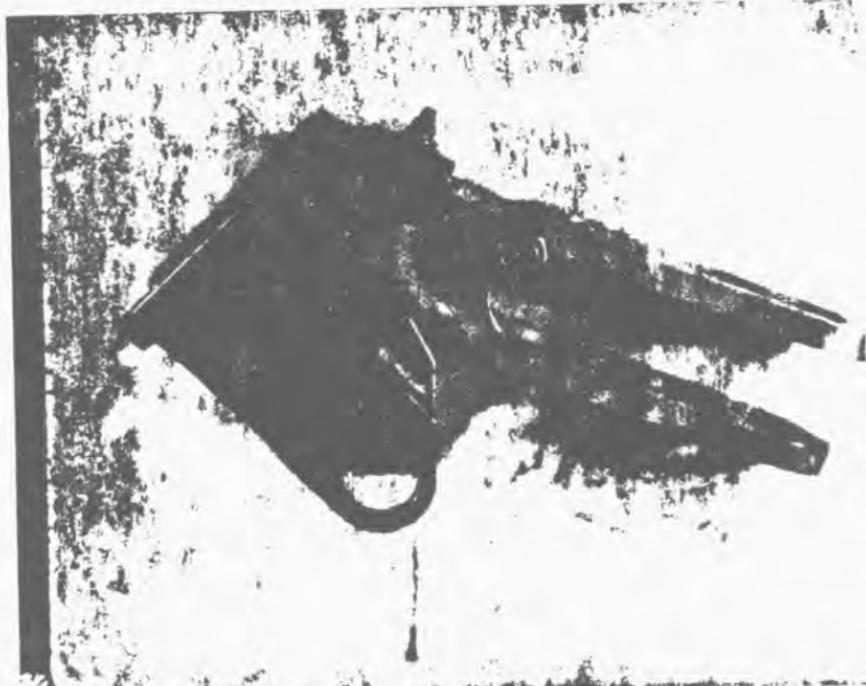
PHOTO #6 Failed crack indication of the monoball.

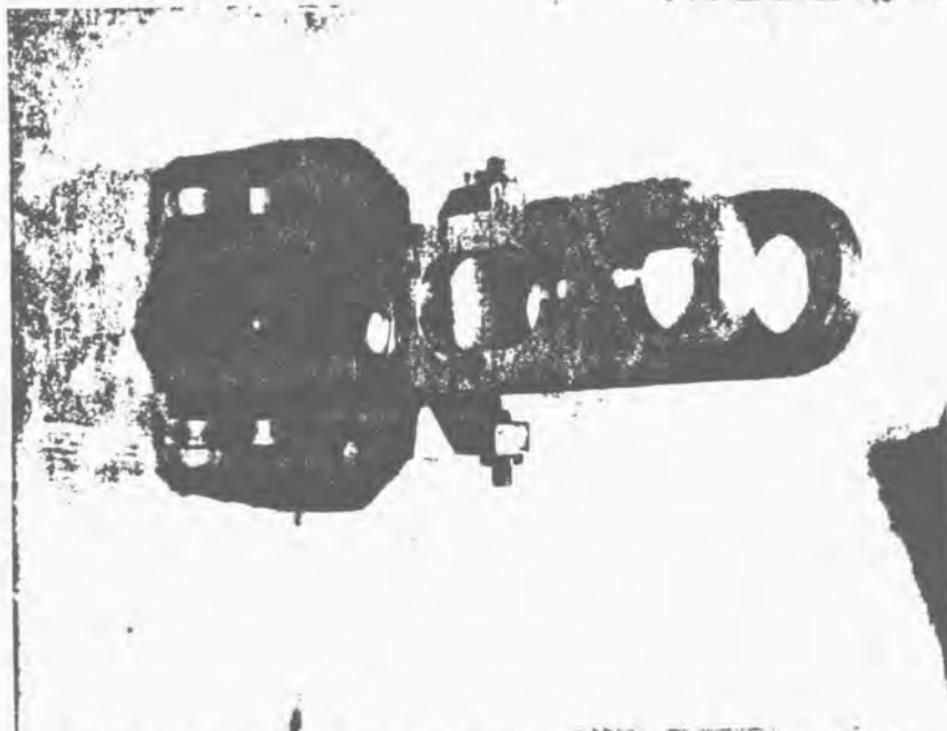
Photo #7 Failed crack indication of the monoball.

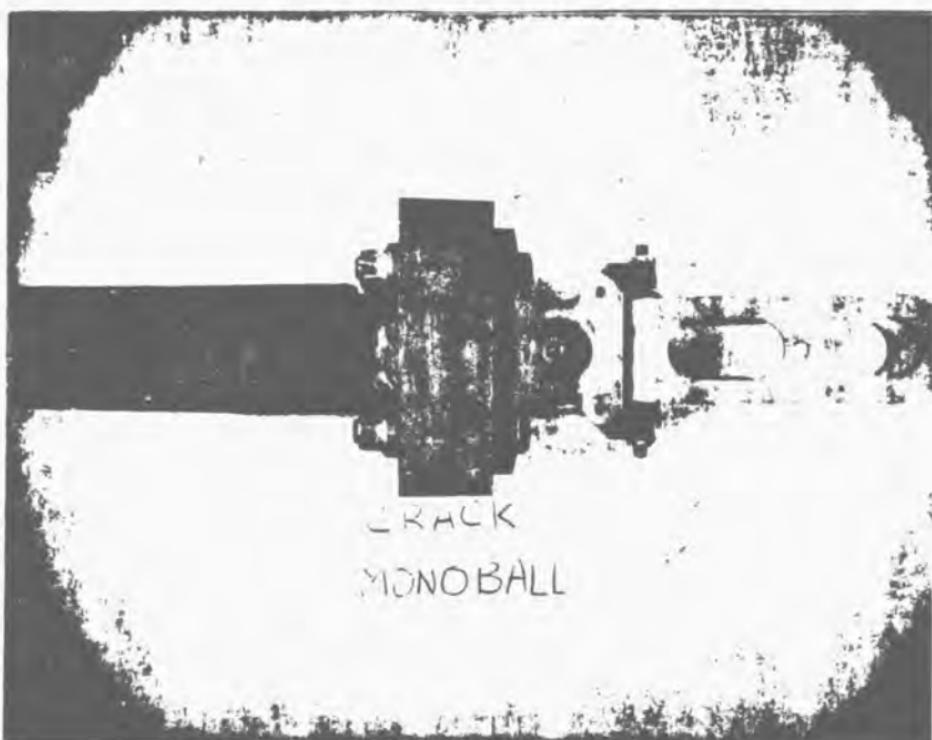
Photo #8 Cracked monoball.

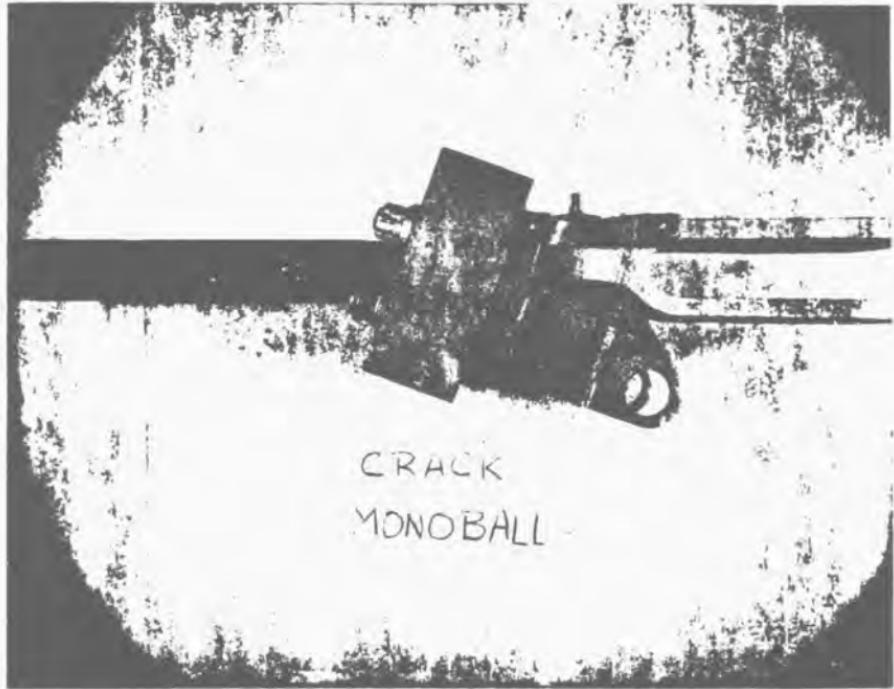
Photo #9 Cracked monoball.

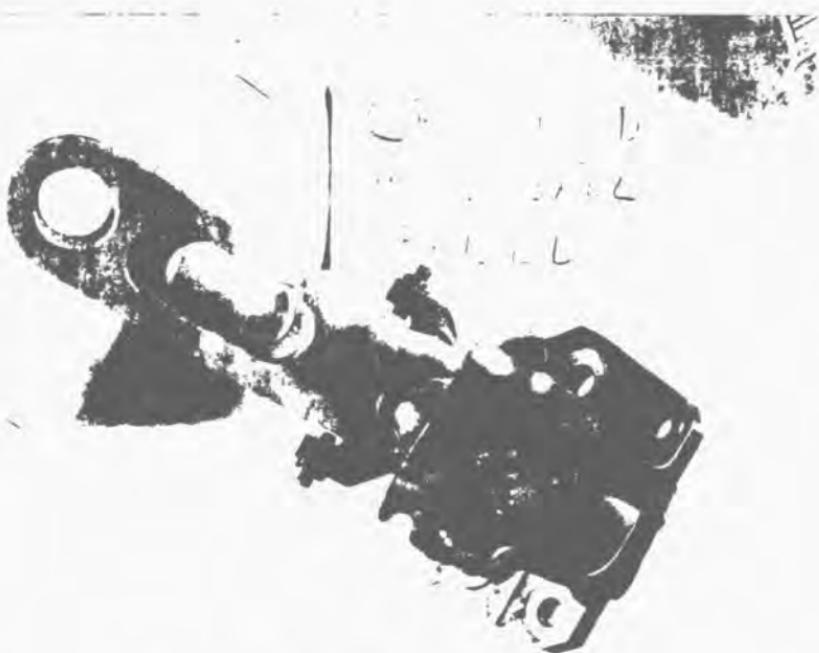
Photo #10 Failed cracked monoball.

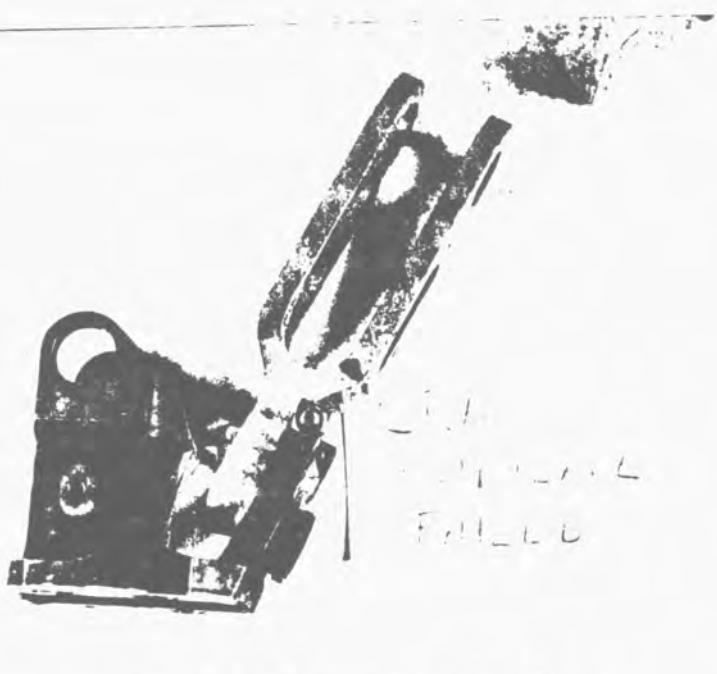
Photo #11 Failed cracked monoball.

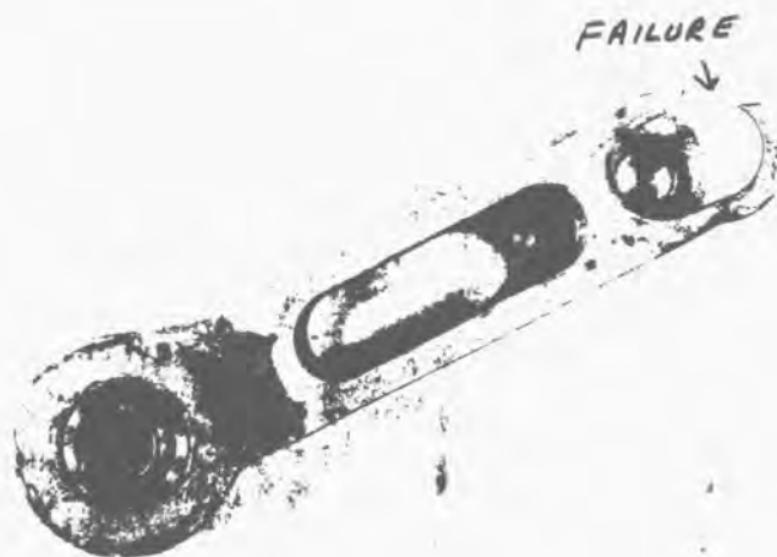
Photo #13 Piece missing from the monoball. Failed.
