SECTION G - NARRATIVE OF ACCIDENT

2. IDENTIFICATION: Aircraft serial number 67-17694, a UH-1H, was assigned to B Troop, 2d Sqdn, 17th Cavalry. The aircraft had been flown a total of 387 hours. The fifth Periodic Inspection was completed on 2 July, and the aircraft was on a test flight when the accident occurred. The test pilot was CW2 Robert W Holditch, W . Assisting on the test flight was the senior maintenance supervisor, SFC Donald L Tovey, E , and a UH-1 helicopter mechanic, SP4 Thomas J Sohnscider, E . Aircraft departed from Chu Lai to the south on the test flight. About 2015 hrs CW4 Thompson, the 333d TC Det maintenance officer discovered the aircraft was missing. A search was initiated. The wreckage of the aircraft was found at 0610 hours, 3 July, at coordinates BT 460166, about 6 nautical miles north-north-west of Chu Lai, RVN. The wreckage was 200 feet off shore in 15-20 feet of water. All three crew-members were killed. The bodies were recovered about 0830 hrs. The aircraft was recovered by a Navy LCT about 1500 hrs. The aircraft was unloaded from the LCT onto the dock at 1630 hours. The accident investigating board examined the aircraft at dockside.

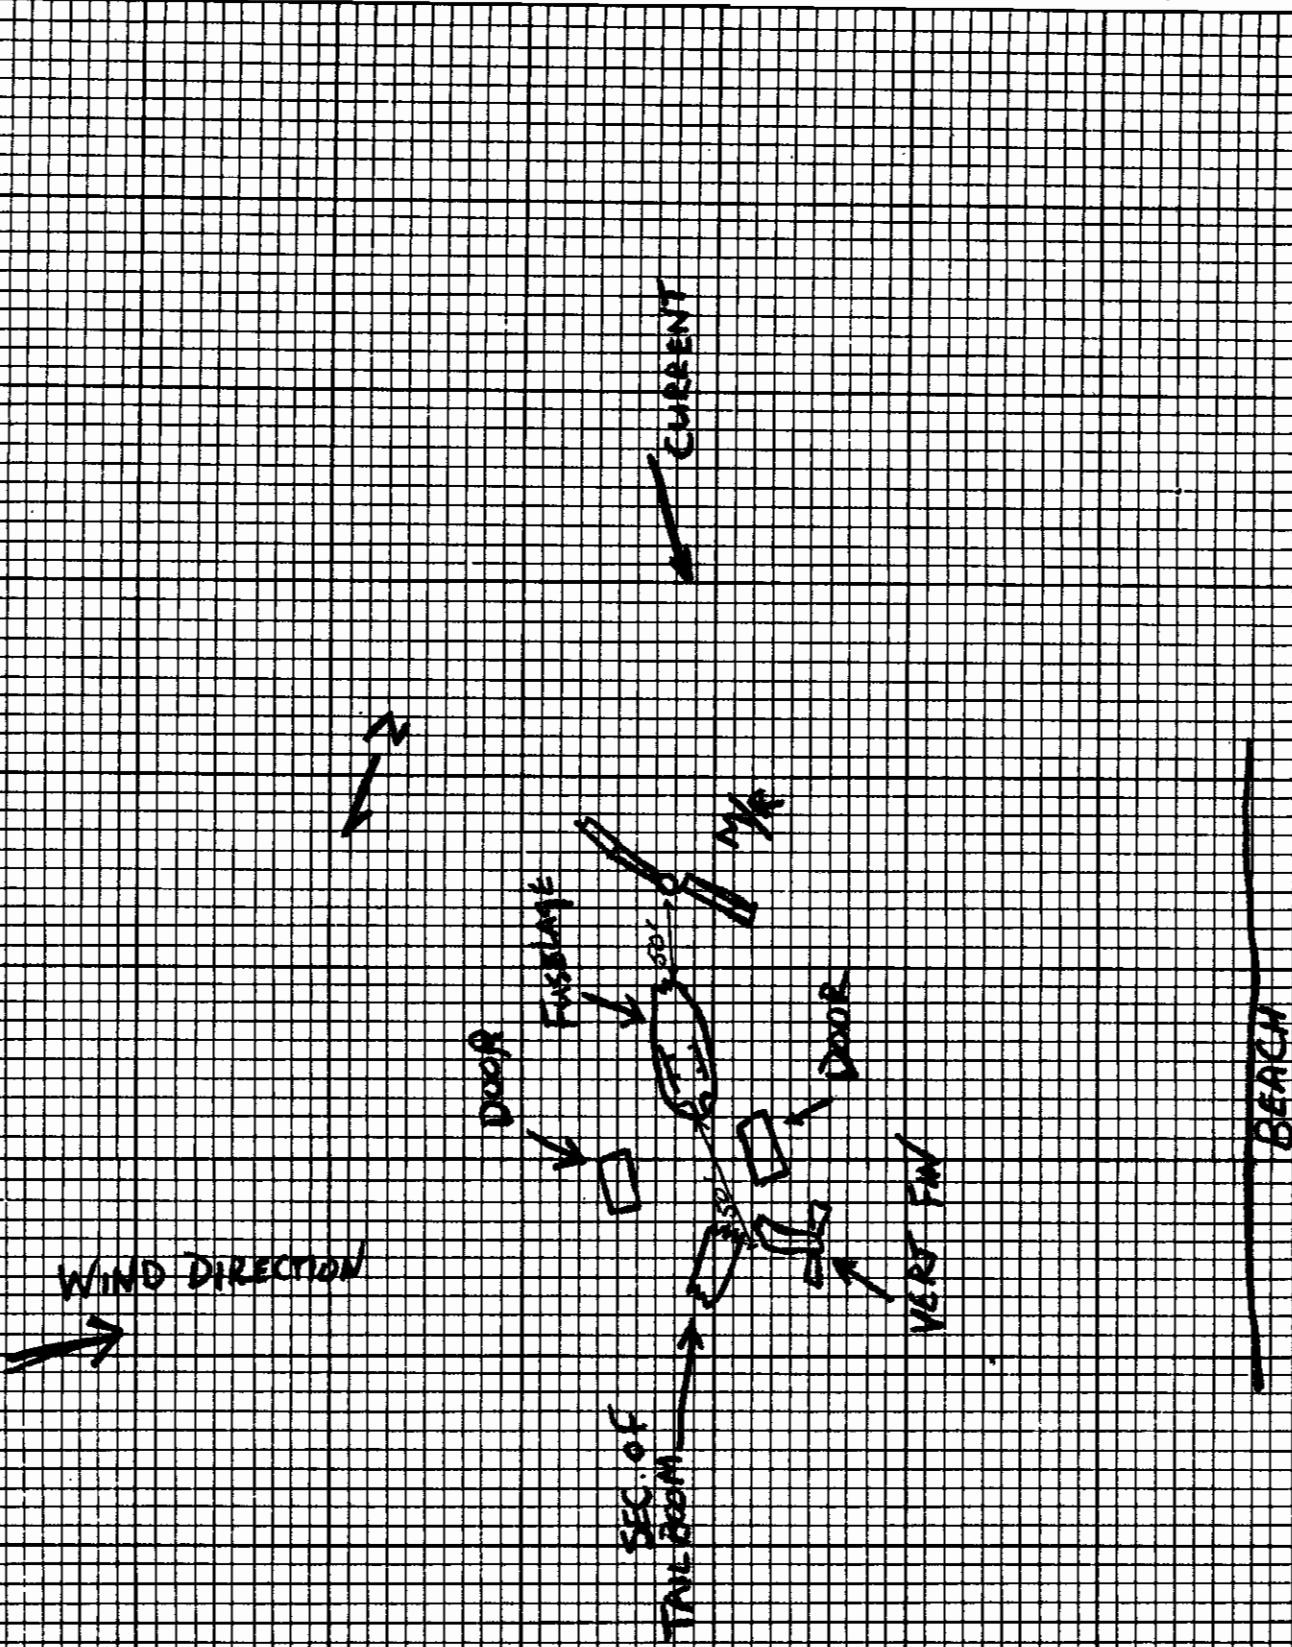
SECTION I - WRECKAGE DISTRIBUTION

Examination of the wreckage indicates that aircraft was flying from north to south. The stinger and tail boom struck the water first causing the compression dent in the tail boom. A tailboom strike of this nature could be caused by a sudden rearward movement of the cyclic. The sudden rearward movement of the cyclic would be instinctive if a pilot suddenly realized he was extremely low. Analysis of the damaged parts indicates that after the tail boom strike, the tailboom rebounded into the air, inducing a severe mast bump that snapped the mast at the main rotor head. The (white) main rotor blade hit the tail boom an instant after snapping the mast, or at the same time. The main rotor blade severed the tail rotor drive shaft, severed the vertical fin from the tailboom, and broke the tailboom from the fuselage. The force of the strike apparently knocked the vertical fin and tailboom down and to the right, into the water. The fact that the tail rotor was not damaged would indicate that the tail rotor drive shaft had been severed, and there were no torque forces on the tail rotor when it hit the water.

The fuselage hit the water in a right nose low attitude. The severe structural damage incurred on impact indicates a relative high forward air-speed. The main fuselage came to rest upside down on the ocean floor about 50 feet from the vertical fin and tailboom. The main rotor carried on coming to rest about 50 feet beyond the fuselage.

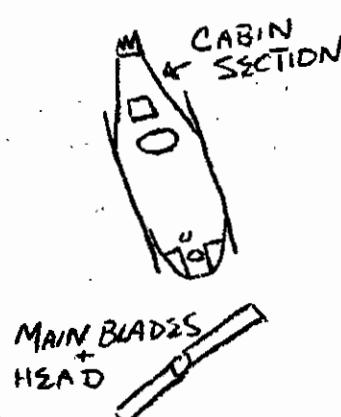
On the morning of 3 July 1969, I recovered the crewmember bodies from aircraft 67-17694, which crashed 2 July 1969. The aircraft was in twenty feet of water approximately one hundred meters from the shore. It's heading was parallel to a southerly heading, along the beach. The ship lay on its left upper roof edge, sides in the air. The "door post" behind the right pilot's door was missing completely and the roof slightly squashed in front. The pilot's doors were both missing. I later found them in the near vicinity, but can not say exactly where. Both pilot's seats were ripped from the floor, tracks included, but held inside the cockpit by the pilot's seat belts. Both seats were twisted towards the center floor console and it was necessary to cut the lap belts and shoulder belts of both pilots to extract them. The right seat pilot and his seat were removed before the body was removed from the seat. The left seat was maneuvered by one diver while another pulled its occupant free after cutting the belts. Neither pilot seemed to be injured externally. The left seat pilot or the right seat pilot had a cyclic in his hand as he was removed, but I do not recall which. Both were not on the controls. Only one was on the controls when I extracted their bodies. Both men had wide open mouths and startled (frightened?) expressions on their faces and open eyes. I pried the right cargo door off, as it was badly sprung anyway, and removed the radio from the compartment on that side. I found the UHF radio in the nose hatch and FM radio 3 to 10 meters ahead of the ship in the sand. The tail boom and vertical fin were 25 to 30 meters further to the southeast, with the miscellaneous cargo (-20, M-60 gun, tool box, etc.) strung in between. The tail boom separated from the main cabin section approximately 3 to 10 inches aft of the tail boom attaching bolts. The vertical fin, including both tail rotor drive gearboxes and the tail rotor assembly, separated from the tail boom at a point between the anchor points of FM Howling Coops. The vertical fin and tail boom were twisted 180 degrees out of phase and attached by only the nav. light wires, chip detector light wires, and one of the tail rotor cables. I cut the wires and cable in order to salvage the vertical fin and the tail boom more easily. During the salvage of the three main sections (cabin, tail boom, and vertical fin) the rotor head and blades lay on the sea floor as a reference point. The head was approximately 5 meters from the main cabin with one blade intact and one bent almost ninety degrees upward toward the sea's surface. All loose pieces of the aircraft and its contents were collected and salvaged as a single load. The larger pieces of that load were the right door (the one I'd removed), the two front doors, the seat, and other loose pieces. The diagram attached shows the approximate relative positions of the pieces.///END OF STATEMENT///

DISPOSITIONS OF PIECES IS ACCURATE.
i.e., BLADES APPROX. NE, CABIN APPROX. S, ETC.
