SECOND ENDORSEMENT on Rear Admiral Jerome H. KING, USN, investigative report of 18 July 1969

From: Commander in Chief U. S. Pacific Fleet  
To: Judge Advocate General

Subj: Joint USN/RAN Investigation - collision of USS FRANK E. EVANS and HMAS MELBOURNE on 3 June 1969 (U)

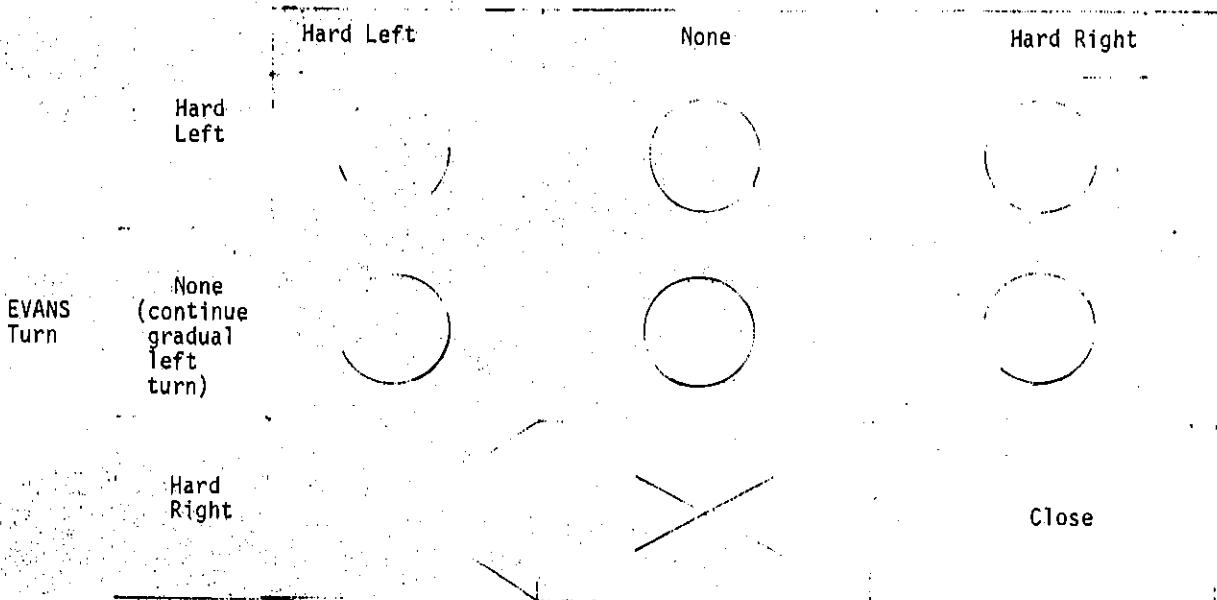
MELBOURNE Turn

98. (U) The following table displays the Board's best estimates of hypothetical alternative final turns by each ship based on reconstruction.

Note: 1. 0 - miss; X - hit; close - 100 yards or less.  
2. Actions referred to are alternatives to be considered in lieu of and at the respective times of EVANS' "Right Full Rudder" and MELBOURNE's "Port 30 - Port 35"  
3. Engine orders are a separate subject.
