Death of a DESTROYER

By CAPTAIN PAUL SHERBO, U.S. NAVAL RESERVE

Many a ship driver reading of the 1969 collision between the USS Frank E. Evans and HMAS Melbourne—here, after the incident—can see familiar errors that again could end in catastrophe. But tracking down the cause of the disaster has been no easy task.

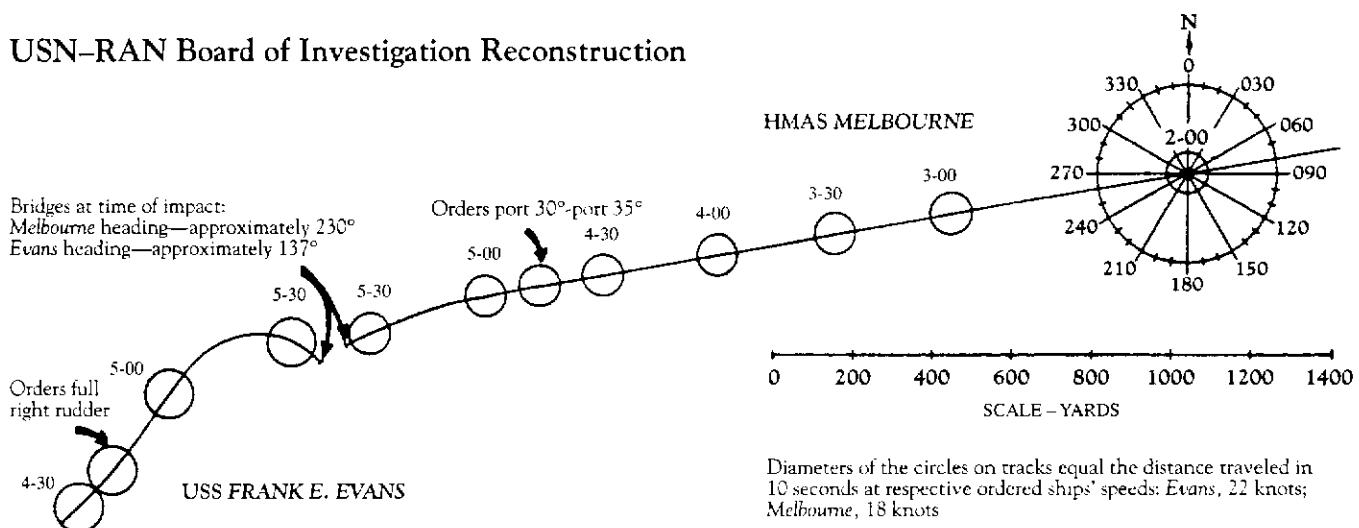
USN-RAN Board of Investigation Reconstruction

Even the U.S. Navy–Royal Australian Navy Board of Investigation was unable to determine the precise cause of the collision between the USS Frank E. Evans and HMAS Melbourne. In presenting its reconstruction of the collision, the board noted, “In view of the imprecision of the evidence on which it is based and the many conflicts in evidence, [the Board’s reconstruction diagram, adapted above] is at best an approximation of the tracks of the ships from the time the signal to form column was executed until collision.”

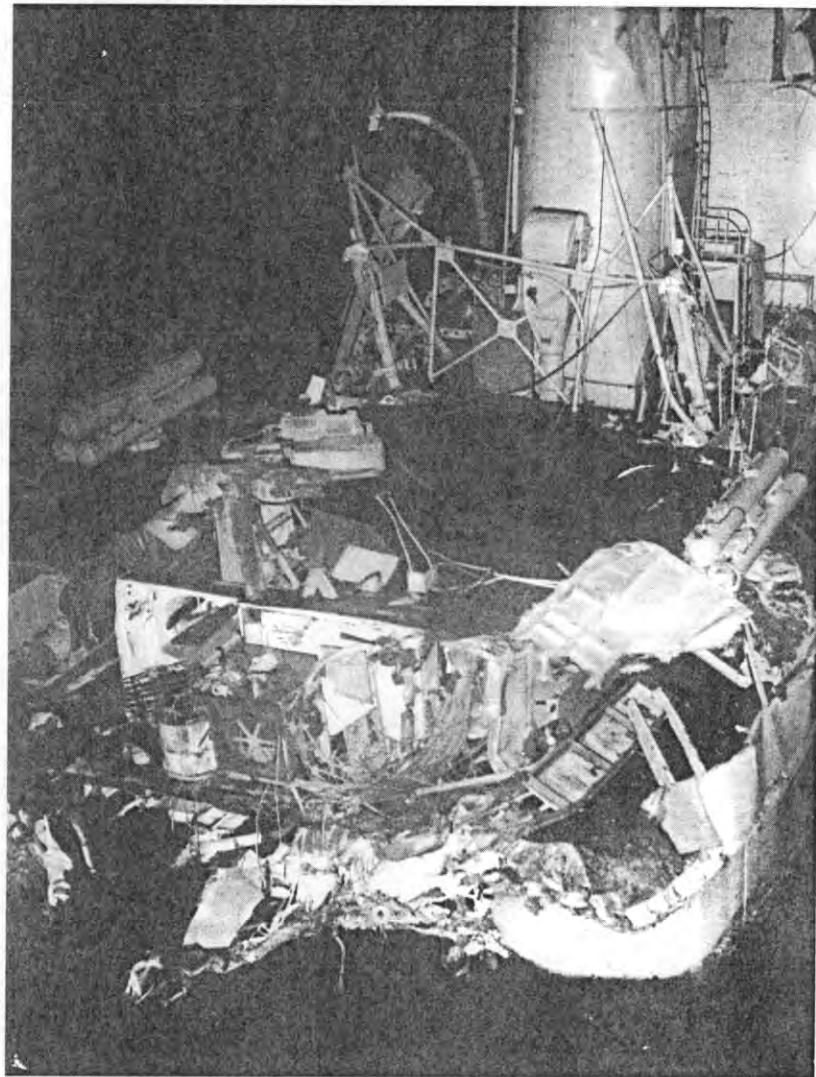
The after half of the USS Frank E. Evans remained afloat after the collision and was manned for four weeks at drydock as a commissioned vessel until the Navy struck the ship from the records (see sidebar).
