NAVSHIPS 0967-000-0070

**ELECTRONICS
INSTALLATION
AND
MAINTENANCE BOOK**

COUNTERMEASURES

**DEPARTMENT OF THE NAVY
NAVAL SHIP ENGINEERING CENTER**

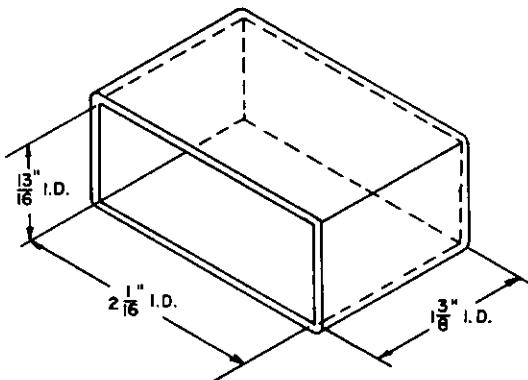
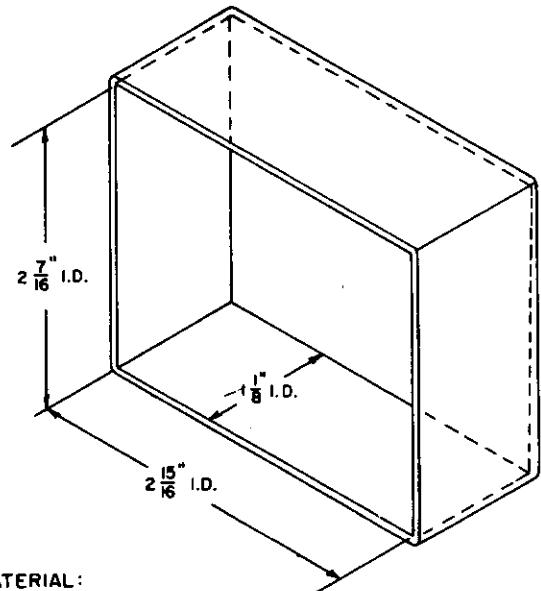
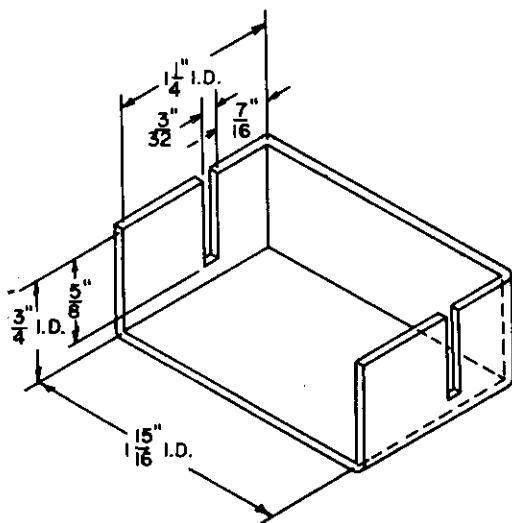
Figures 1 and 2

The use of plug covers to protect the connectors on the tuners and mixer amplifiers of the AN/BLR-1 and AN/SLR-2 Countermeasures Receiving Sets has been suggested by Walter C. Hanke of the San Francisco Naval Shipyard.

These plug covers eliminate breakage during transit to and from the shop and the ship. The covers can be made

from 1/16-inch aluminum stock. Fabricate the three different sized covers, as shown in figures 1, 2, and 3, to protect the plugs in the tuners and mixer-amplifiers.

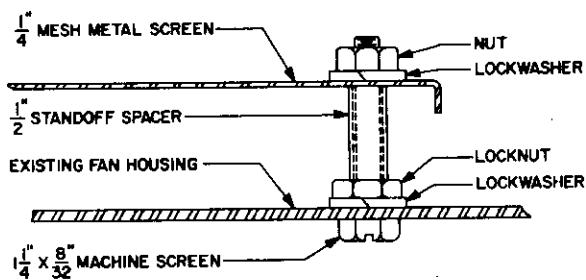
Figure 1. Method of Installing Protective Screen

Operation and safety have been enhanced by maintenance personnel of the Naval Communication Station, Honolulu, by the installation of a screen over the blower fan assembly in the base of the RO-247/F and RP-132/F units of the AN/FLR-11(V) and AN/FRA-54(V) equipments. Not only has the blower screen installation eliminated a personnel safety hazard from exposed fan blades, but damage from cable connectors, tools, or other items accidentally dropped during maintenance has been avoided. This desirable equipment improvement is described here for implementation by all activities utilizing the RO-247/F and RP-132/F record/reproduce machines.

1. Clip two of the screen corners at 45 degree angles.
2. Bend edge of screen all around to a 90 degree angle to form $\frac{1}{4}$ inch lip.
3. Secure power to blower unit.
4. Install screws and stand-off spacers in screen and top cover of blower unit (see figure 1 detail).
5. Place screen over the four installed screws and secure with 8/32 nuts. Should it be necessary to remove the screen, only the four nuts need be removed. (17S)

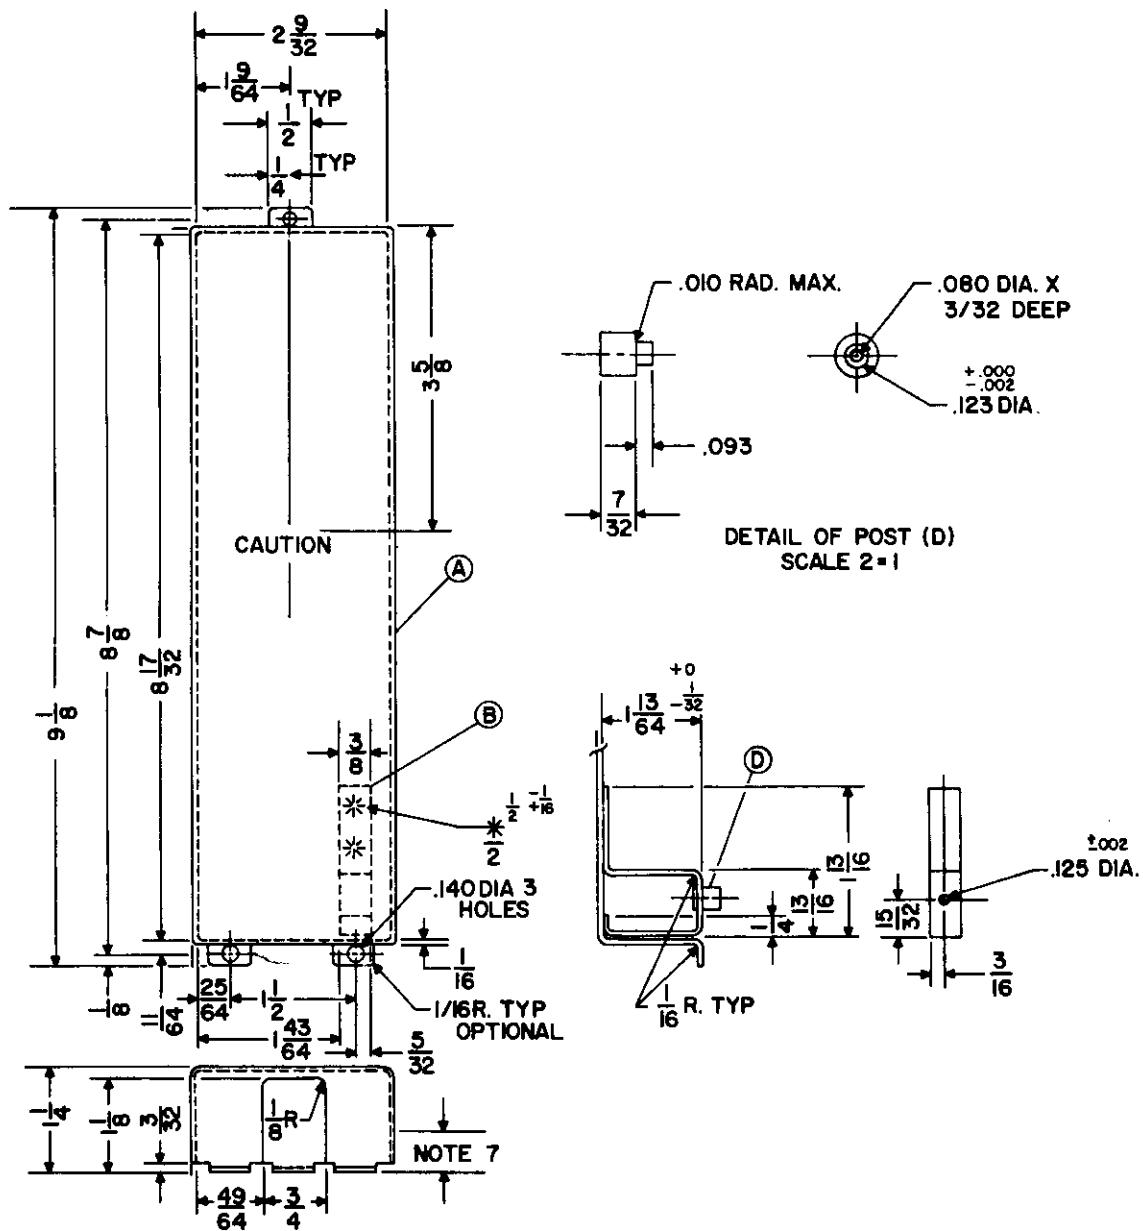
Figure 1.

The cover for TB-8 has no symbol or federal stock number at this time. Electronic Supply Office will assign stock numbers and procure the covers for replacement and Bureau of Ships will provide technical manual changes when the stock numbers become available.

In the meantime, if the cover for the high-voltage terminal board has been damaged, it is recommended that a temporary cover, similar to that shown in figure 1, be manufactured for temporary use until Electronic Supply Office can stock the replacements.
