101ST AIRBORNE DIVISION (AIRMOBILE)

FINAL REPORT

AIRMOBILE OPERATIONS IN SUPPORT OF  
OPERATION LAMSON 719  
8 February - 6 April 1971

VOLUME II

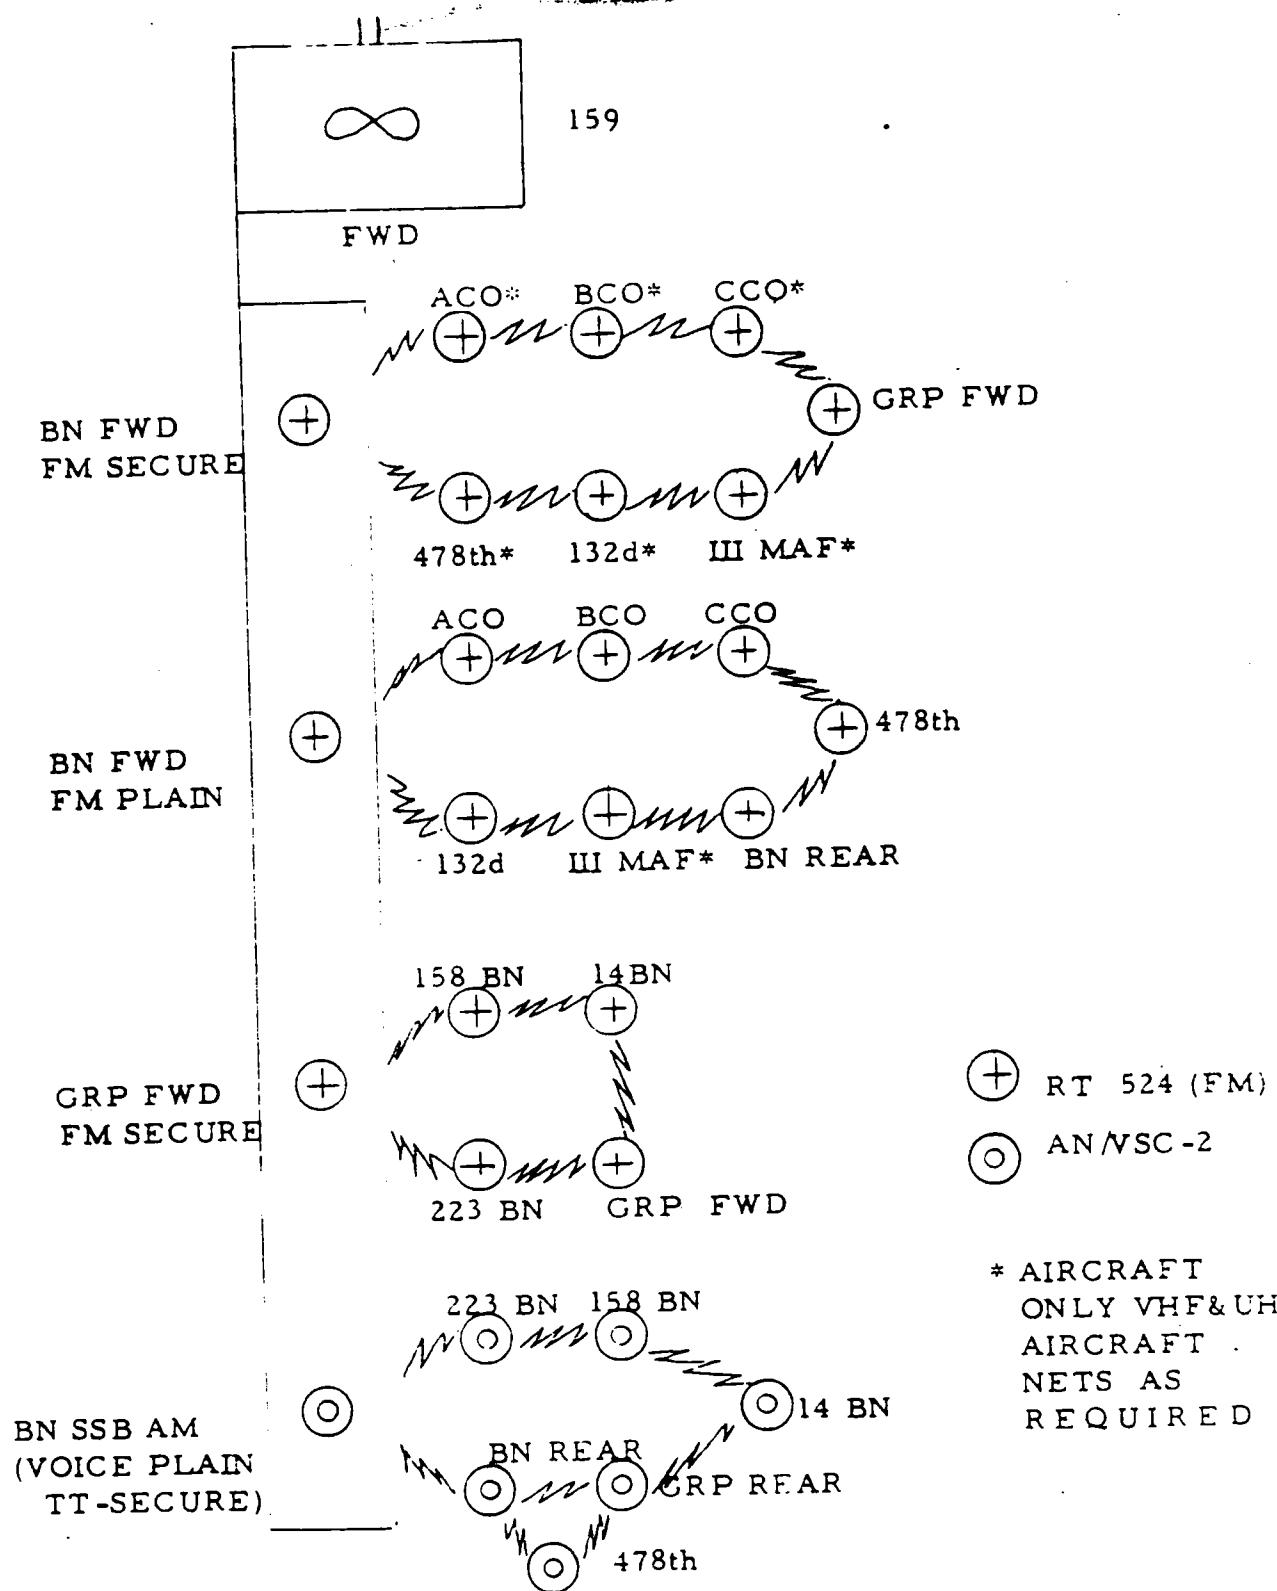
FIGURE IV-1 (U) Radio Net Diagram for 159 Avn Bn (ASHB) (U).

The primary means of voice communications on this operation was FM radio. Three RT-524 radios were set up at a forward operations tent, providing a battalion secure net, a battalion plain net and a station in the group secure net. The secure capability was achieved by using two KY-8 secure sets. Power for this FM configuration was supplied initially by two 1.5 KW DC generator sets and four 12 volt DC batteries. Later on, because of generator failure and battery problems, a 3 KW DC generator set was used in conjunction with an RA-91C rectifier. A net diagram of the FM radio system is shown at Figure IV-1. The battalion (fwd) plain net was originally designed to communicate with the rear area by means of an FM retrans site. Because of equipment shortages, this retrans site was not installed and bad atmospheric conditions nullified the possibility of communicating to the rear without it. The battalion (fwd) plain net was then used, as was the battalion (fwd) secure net, primarily for contact with aircraft in the area of operations. Aircraft VHF and UHF radios were also employed as required.

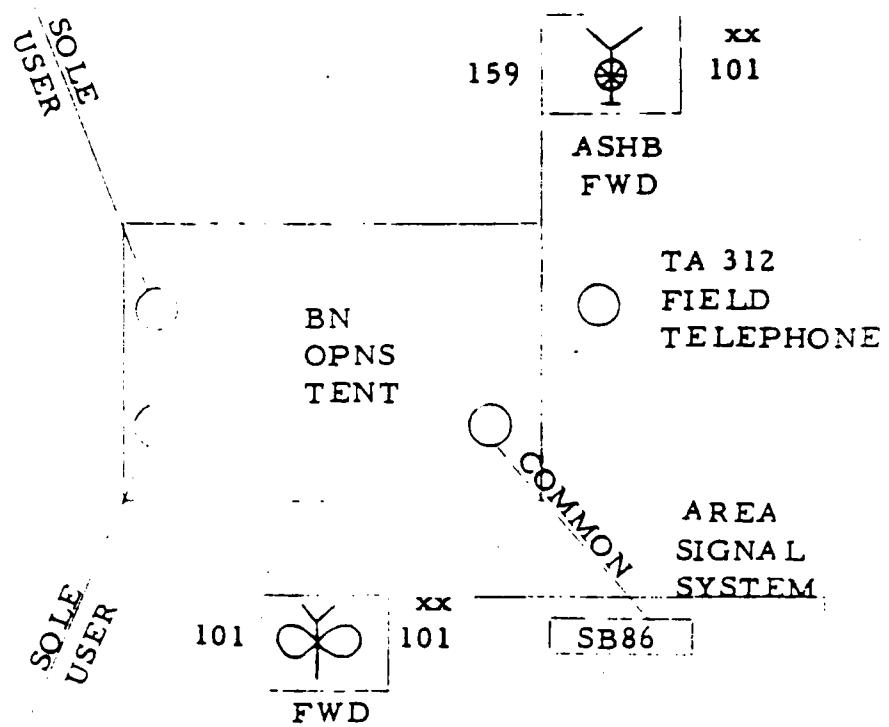
FIGURE IV-2 (U) Wire Diagram for 159th Avn Bn (ASHB) (U)

WD-1 wire and field telephones were used for local land

159th ASHB  
COMMO  
TENT

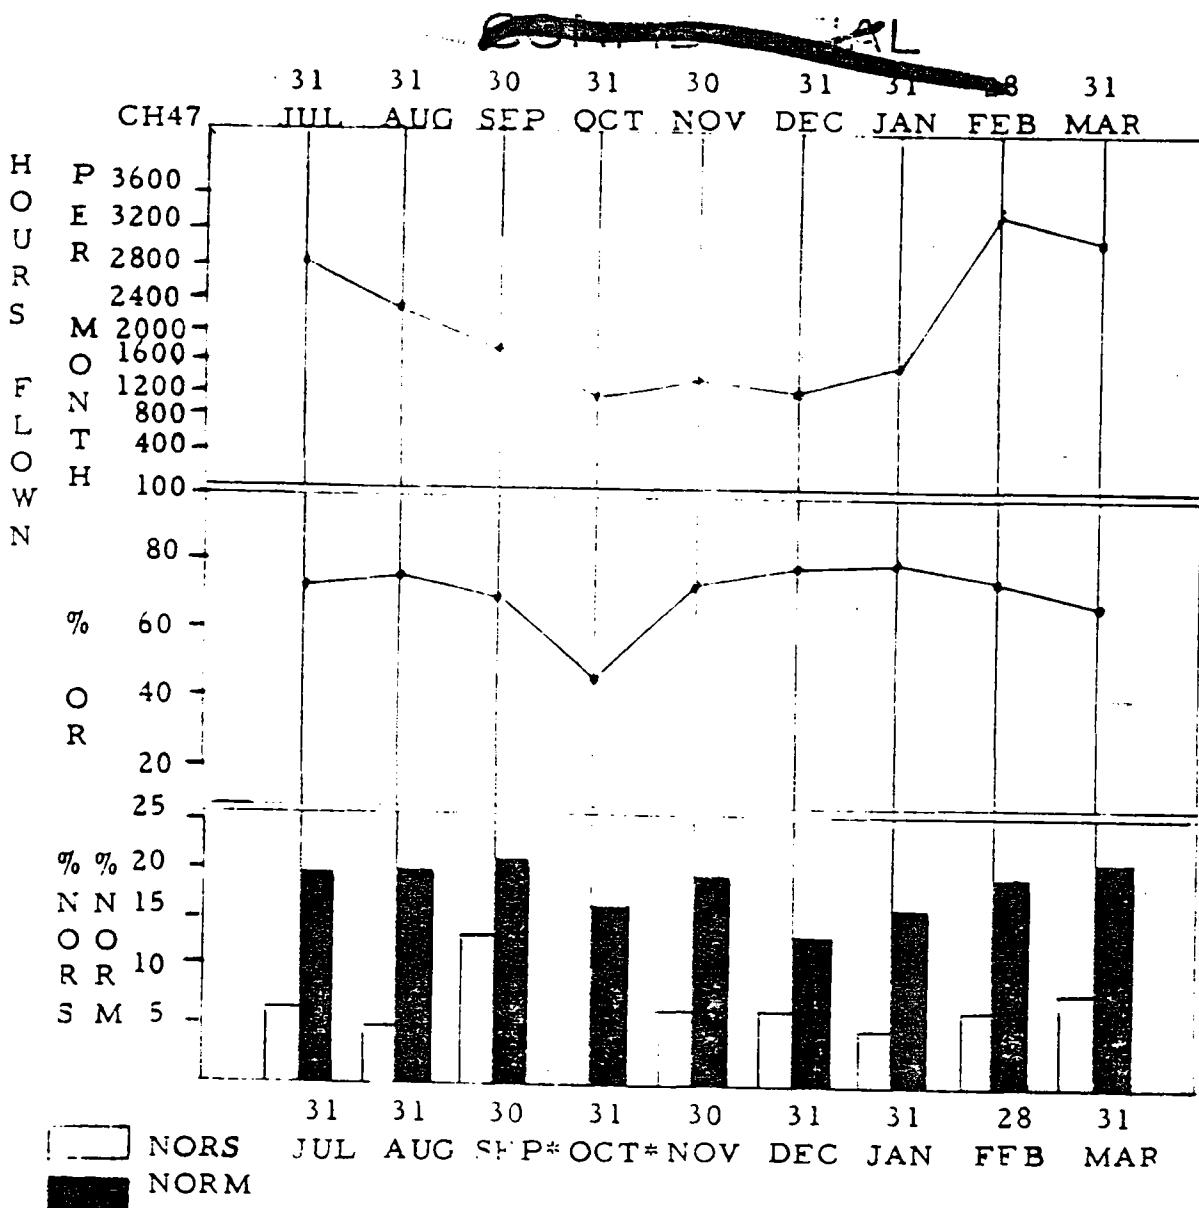
FIGURE IV-4 (U) Monthly Flying Hours, CH-47 (U)

A, B, C, CO., 159th ASHB (AMBL)  
48 ASSIGNED CH-47's

DEPICTING COMBINED MONTHLY FLYING HOUR  
PROGRAM AVG OPERATIONAL READY RATES & AVG  
MONTHLY NORM/NORS RATES FOR MONTHS SHOWN  
DURING 1970-1971

\* DURING THIS PERIOD, THE 159th ASHB WAS  
UNDERGOING SUPER "C" CONVERSION

The three primary indicators for determining the efficiency of the maintenance effort during this period were the operational ready rate (OR), and the NORM/NORS rates. At Figures IV-4, 5, and 6 are charts which graphically depict these indicators with relation to the associated flying hour program of the CH-47's and CH-54's. As the flying hour program increased abruptly in February, the NORM rates, and in the case of the CH-47's, the NORS rates, also increased. It is significant to note that the NORS rate, although increasing slightly, remained relatively constant when compared with the previous seven month period. This was due primarily to the amount of command interest and emphasis on the aviation repair parts supply system. A forward liaison element of the 34th General Support Group, operating out of Quang Tri, was in a large measure responsible for insuring that the necessary repair parts were made available to the requesting units in an absolute minimum of time. This element also maintained close liaison with the civilian PMP teams, and determined where their assistance was most urgently required. One of the primary reasons for the light increase in the NORS rates was that some of the repair parts for which there was a sudden demand were items that had acquired little if any demand data in previous operations. Many of the parts damaged by enemy fire were rarely required under normal operating conditions. It must be emphasized at this point, that a major factor in keeping NORS/NORM rates at an acceptable level was the prior planning done by the units of the 159th Assault Support Helicopter Battalion, and the aircraft scheduling program which they used. They were able to adequately forecast, in most cases, the repair parts which would be required based on the increased flying hour program. A major area of concern to the maintenance activities during the operation was the conditions under which the aircraft were operating in the forward areas. The dust in which the CH-47's and CH-54's were forced to operate on a continuous basis was a critical factor in increased wear on engines and rotor blades. As a result of the battalion policy of flushing each CH-47 engine with water after every flying day, the damage to engines remained negligible. The wear on CH-54 engines was also negligible because of their Engine Air Particle Separators (EAPS). Most of the damage done by the dust was to the aircraft rotor blades. The abrasive nature of the dust coupled with the extremely high winds generated by the rotor wash, resulted in abnormally rapid deterioration of the leading

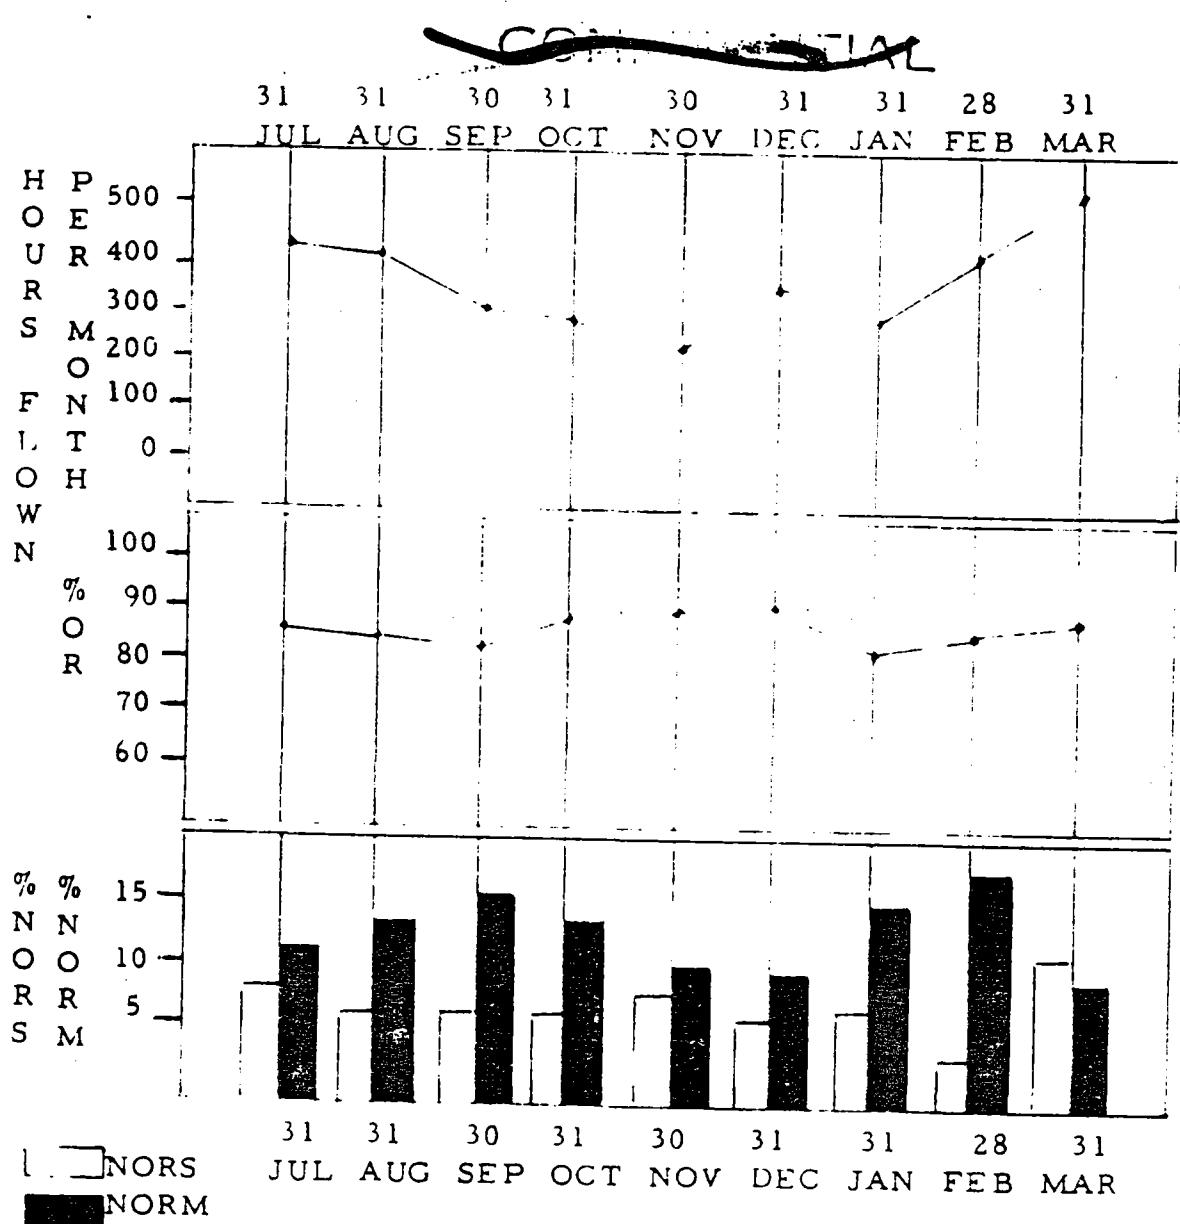
FIGURE IV-5 (U) Monthly Flying Hours, CH-54A (U)

478th AVN CO. (HEAVY HELICOPTER)  
 159th ASHB (AMBL) 101st ABN DIV (AMBL)  
 \* ASSIGNED CH-54A's

DEPICTING MONTHLY FLYING HOUR PROGRAM,  
 OPERATIONAL READY RATES & MONTHLY NORM/NORS  
 RATES FOR PERIOD SHOWN DURING 1970-1971

\* IN NOV 70 ASSGD A/C INCREASED FROM SEVEN TO  
 EIGHT CH-54A'S

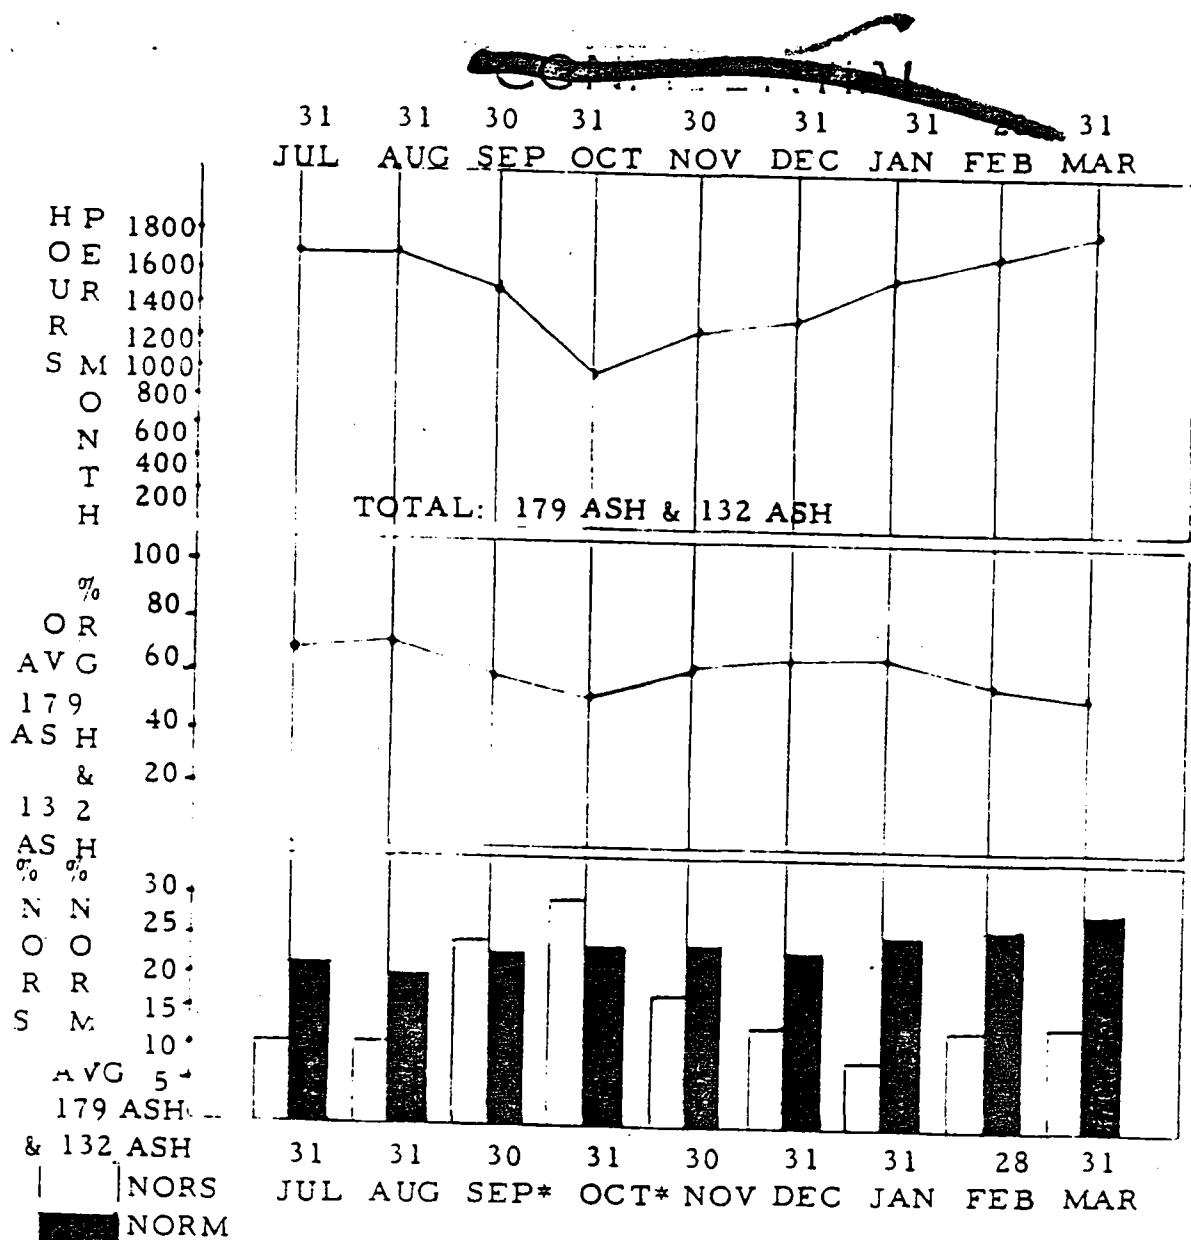
\* DURING THIS PERIOD  
179 ASH CO UNDERWENT  
SUPER "C" CONVERSION

179 ASH CO & 132 ASH CO OPCON TO 159 ASH  
(AMBL) 32 ASSIGNED CH47 DEPICTING COM-  
BINED MONTHLY FLYING HOUR PROGRAM,  
AVG. OPERATIONAL READY RATES & AVG.  
MONTHLY NORMS/NORS RATES FOR  
MONTHS SHOWN DURING 1970-1971

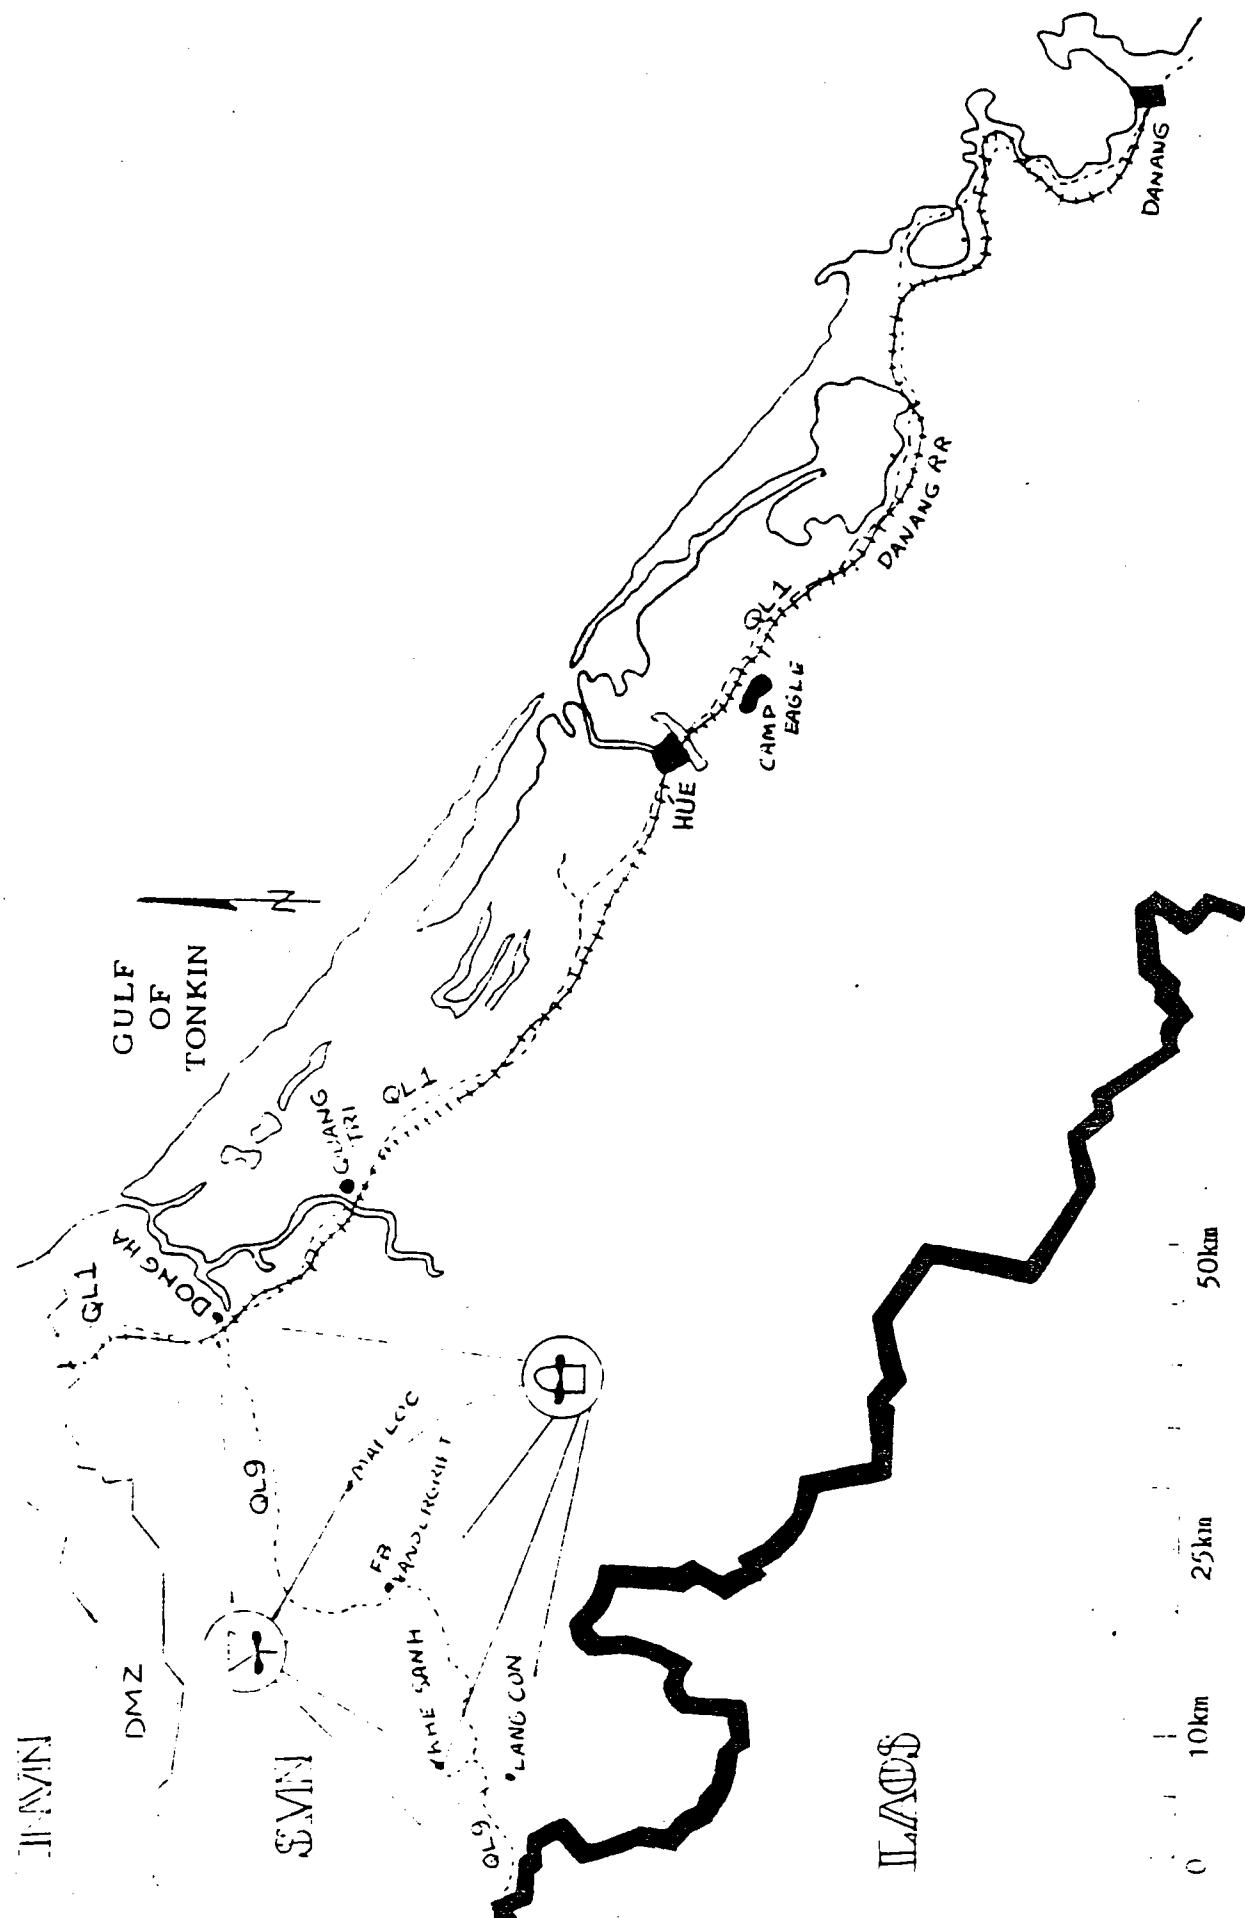
MAP IV-11 (U) REARM/REFUEL POINTS (1)

The rearm points were constructed using earth-filled 2.75 rocket ammunition boxes. A double rearm point was constructed consisting of a central barricade with open rockets pointing into each side. Within each point were three side by side compartments, one for 17 pound HE rockets, one for flechette rockets, and one for 10 pound HE rockets. This large storage capacity was deemed necessary since it was anticipated that as many as six gunships

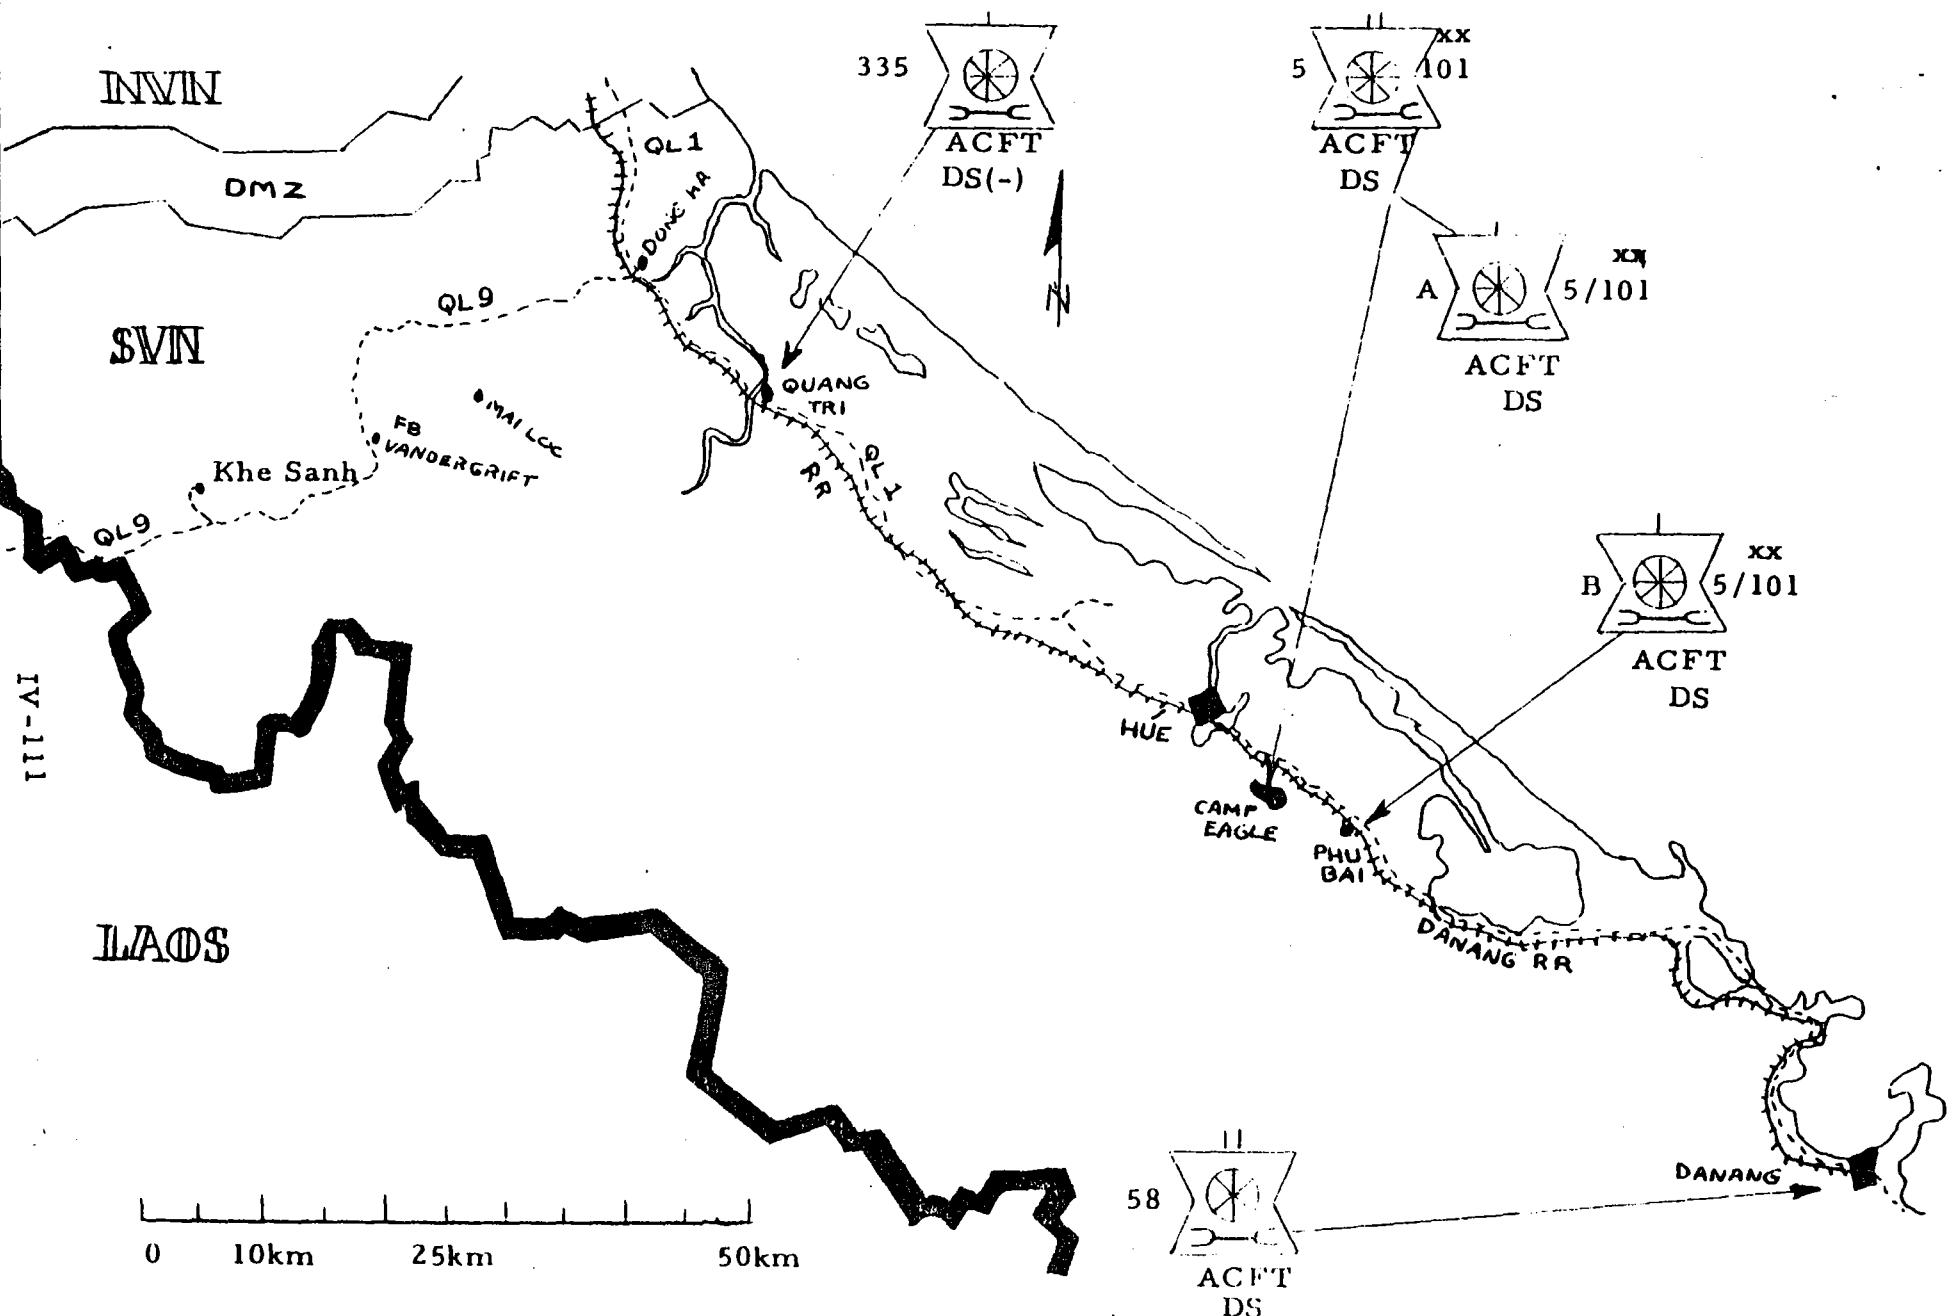
FIGURE IV-24 (U). Aircraft Maintenance Facilities (U).

It was planned that the 335th Direct Support Company (-) of the 23d Inf Div would be attached to the 101st Abn Div (Ambl). It was felt that this addition would provide a capability adequate to support the operation. The units of the 5th Transportation Battalion (AM&F) were scheduled to remain at pre-operation locations at Camp Eagle and Phu Bai. The 335th, augmented as necessary would operate at Quang Tri for about 90 days. Mission alignment

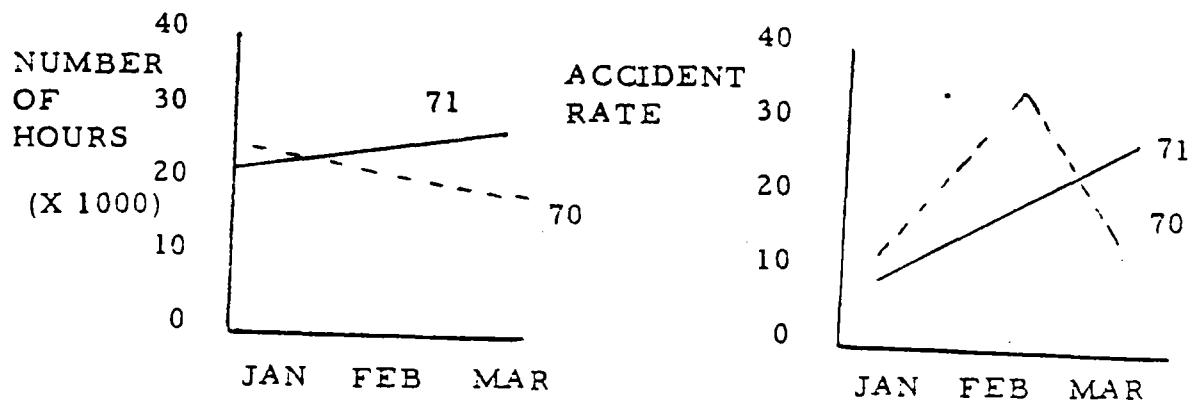
FIGURE IV-31 (U). 101st Abn Div (Ambl) Hours Flown and Accident Rate, 3rd Qtr FY 70 and 71 (U).

b. The division flew 7,548 hours during the period of February and March 1971 than during the same time period in 1970. See Figure IV-31 below:

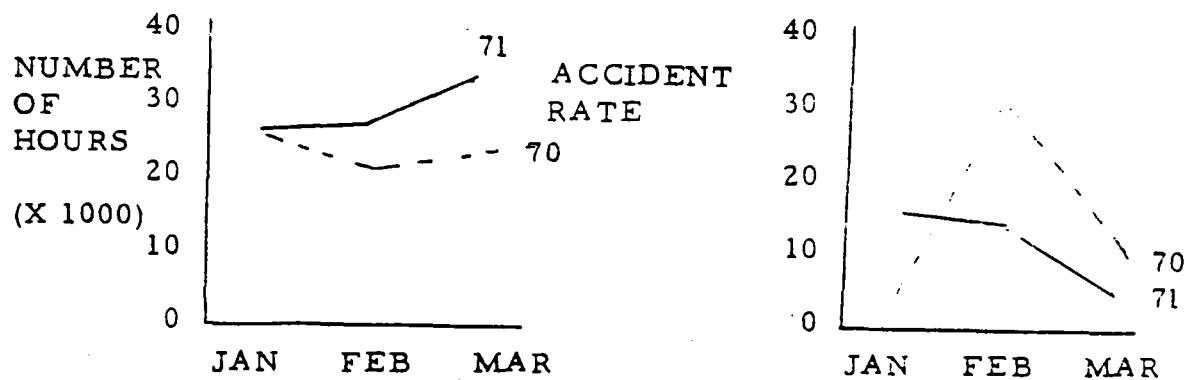
FIGURE IV-32 (U) 101st Avn Gp Hours Flown and Accident Rate, 3rd Qtr FY 70 and 71 (U).

c. An examination of hours and rates in the 101st Aviation Group shows that the Group flew 8,188 hours more during the month of February and March 1971 than during the same period in 1970, experiencing an average rate reduction of 13.8 accidents per 100,000 flying hours. See Figure IV-32 below:

d. The increase in flying hours is a result of the operational requirements of LAMSON 719 and also the requirement to support troops in the Division area of operations. When flying hours are increased, the rate will drop if the number of accidents remains relatively stable or decreases.

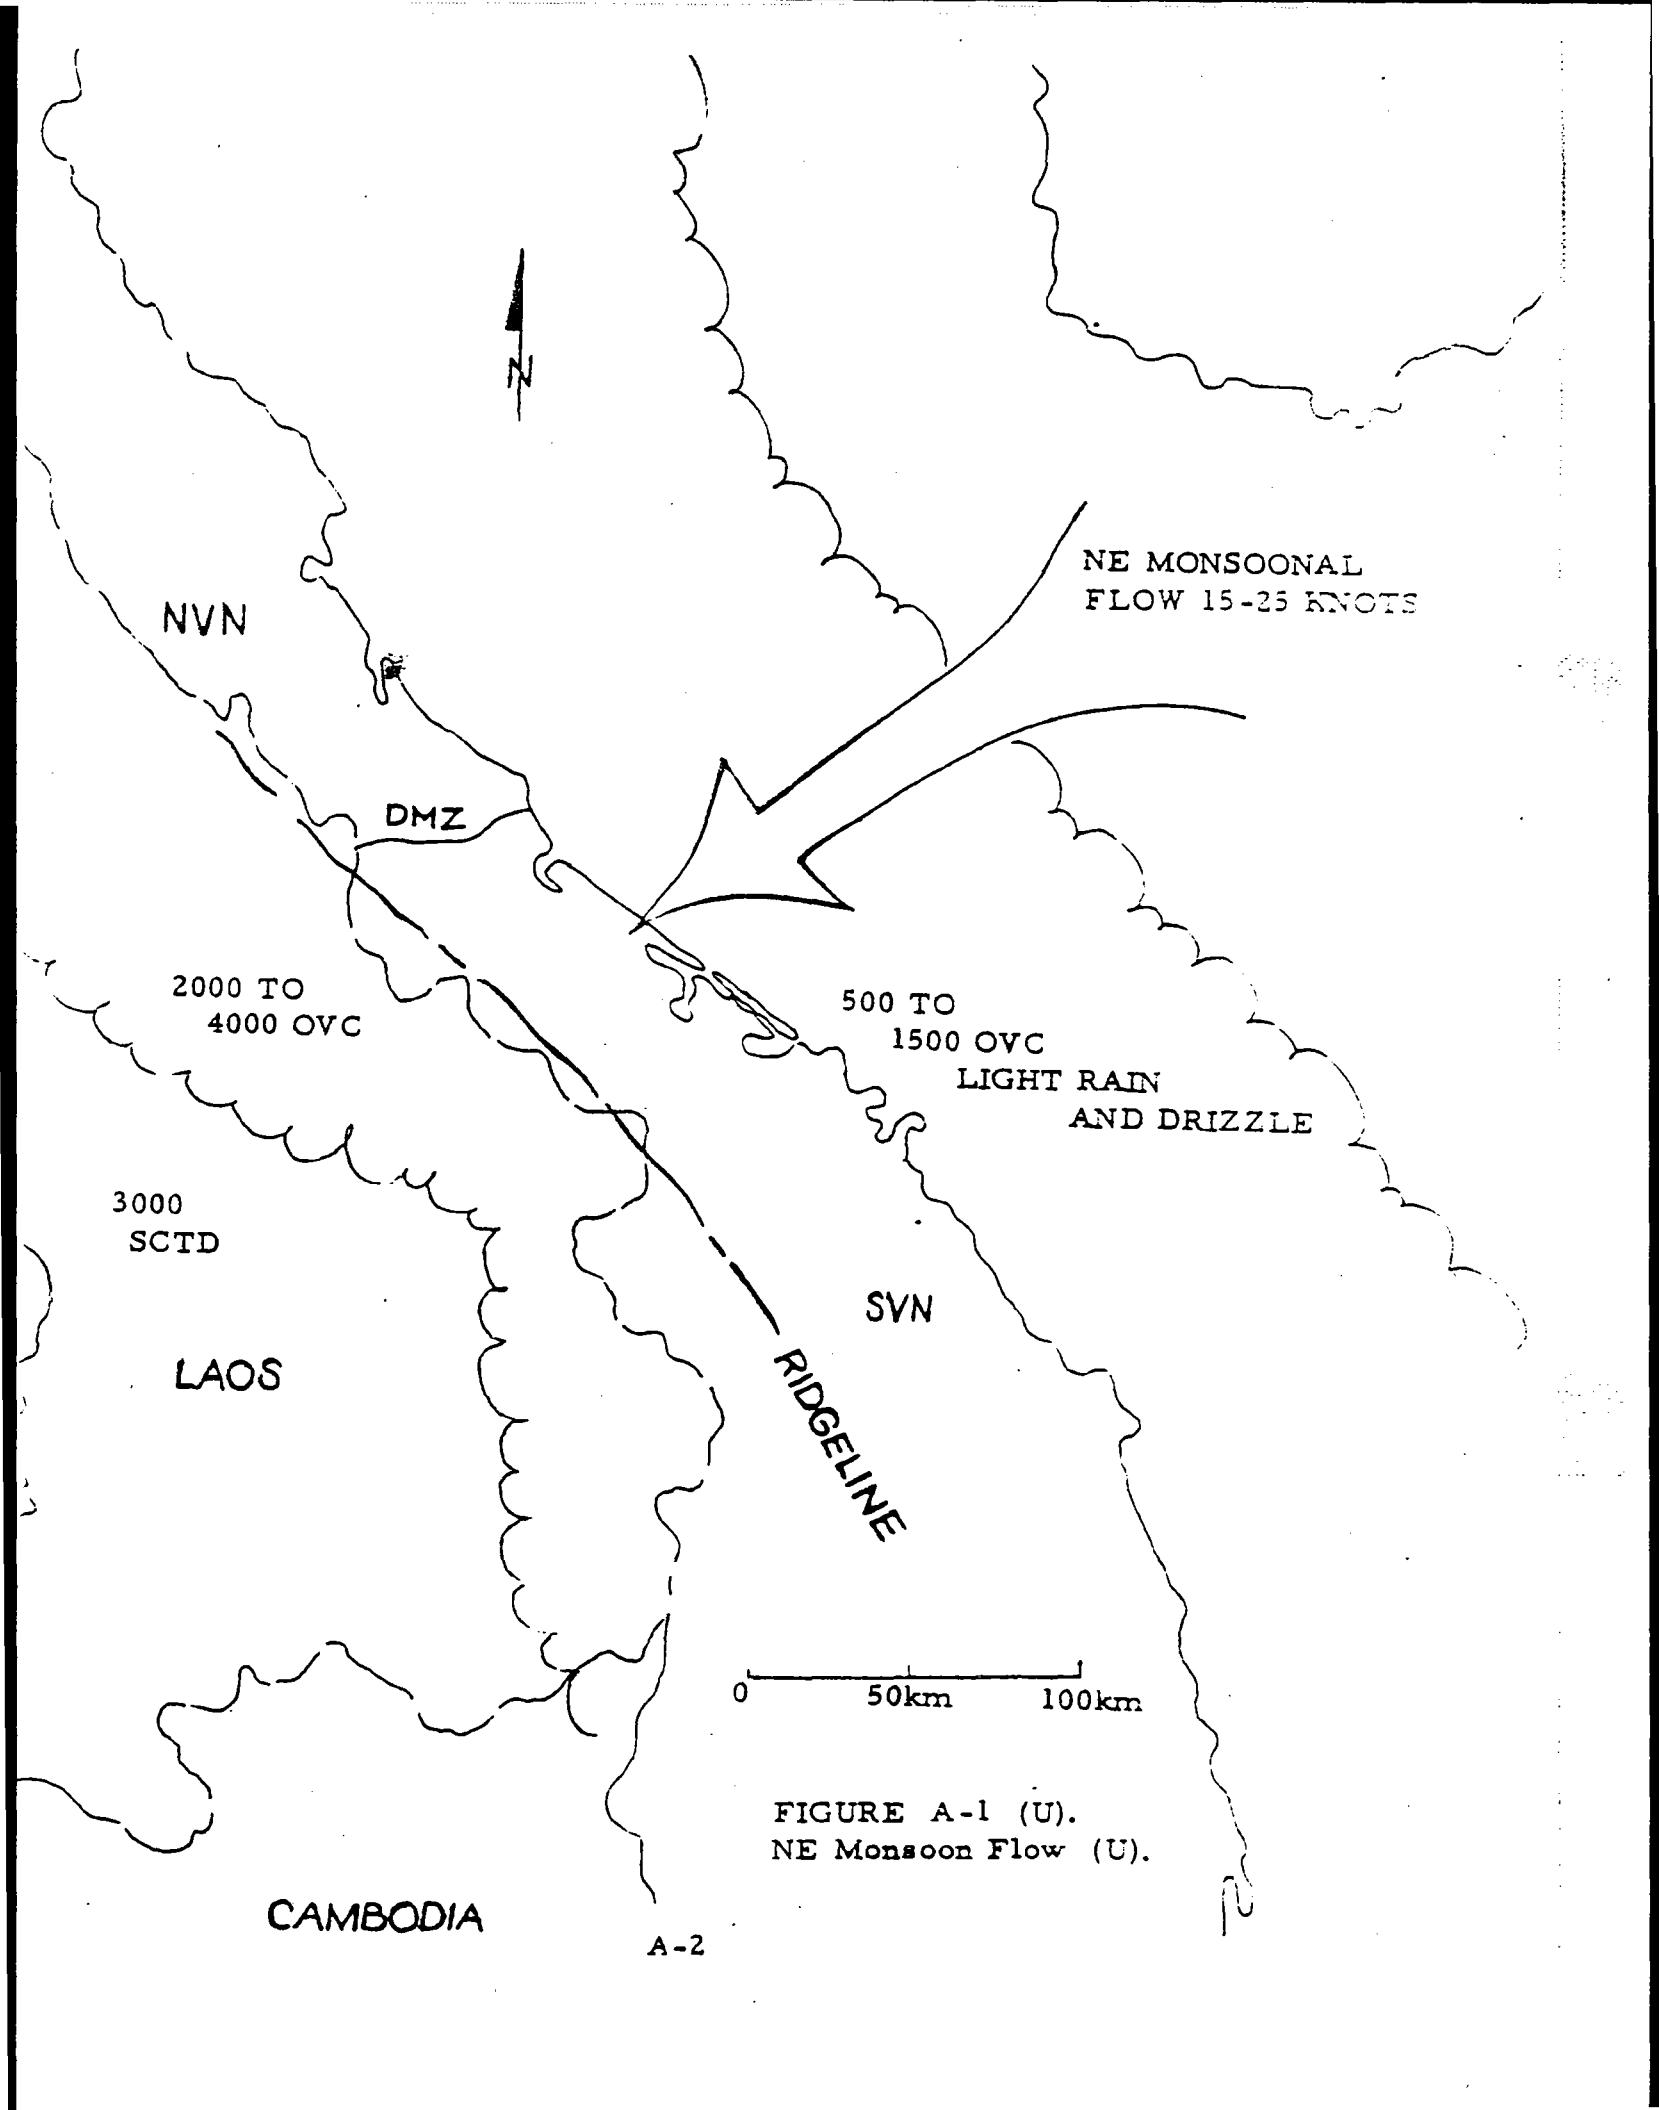
If a moderate northeasterly flow of 15 to 25 knots is present through the first eight to ten thousand feet above the ground, (Figure A-1) "spill over" into Laos will occur. This "spill over" will produce

ceilings from 2,000 to 4,000 feet above mean sea level extending 50 to 70 miles into eastern Laos, becoming mostly scattered in western Laos. This same flow pattern will cause ceilings to average between 500 and 1,500 feet with light rain and drizzle along the coastal areas of South Vietnam. All higher elevations will be obscured in clouds.

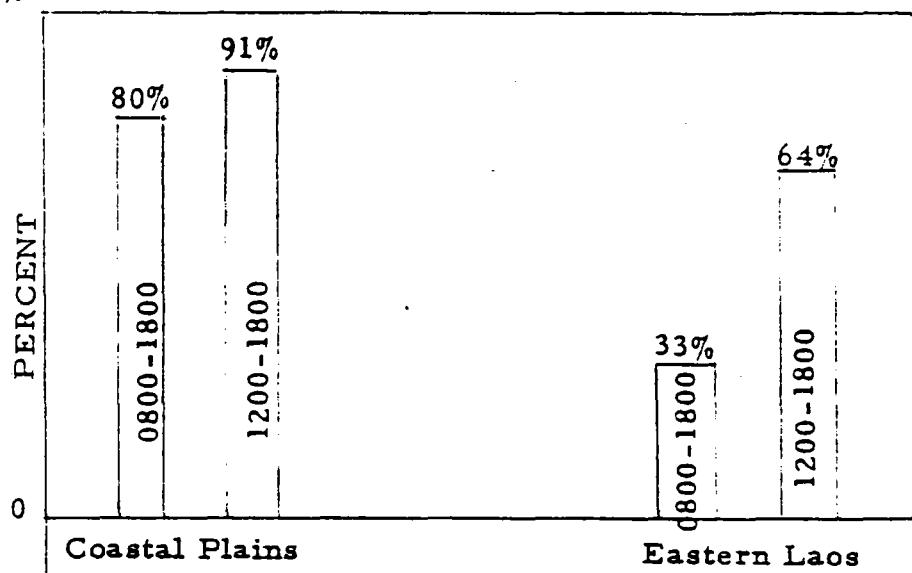
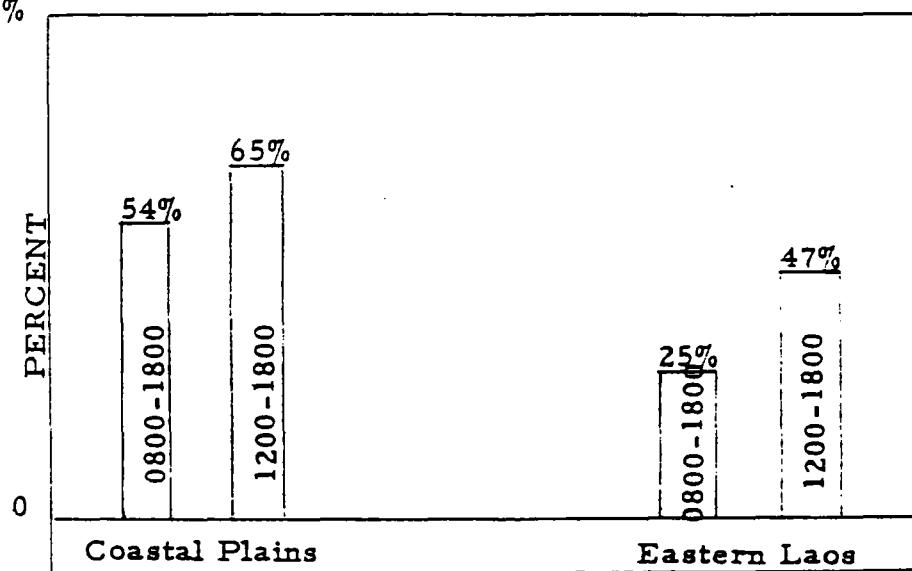
FIGURE A-4 (U). Aviation Weather Minimums (U).

Period 8 Feb thru 24 Mar 71

Ceilings of 1000 feet (AGL) or better

Ceilings of 3000 feet (AGL) or better

1. Aviation support was affected by weather in three separate regions. The majority of aircraft were based in the Vietnamese coastal plains, crossed the Annamite chain, staged at Khe Sanh and then operated in eastern Laos. Under most conditions, the weather was marginal in one of the three areas during most of the period. Ceilings of 1,000 feet above ground level (AGL) were used as a minimum standard for effective operation of Army aircraft, whereas ceilings of 3,000 feet AGL were used for employment of normal USAF TAC air support. Data in Figure A-4 is derived from USAF observation stations in the Coastal Plains. No weather stations were established
