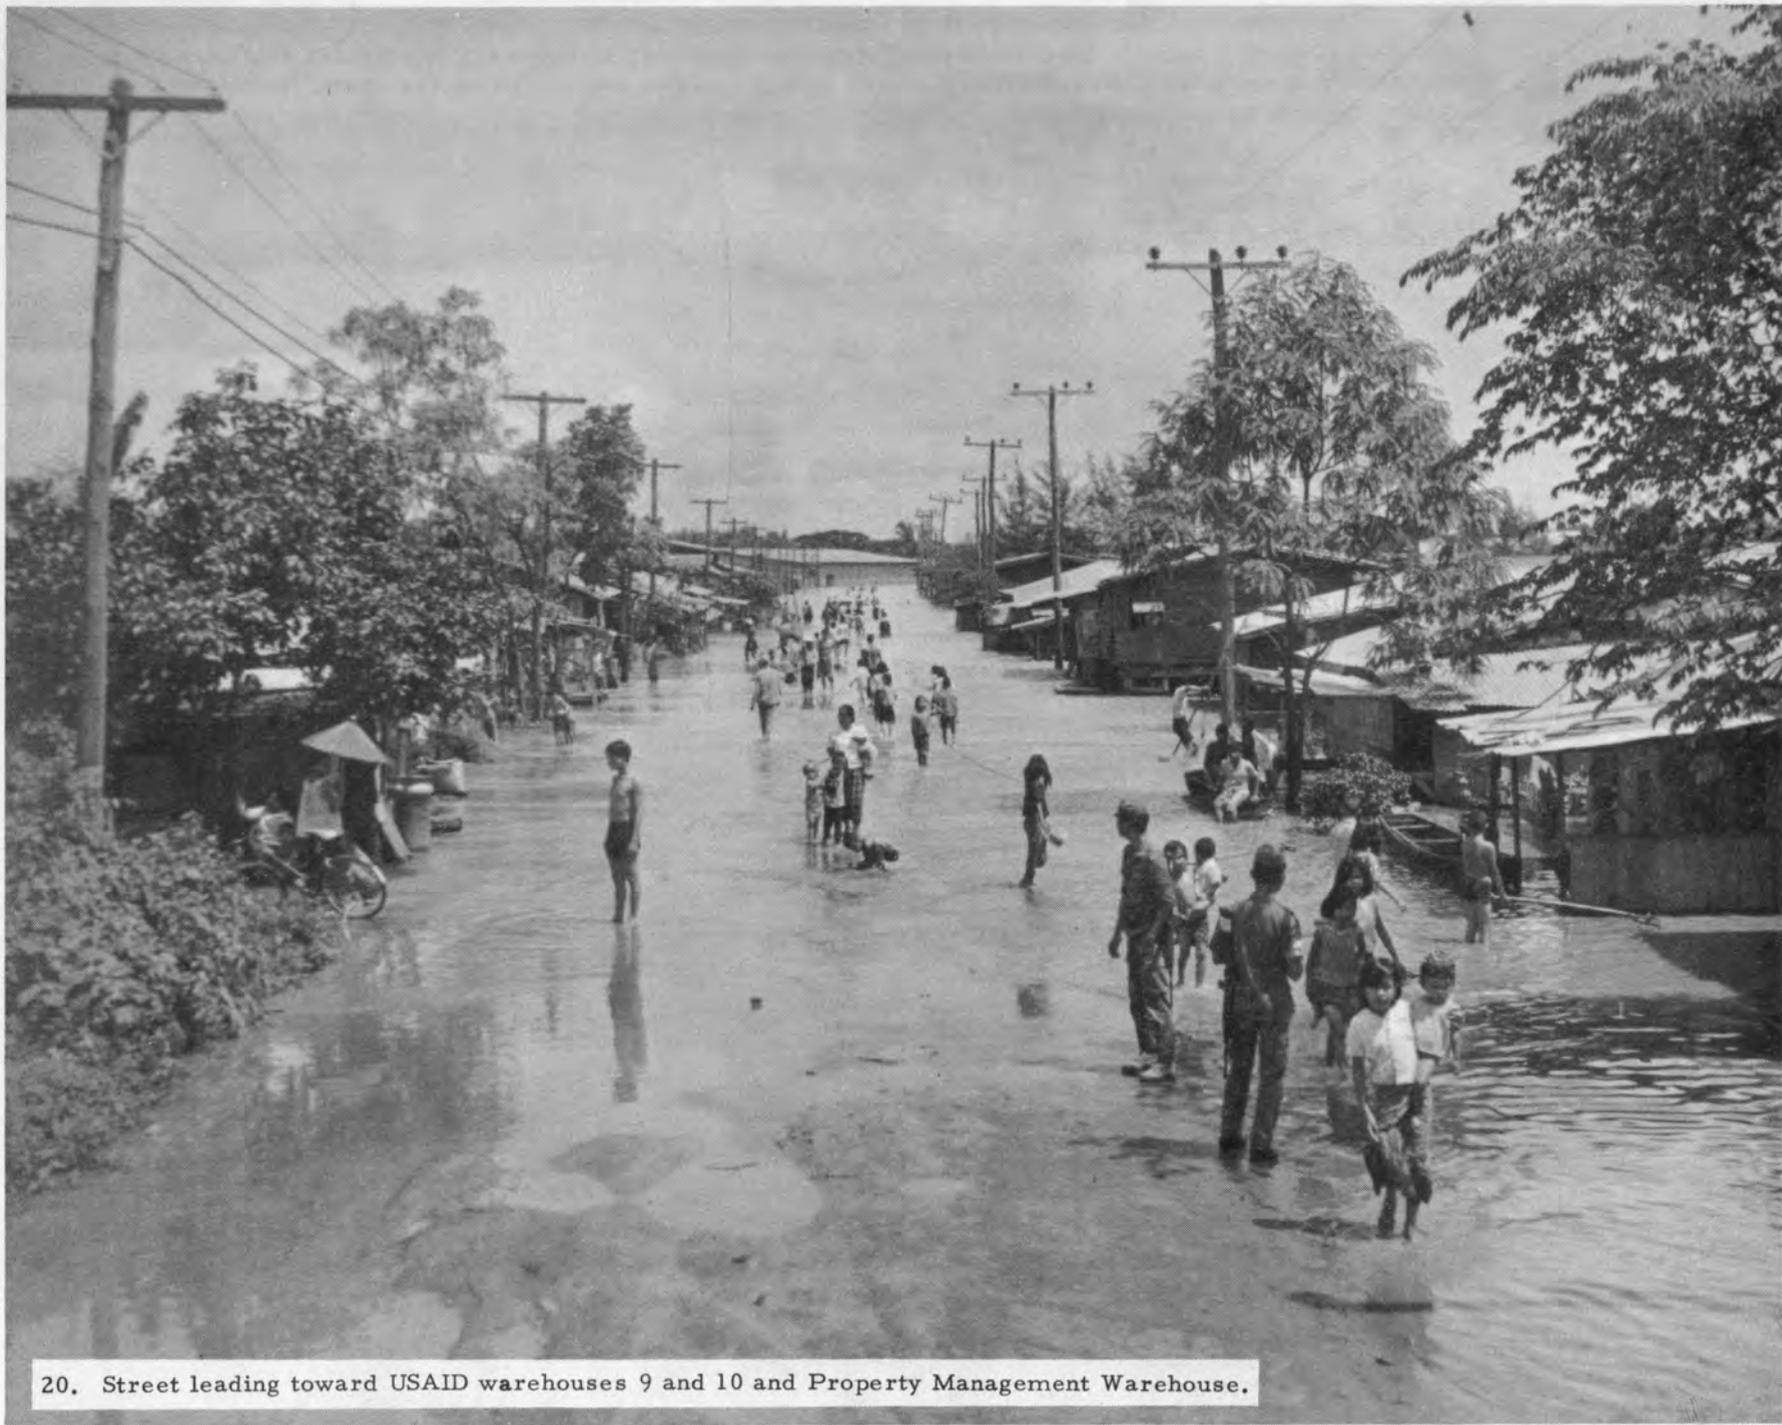
20. Street leading toward USAID warehouses 9 and 10 and Property Management Warehouse.

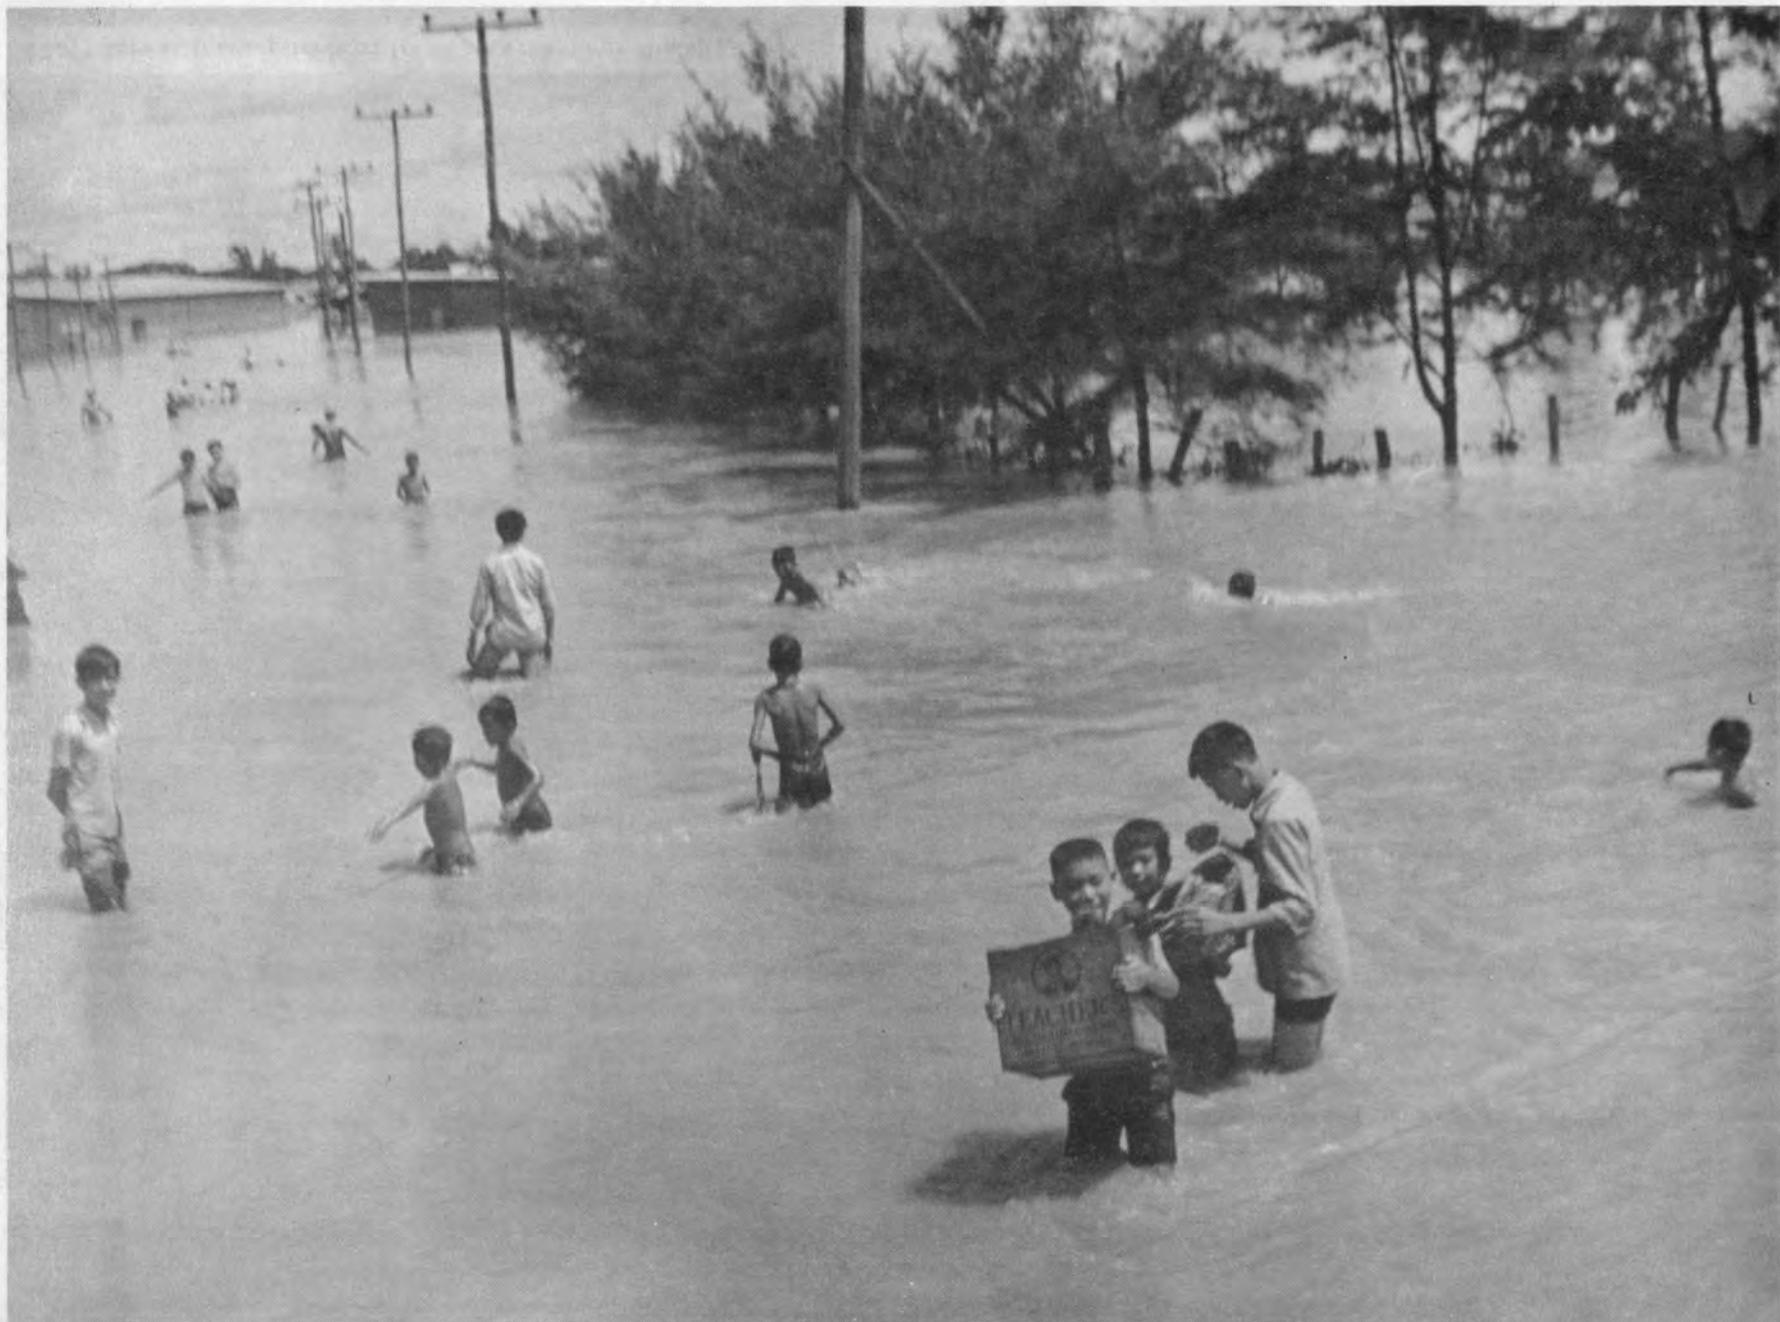
21. For the young, floods are more fun than worry. USAID Property Management Warehouse in background. Only drowning reported in Vientiane in first week of flooding was one infant.

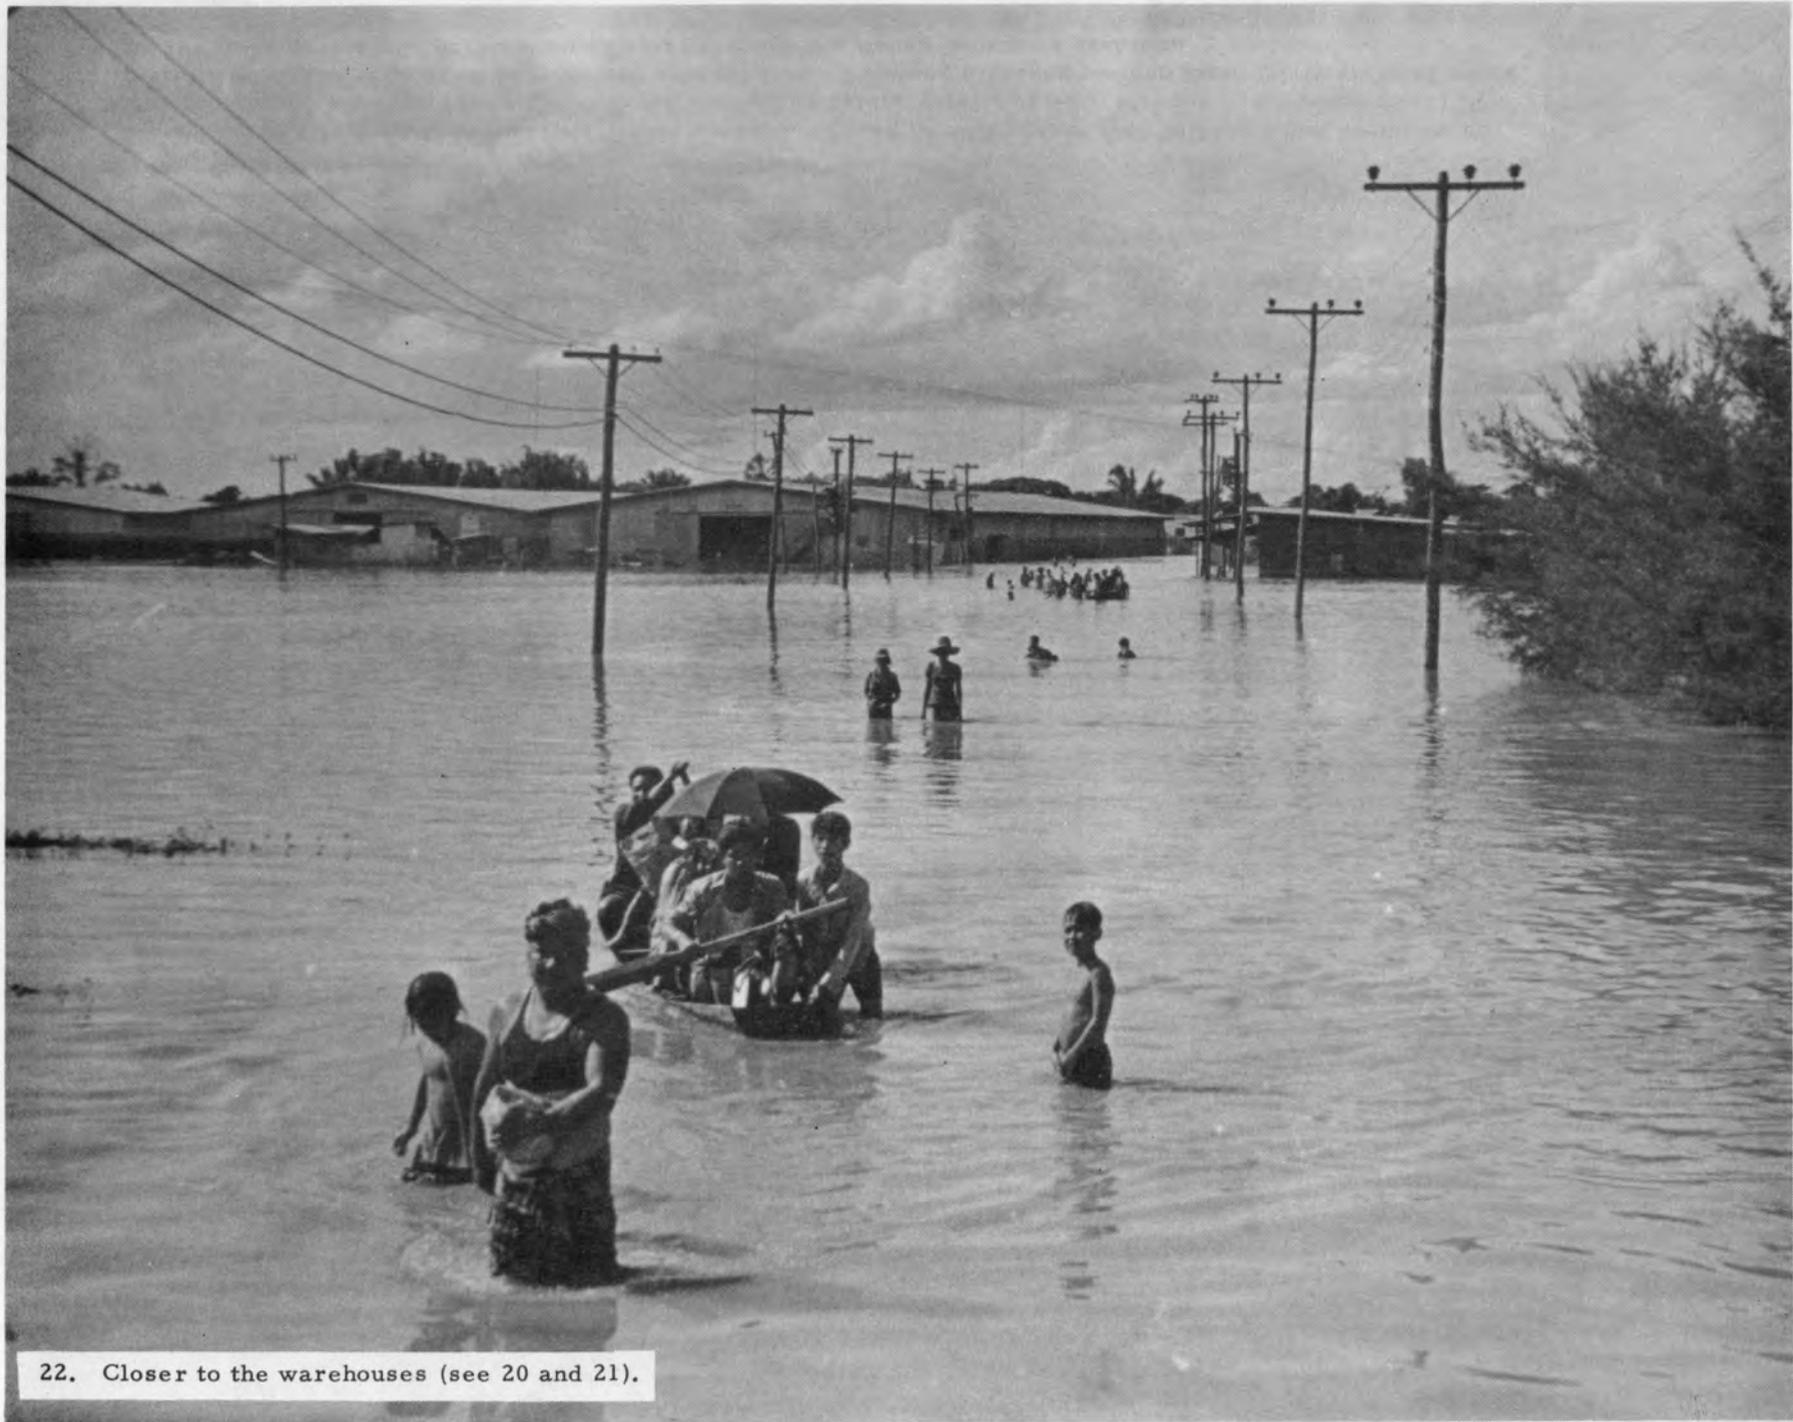
22. Closer to the warehouses (see 20 and 21).

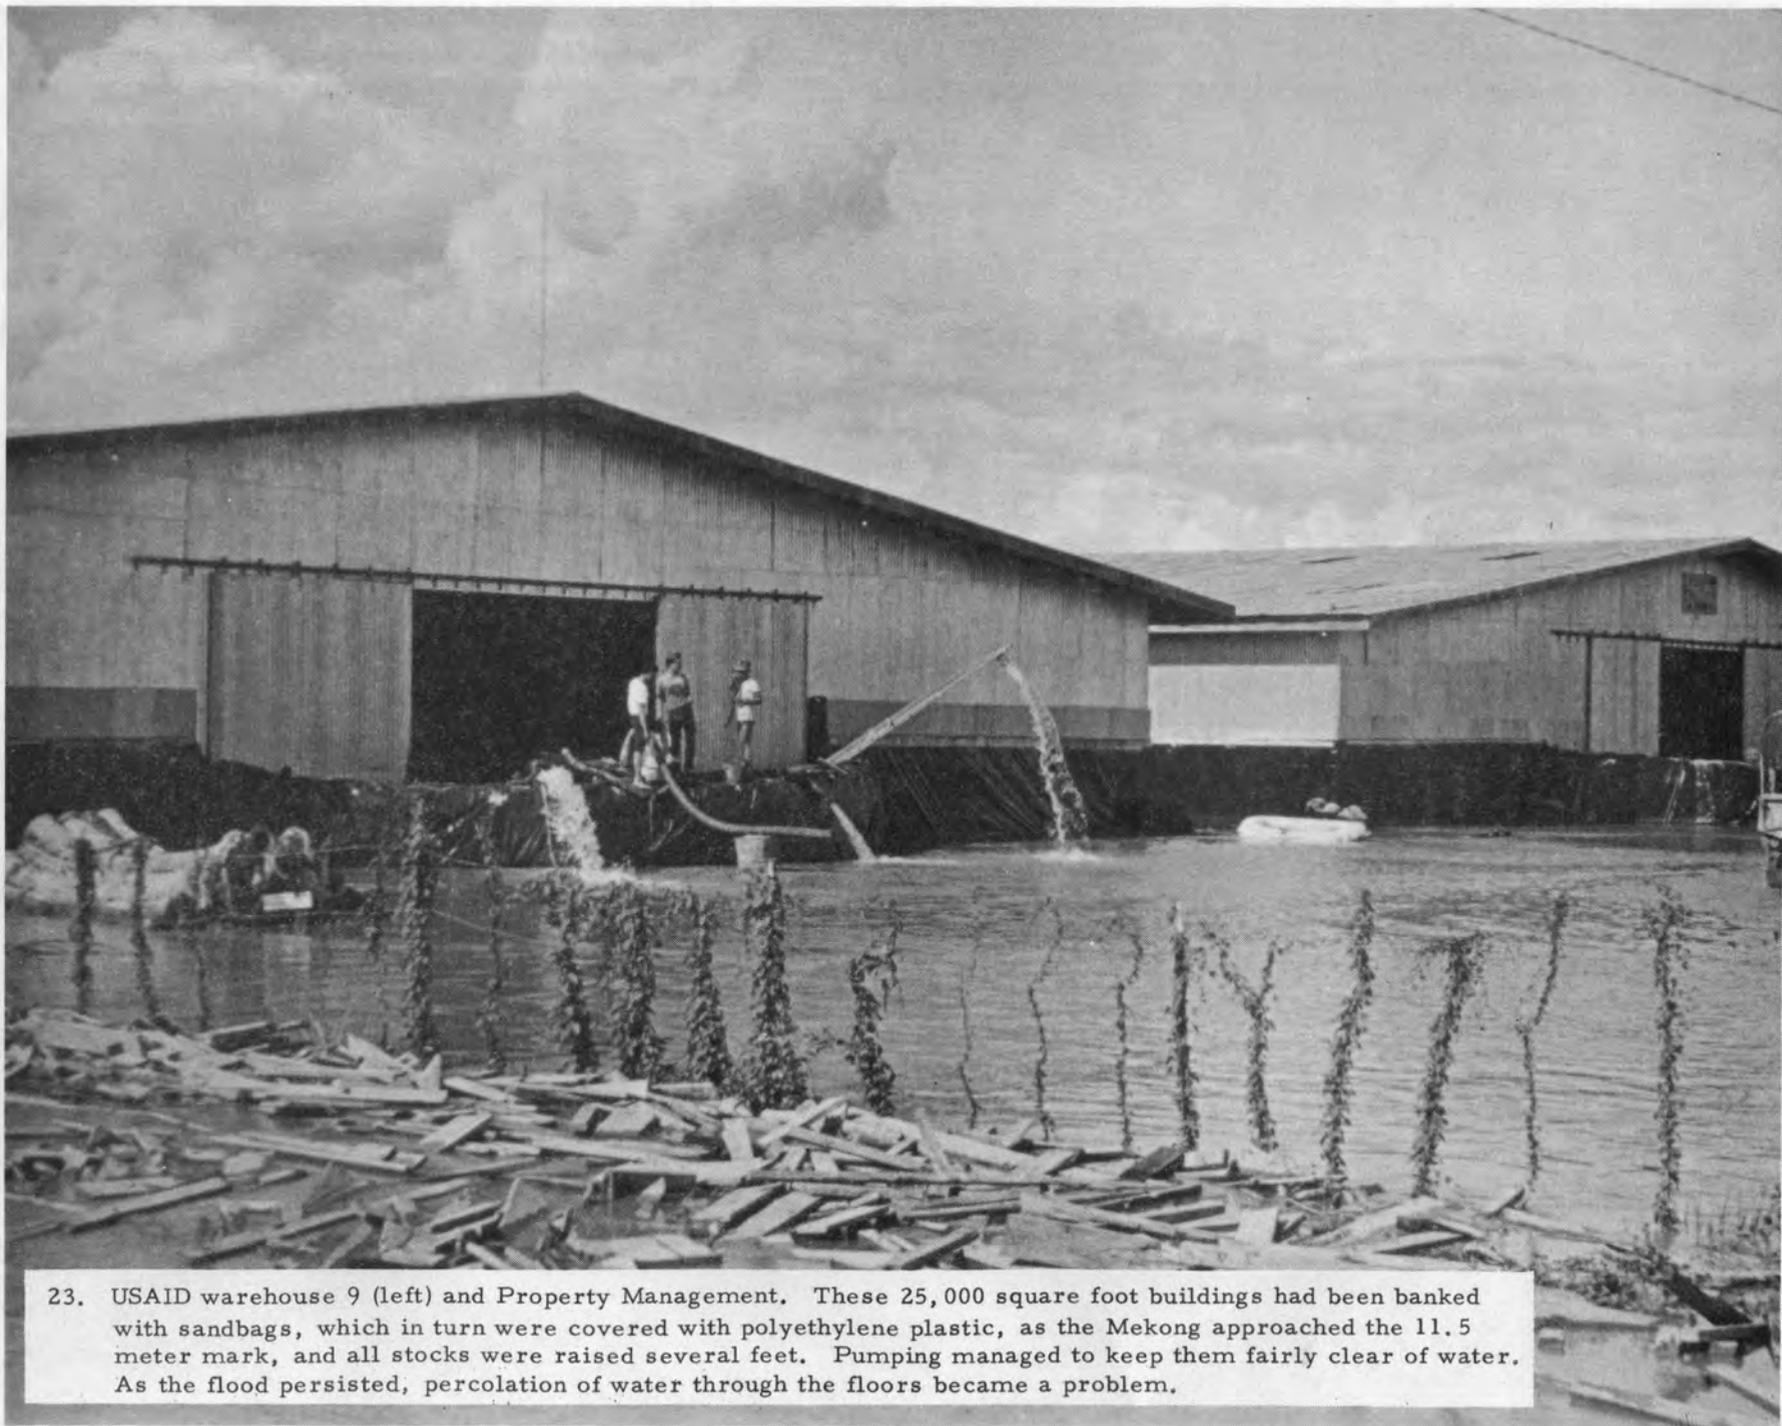
23. USAID warehouse 9 (left) and Property Management. These 25,000 square foot buildings had been banked with sandbags, which in turn were covered with polyethylene plastic, as the Mekong approached the 11.5 meter mark, and all stocks were raised several feet. Pumping managed to keep them fairly clear of water. As the flood persisted, percolation of water through the floors became a problem.

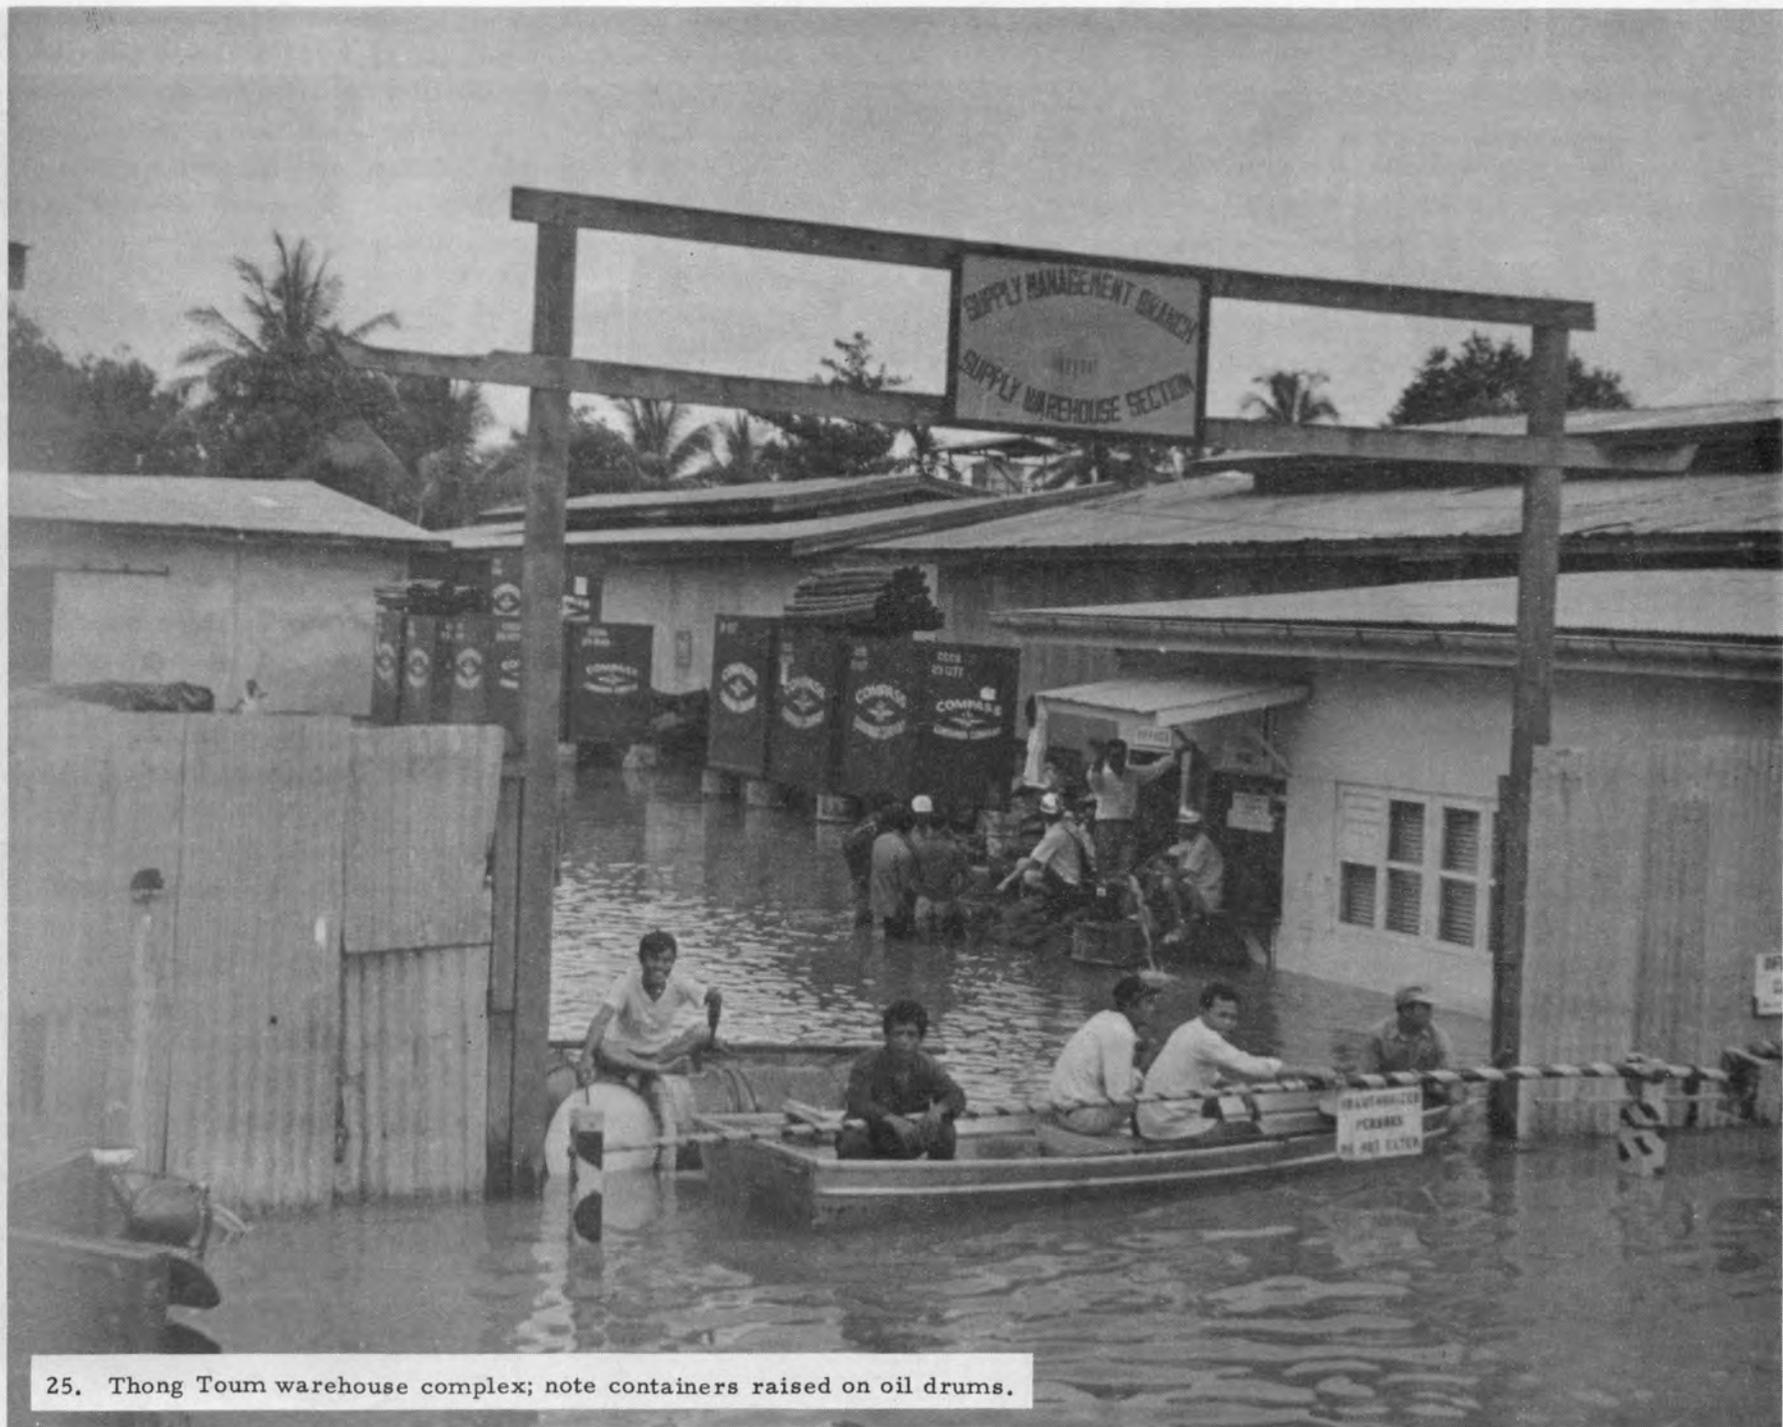
25. Thong Toun warehouse complex; note containers raised on oil drums.

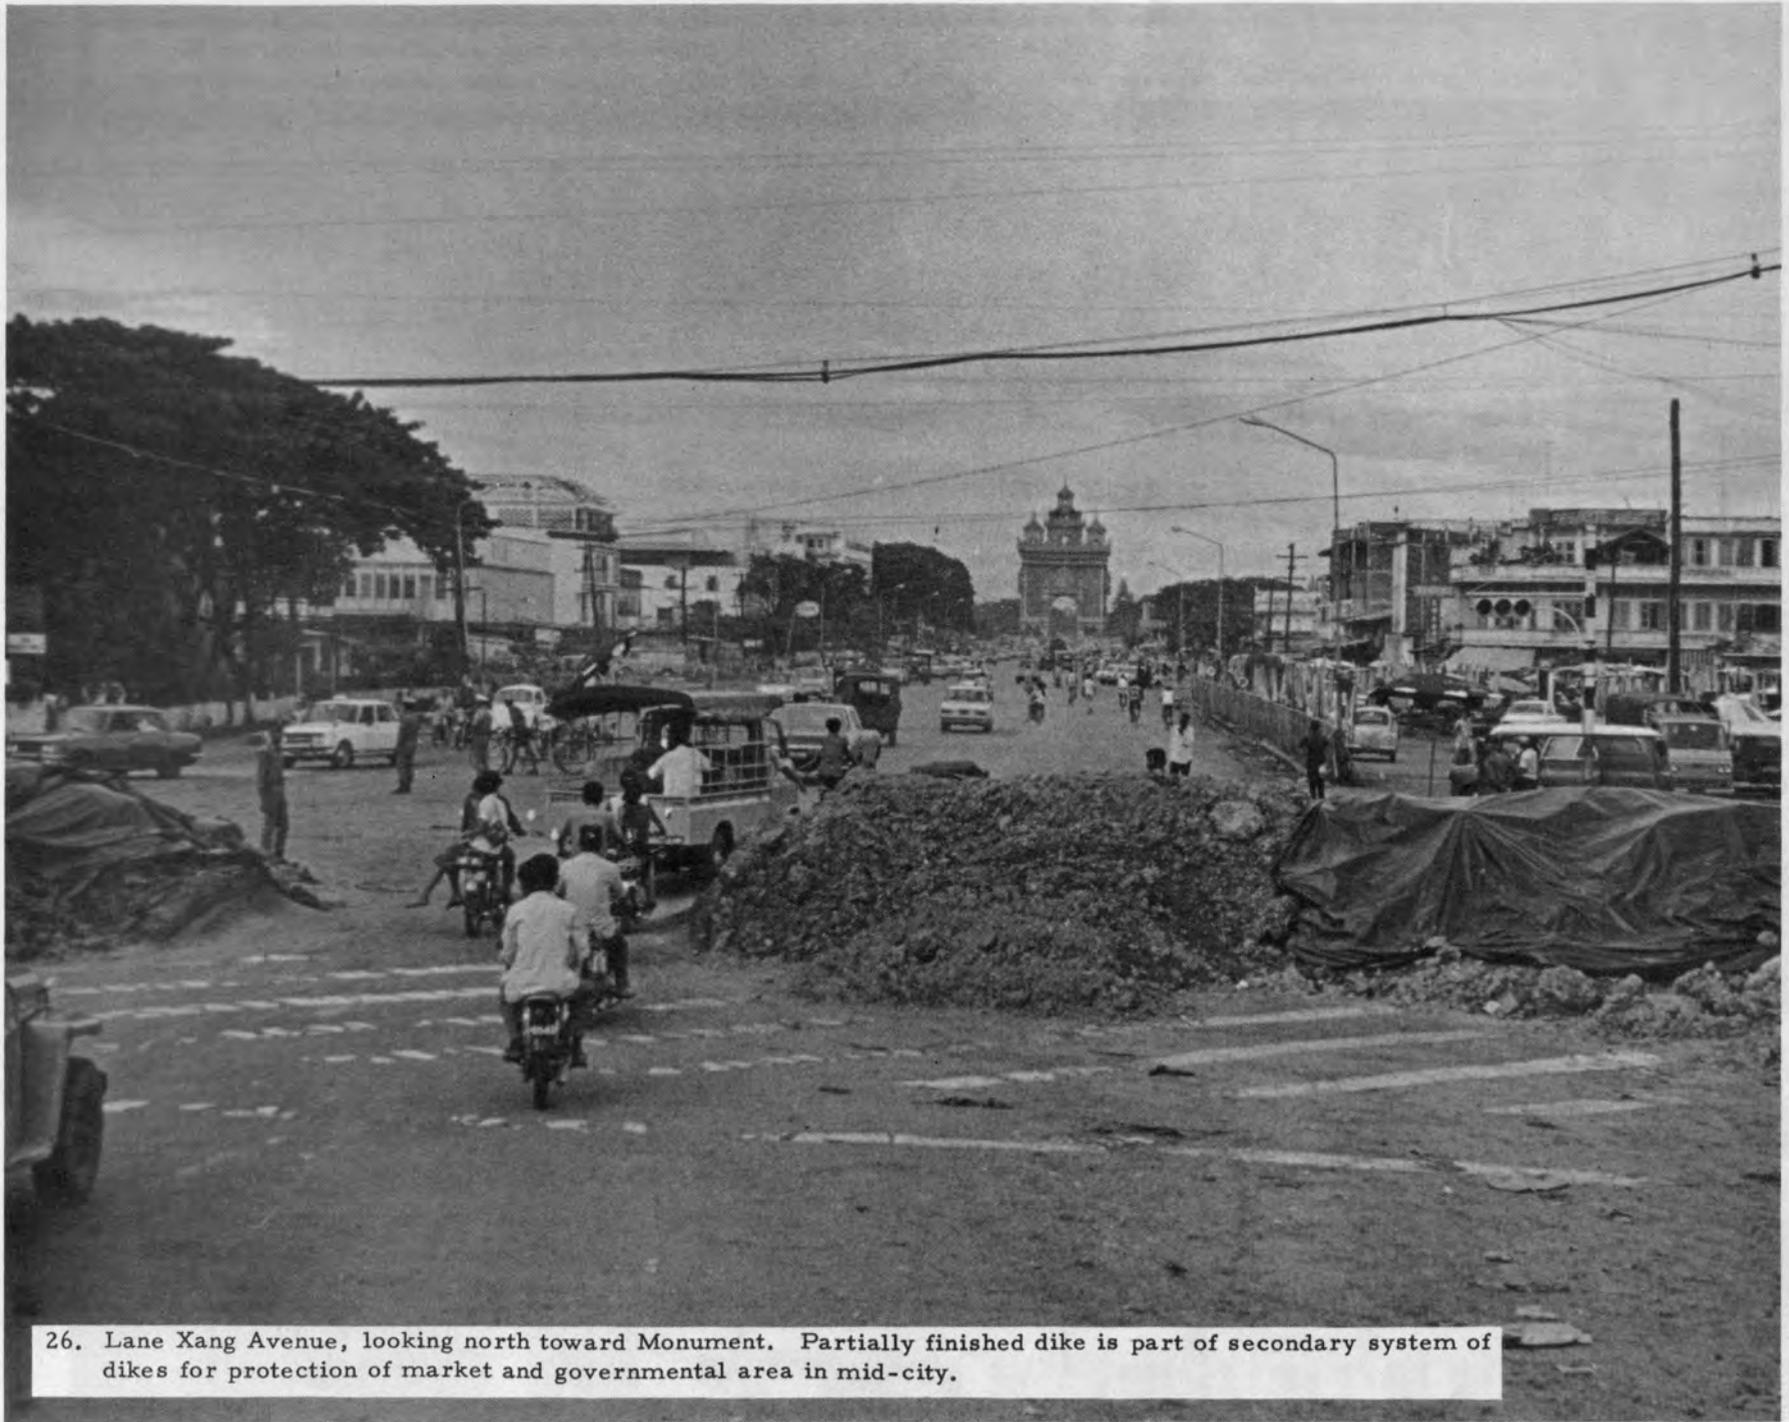
26. Lane Xang Avenue, looking north toward Monument. Partially finished dike is part of secondary system of dikes for protection of market and governmental area in mid-city.

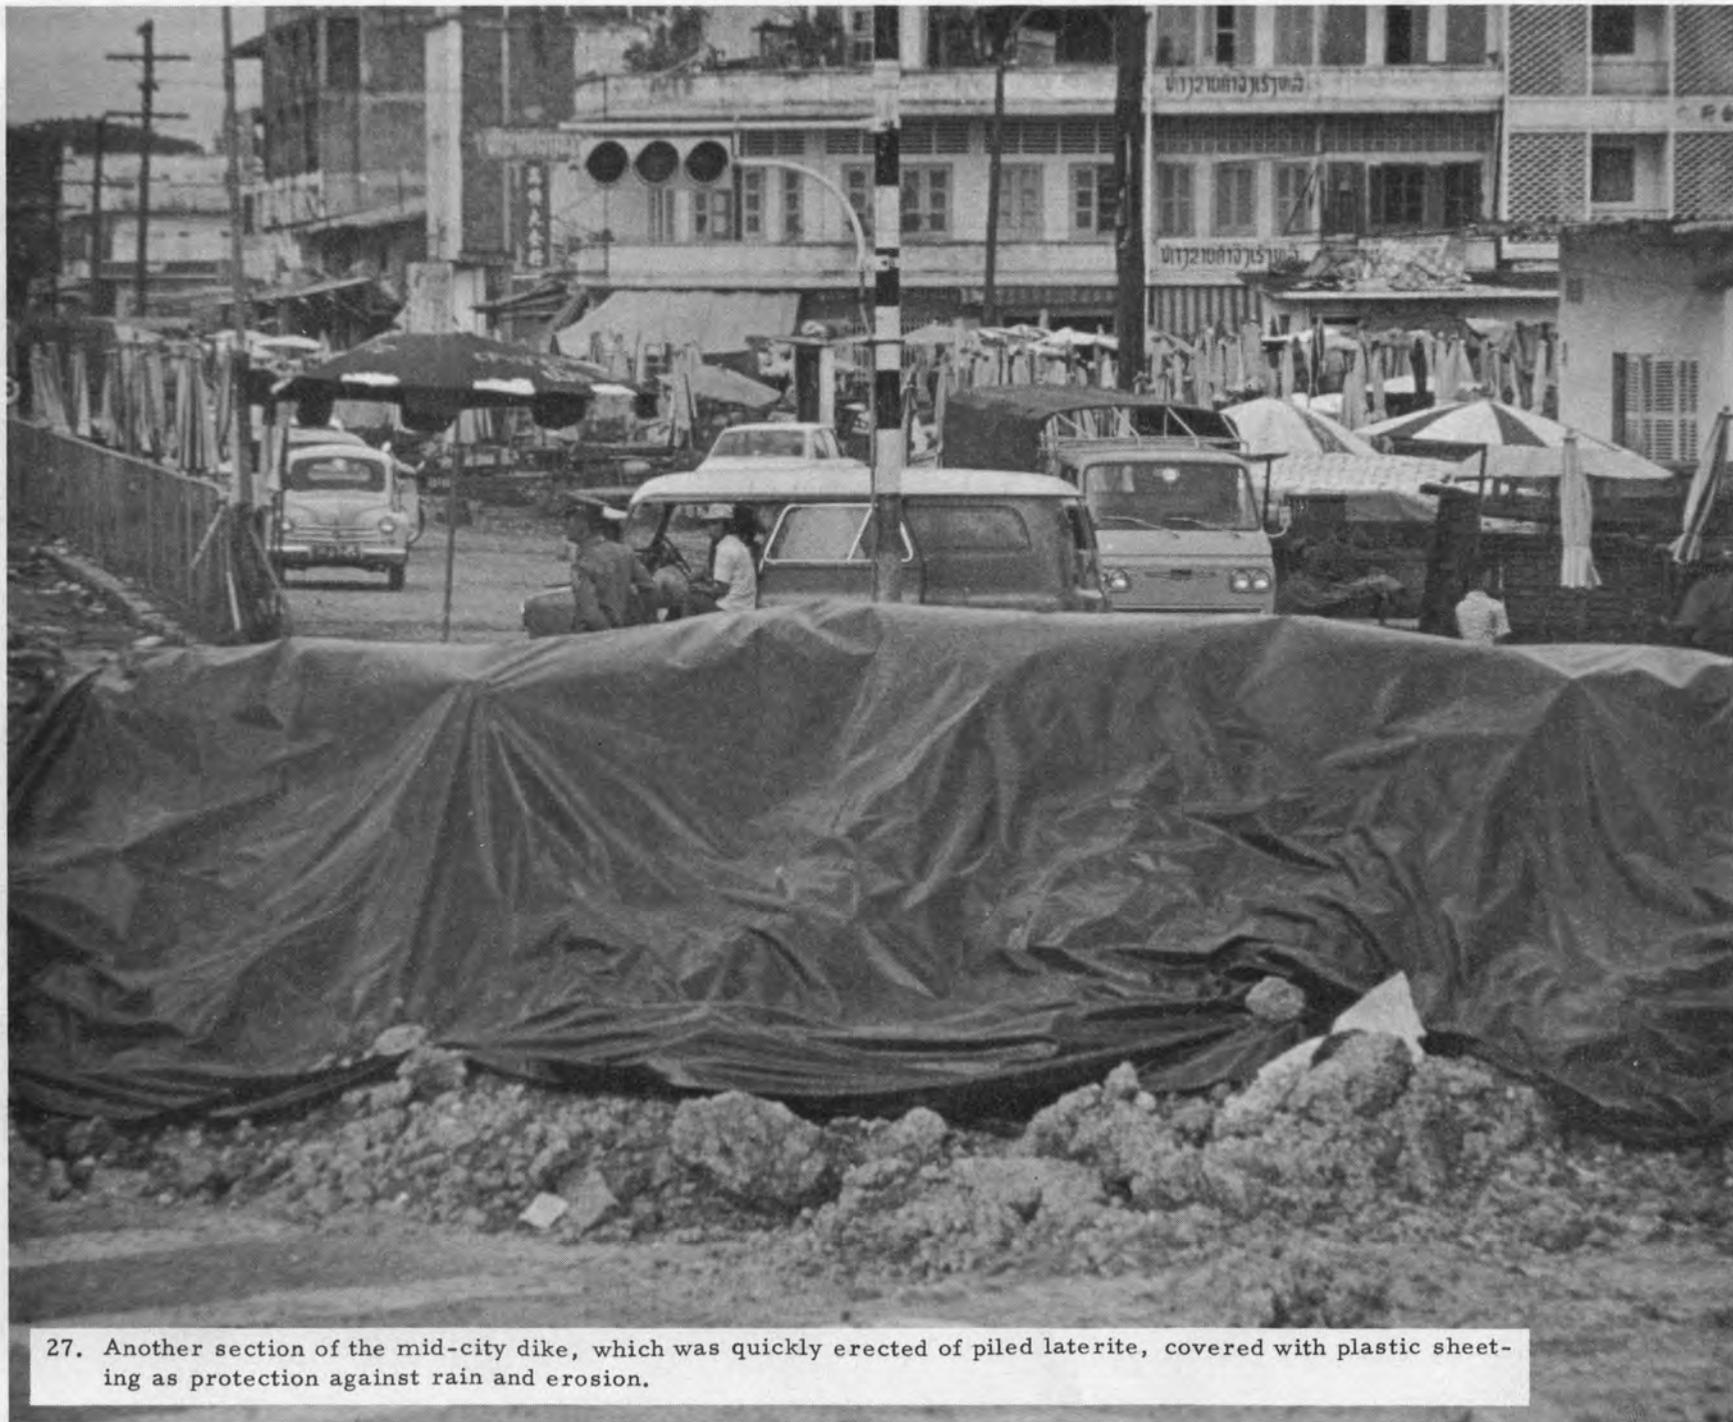
27. Another section of the mid-city dike, which was quickly erected of piled laterite, covered with plastic sheeting as protection against rain and erosion.

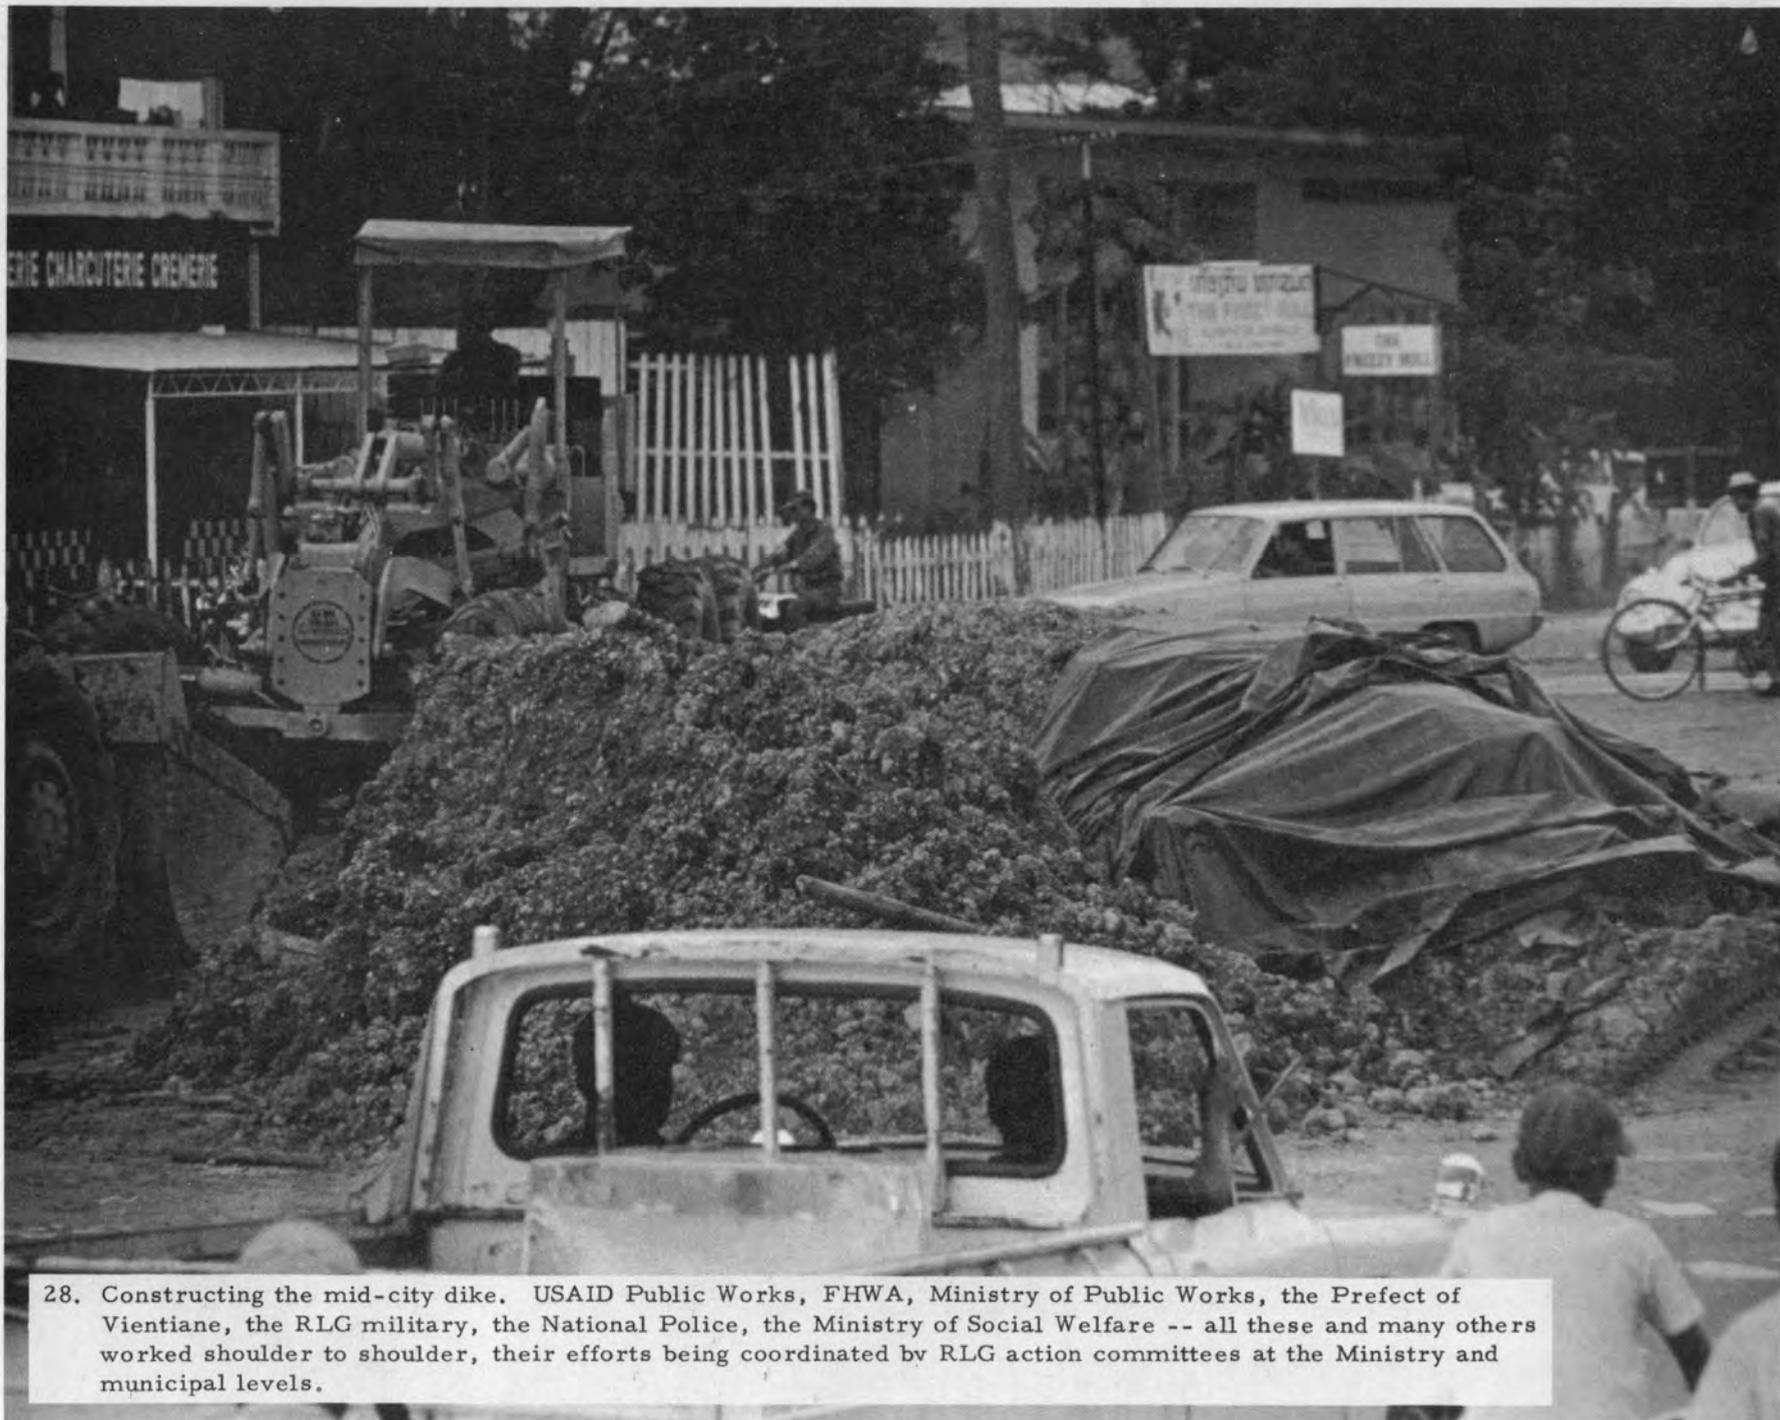
28. Constructing the mid-city dike. USAID Public Works, FHWA, Ministry of Public Works, the Prefect of Vientiane, the RLG military, the National Police, the Ministry of Social Welfare -- all these and many others worked shoulder to shoulder, their efforts being coordinated by RLG action committees at the Ministry and municipal levels.

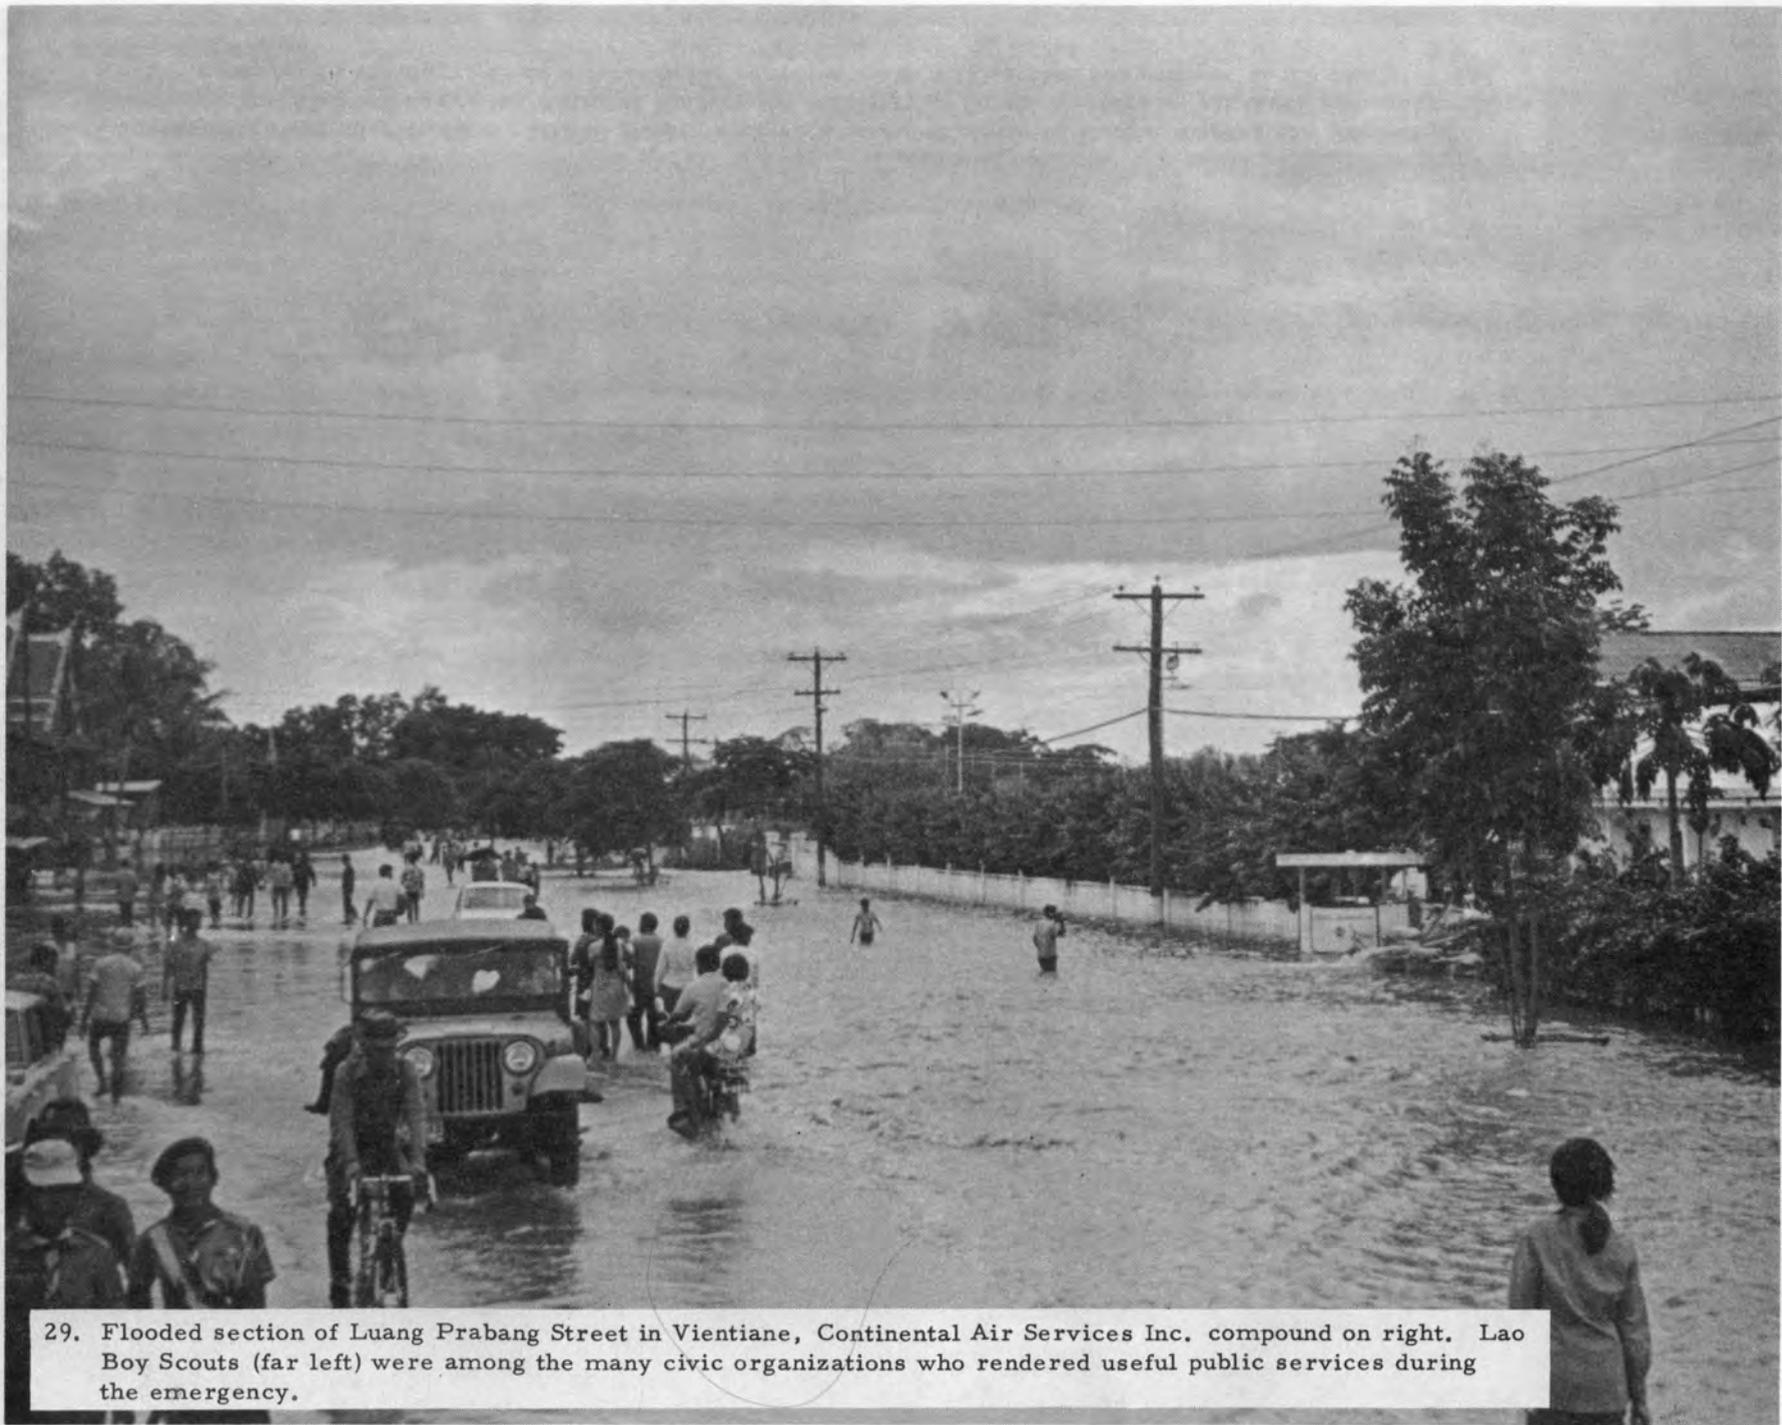
29. Flooded section of Luang Prabang Street in Vientiane, Continental Air Services Inc. compound on right. Lao Boy Scouts (far left) were among the many civic organizations who rendered useful public services during the emergency.
