101ST AIRBORNE DIVISION (AIRMOBILE)

FINAL REPORT

AIRMOBILE OPERATIONS IN SUPPORT OF
OPERATION LAMSON 719
8 February - 6 April 1971

VOLUME II

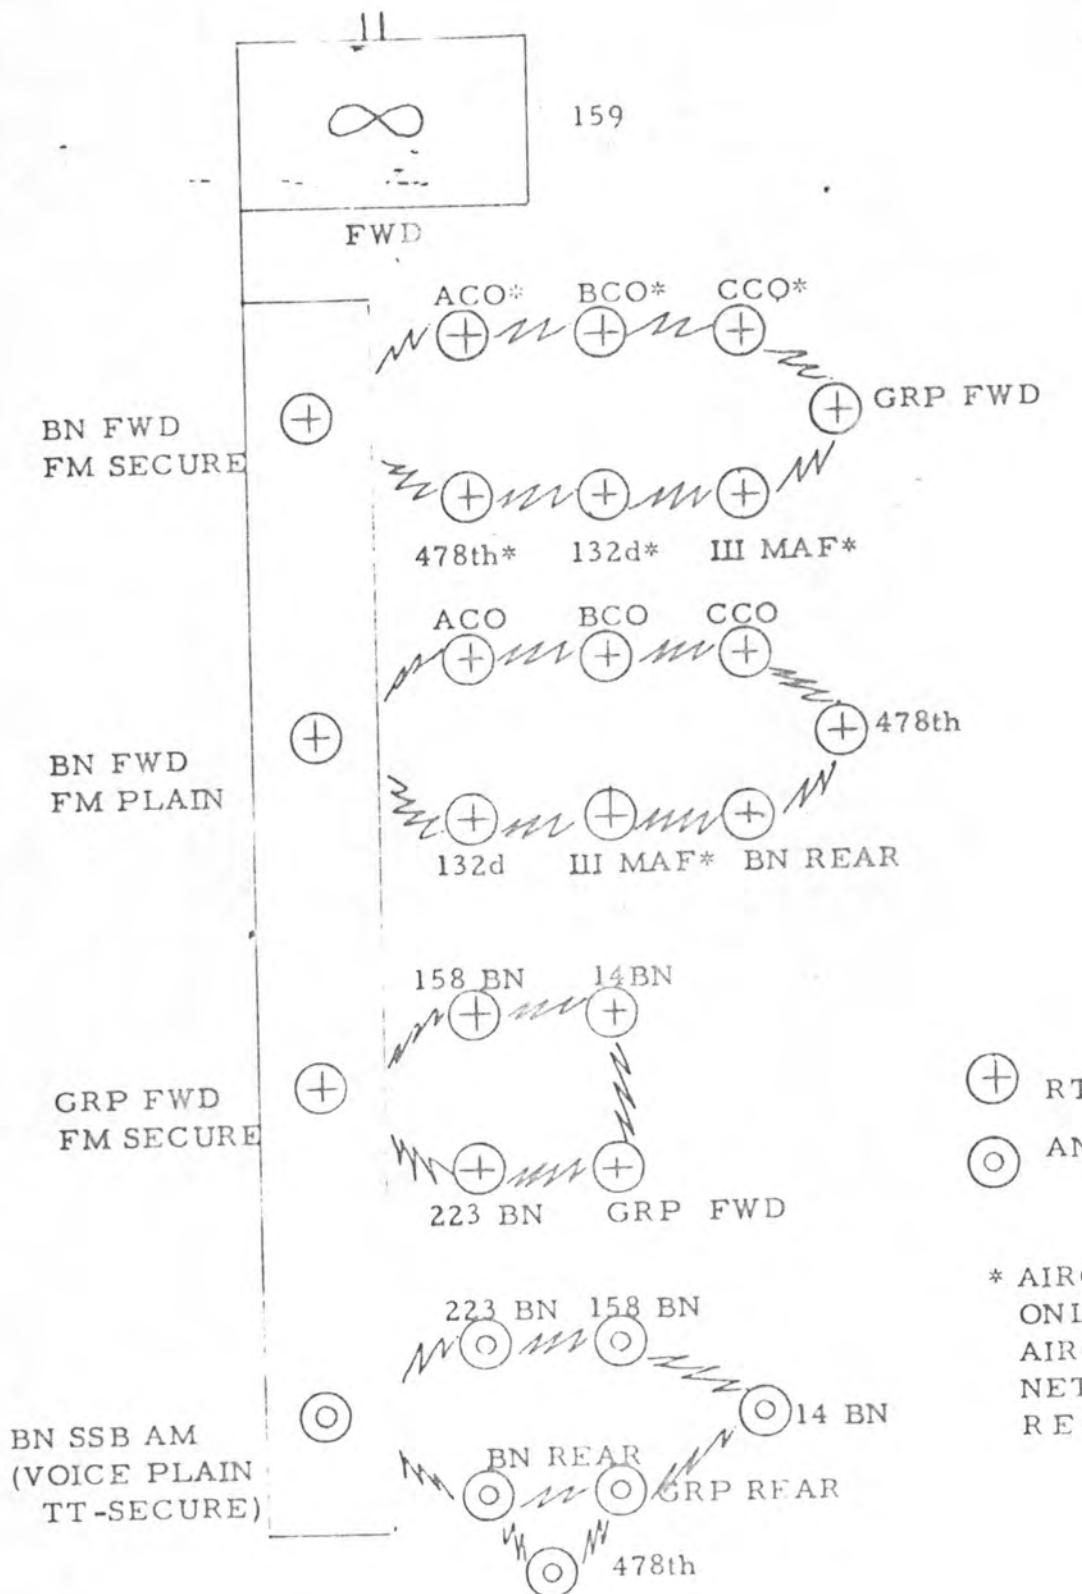
FIGURE IV-1 (U) Radio Net Diagram for 159 Avn Bn (ASHB) (U).

The primary means of voice communications on this operation was FM radio. Three RT-524 radios were set up at a forward operations tent, providing a battalion secure net, a battalion plain net and a station in the group secure net. The secure capability was achieved by using two KY-8 secure sets. Power for this FM configuration was supplied initially by two 1.5 KW DC generator sets and four 12 volt DC batteries. Later on, because of generator failure and battery problems, a 3 KW DC generator set was used in conjunction with an RA-91C rectifier. A net diagram of the FM radio system is shown at Figure IV-1. The battalion (fwd) plain net was originally designed to communicate with the rear area by means of an FM retrans site. Because of equipment shortages, this retrans site was not installed and bad atmospheric conditions nullified the possibility of communicating to the rear without it. The battalion (fwd) plain net was then used, as was the battalion (fwd) secure net, primarily for contact with aircraft in the area of operations. Aircraft VHF and UHF radios were also employed as required.

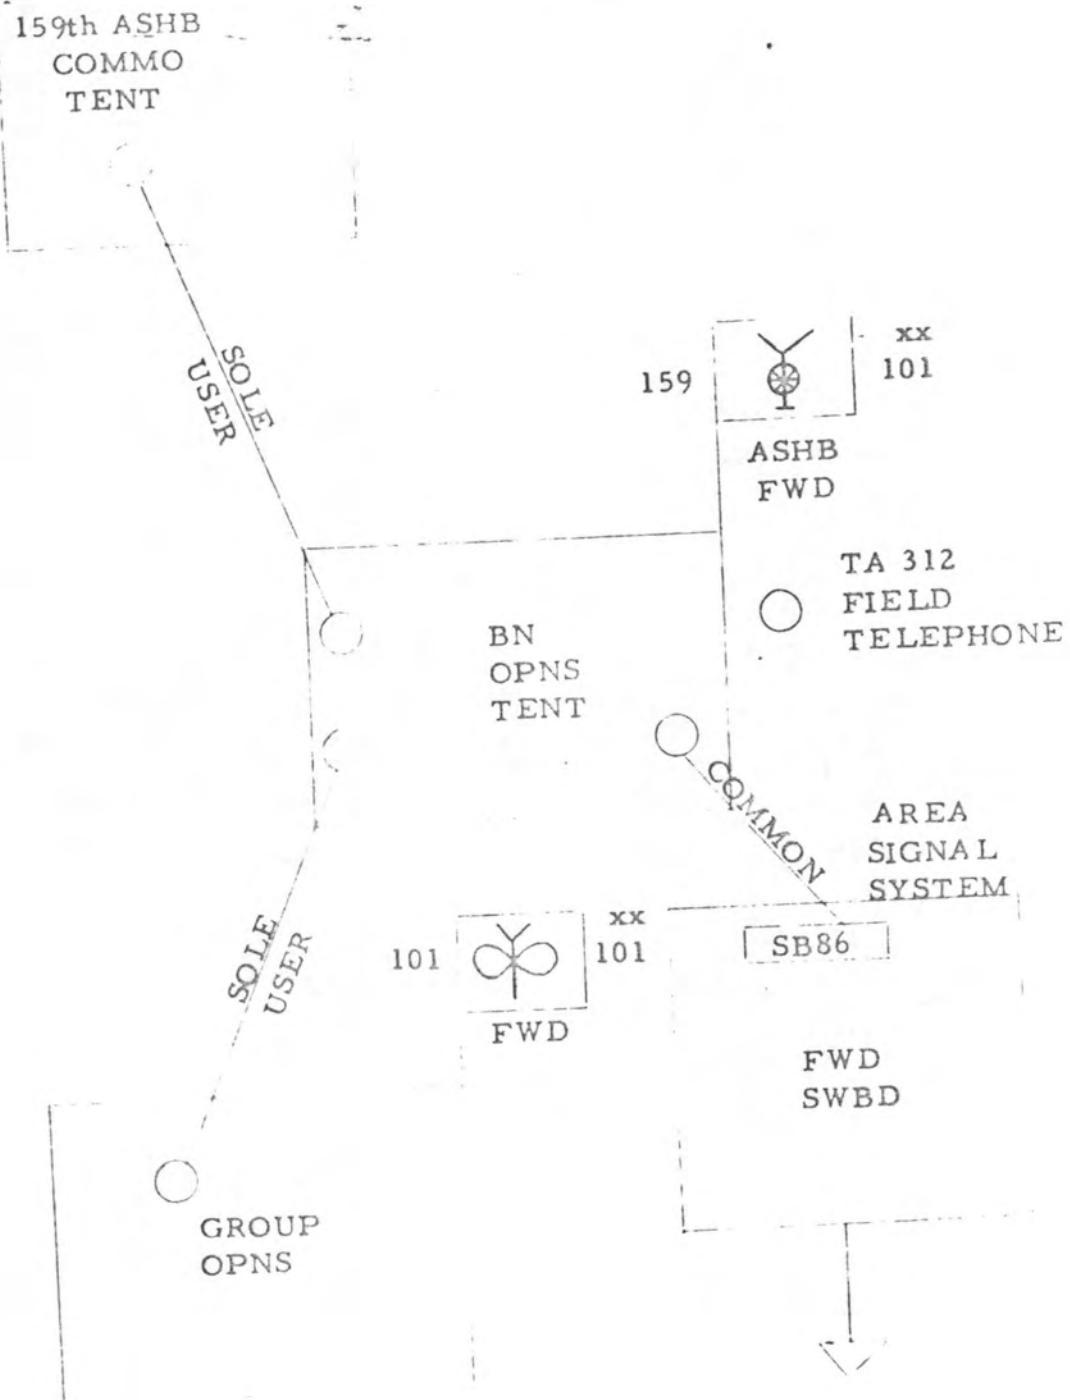
FIGURE IV-2 (U) Wire Diagram for 159th Avn Bn (ASHB) (U)

WD-1 wire and field telephones were used for local land

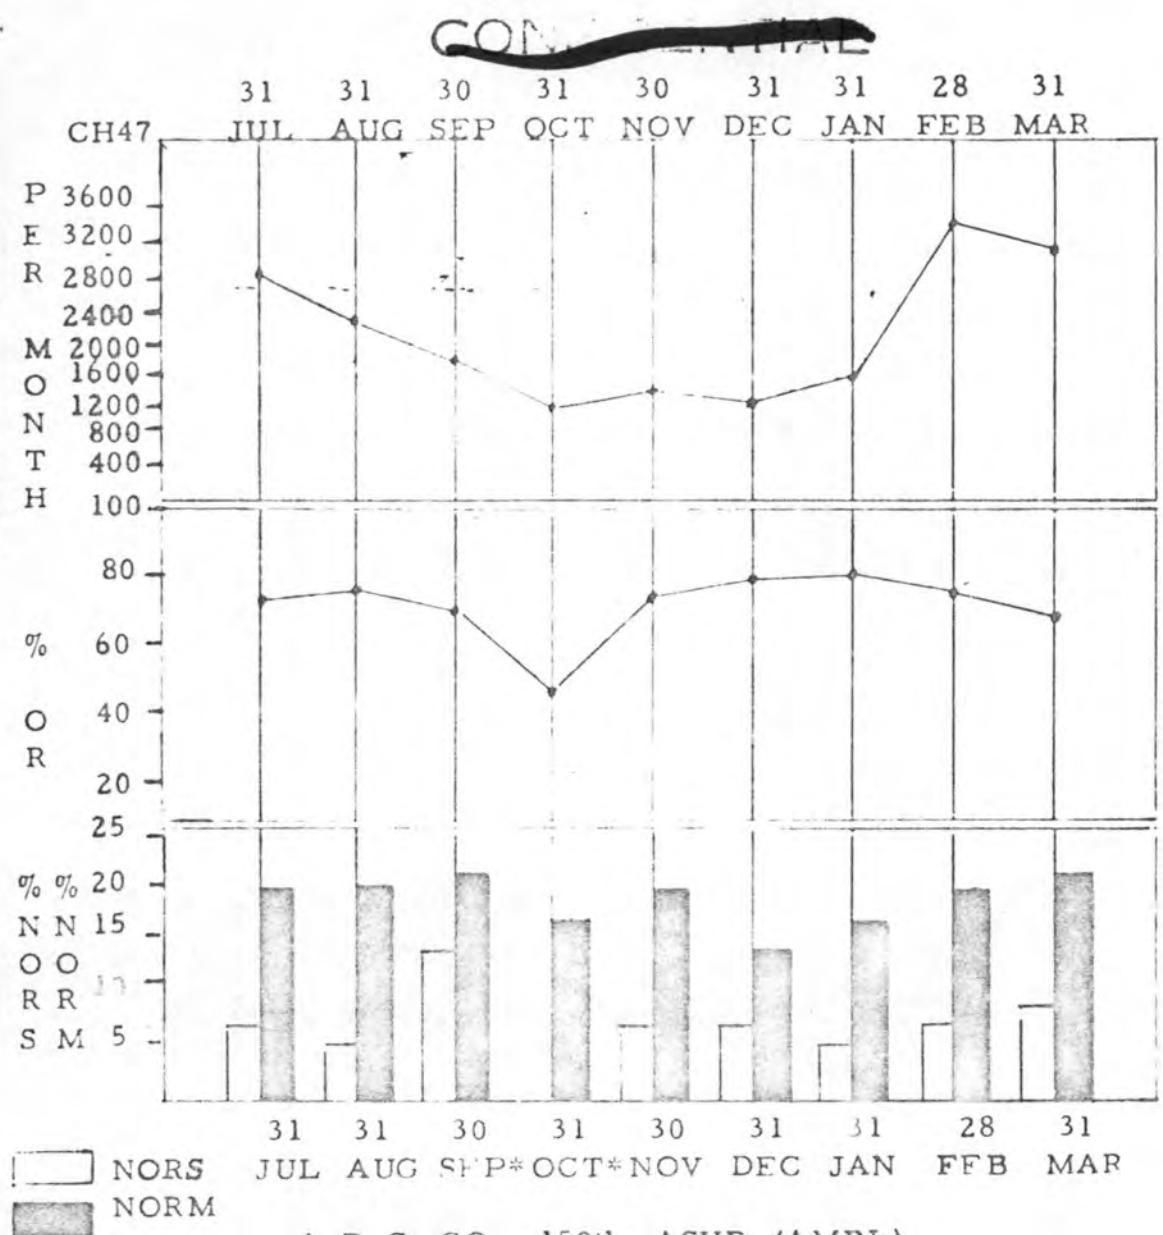
FIGURE IV-4 (U) Monthly Flying Hours, CH-47 (U)

A, B, C, CO., 159th ASHB (AMBL)
48 ASSIGNED CH-47's

DEPICTING COMBINED MONTHLY FLYING HOUR
PROGRAM AVG OPERATIONAL READY RATES & AVG
MONTHLY NORM/NORS RATES FOR MONTHS SHOWN
DURING 1970-1971

The three primary indicators for determining the efficiency of the maintenance effort during this period were the operational ready rate (OR), and the NORM/NORS rates. At Figures IV-4, 5, and 6 are charts which graphically depict these indicators with relation to the associated flying hour program of the CH-47's and CH-54's. As the flying hour program increased abruptly in February, the NORM rates, and in the case of the CH-47's, the NORS rates, also increased. It is significant to note that the NORS rate, although increasing slightly, remained relatively constant when compared with the previous seven month period. This was due primarily to the amount of command interest and emphasis on the aviation repair parts supply system. A forward liaison element of the 34th General Support Group, operating out of Quang Tri, was in a large measure responsible for insuring that the necessary repair parts were made available to the requesting units in an absolute minimum of time. This element also maintained close liaison with the civilian PMP teams, and determined where their assistance was most urgently required. One of the primary reasons for the light increase in the NORS rates was that some of the repair parts for which there was a sudden demand were items that had acquired little if any demand data in previous operations. Many of the parts damaged by enemy fire were rarely required under normal operating conditions. It must be emphasized at this point, that a major factor in keeping NORS/NORM rates at an acceptable level was the prior planning done by the units of the 159th Assault Support Helicopter Battalion, and the aircraft scheduling program which they used. They were able to adequately forecast, in most cases, the repair parts which would be required based on the increased flying hour program. A major area of concern to the maintenance activities during the operation was the conditions under which the aircraft were operating in the forward areas. The dust in which the CH-47's and CH-54's were forced to operate on a continuous basis was a critical factor in increased wear on engines and rotor blades. As a result of the battalion policy of flushing each CH-47 engine with water after every flying day, the damage to engines remained negligible. The wear on CH-54 engines was also negligible because of their Engine Air Particle Separators (EAPS). Most of the damage done by the dust was to the aircraft rotor blades. The abrasive nature of the dust coupled with the extremely high winds generated by the rotor wash, resulted in abnormally rapid deterioration of the leading

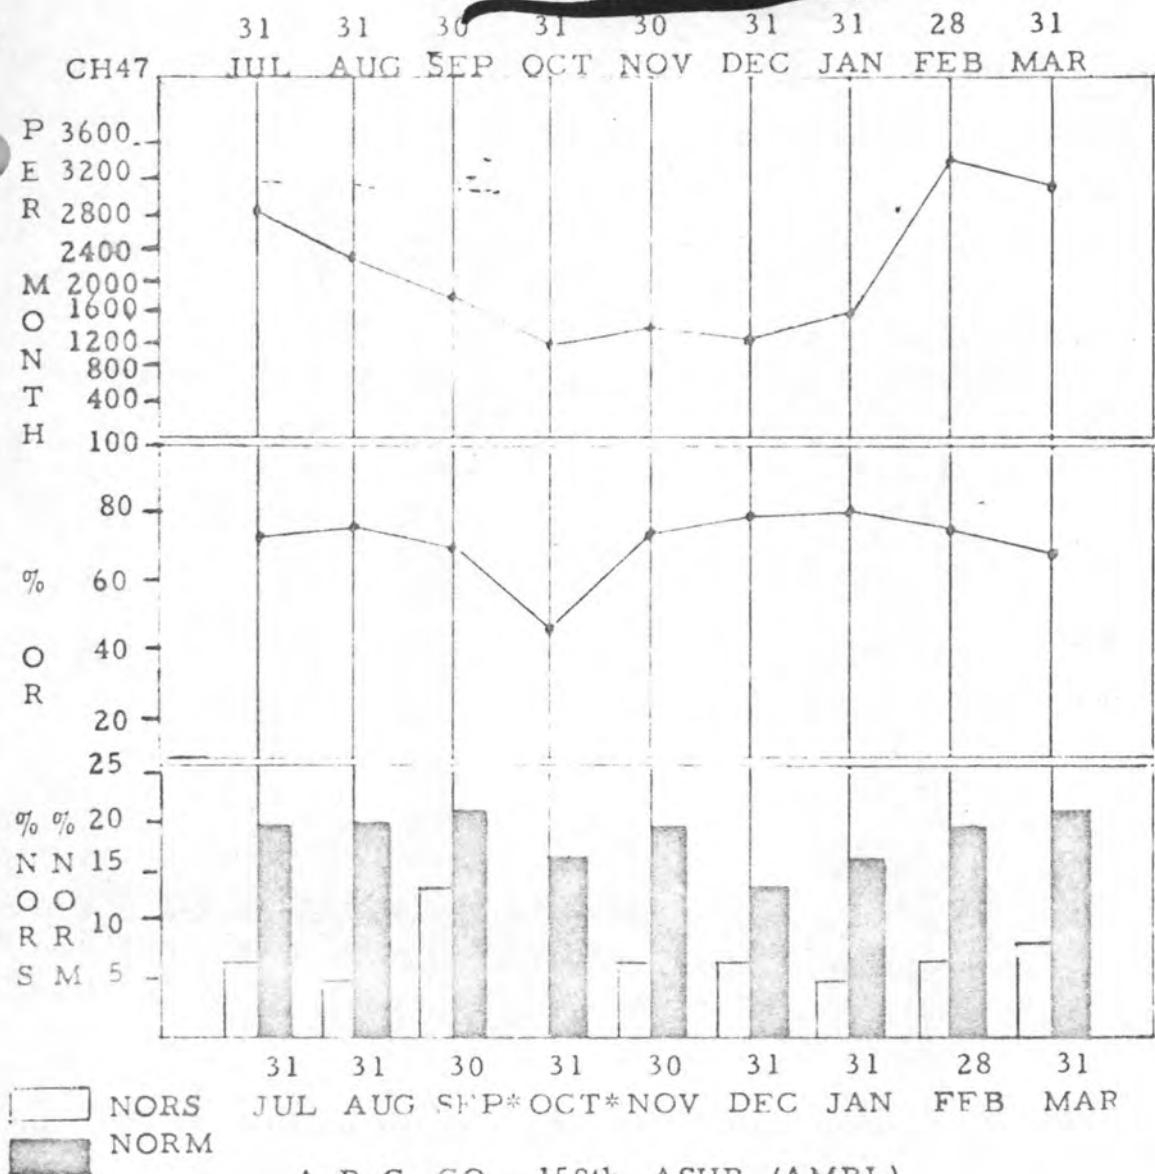
FIGURE IV-4 (U) Monthly Flying Hours, CH-47 (U)

A, B, C, CO., 159th ASHB (AMBL)
48 ASSIGNED CH-47's

DEPICTING COMBINED MONTHLY FLYING HOUR
PROGRAM AVG OPERATIONAL READY RATES & AVG
MONTHLY NORM/NORS RATES FOR MONTHS SHOWN
DURING 1970-1971

* DURING THIS PERIOD, THE 159th ASHB WAS
UNDERGOING SUPER "C" CONVERSION

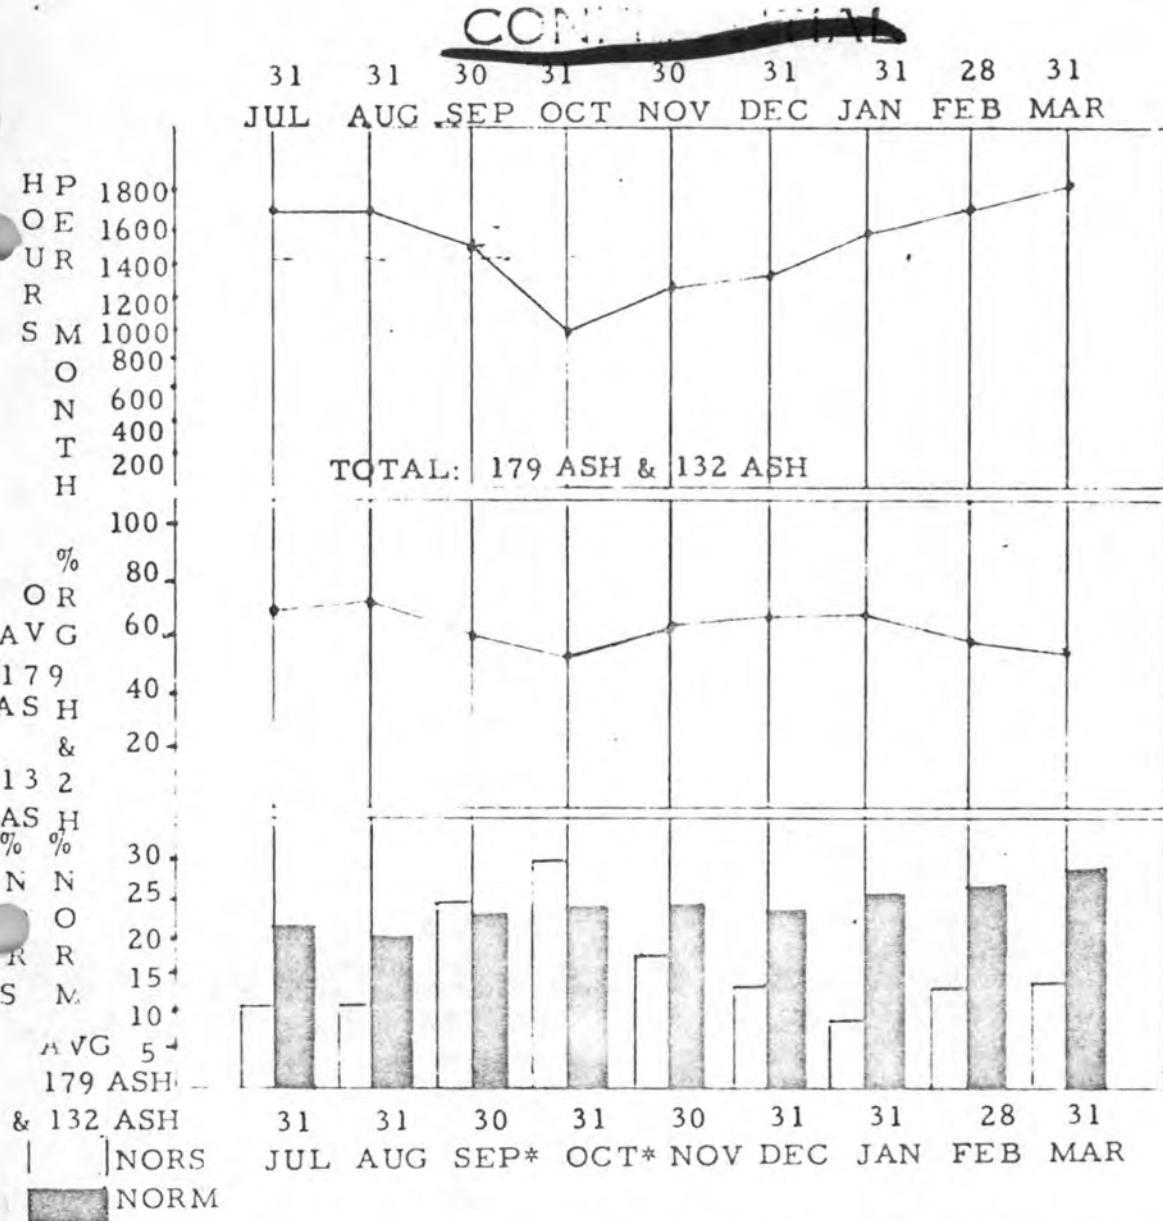
* DURING THIS PERIOD
 179 ASH CO UNDERWENT
 SUPER "C" CONVERSION

179 ASH CO & 132 ASH CO OPCON TO 159 ASHB
 (AMBL) 32 ASSIGNED CH47 DEPICTING COM-
 BINED MONTHLY FLYING HOUR PROGRAM,
 AVG. OPERATIONAL READY RATES & AVG.
 MONTHLY NORMS/NORS RATES FOR
 MONTHS SHOWN DURING 1970-1971

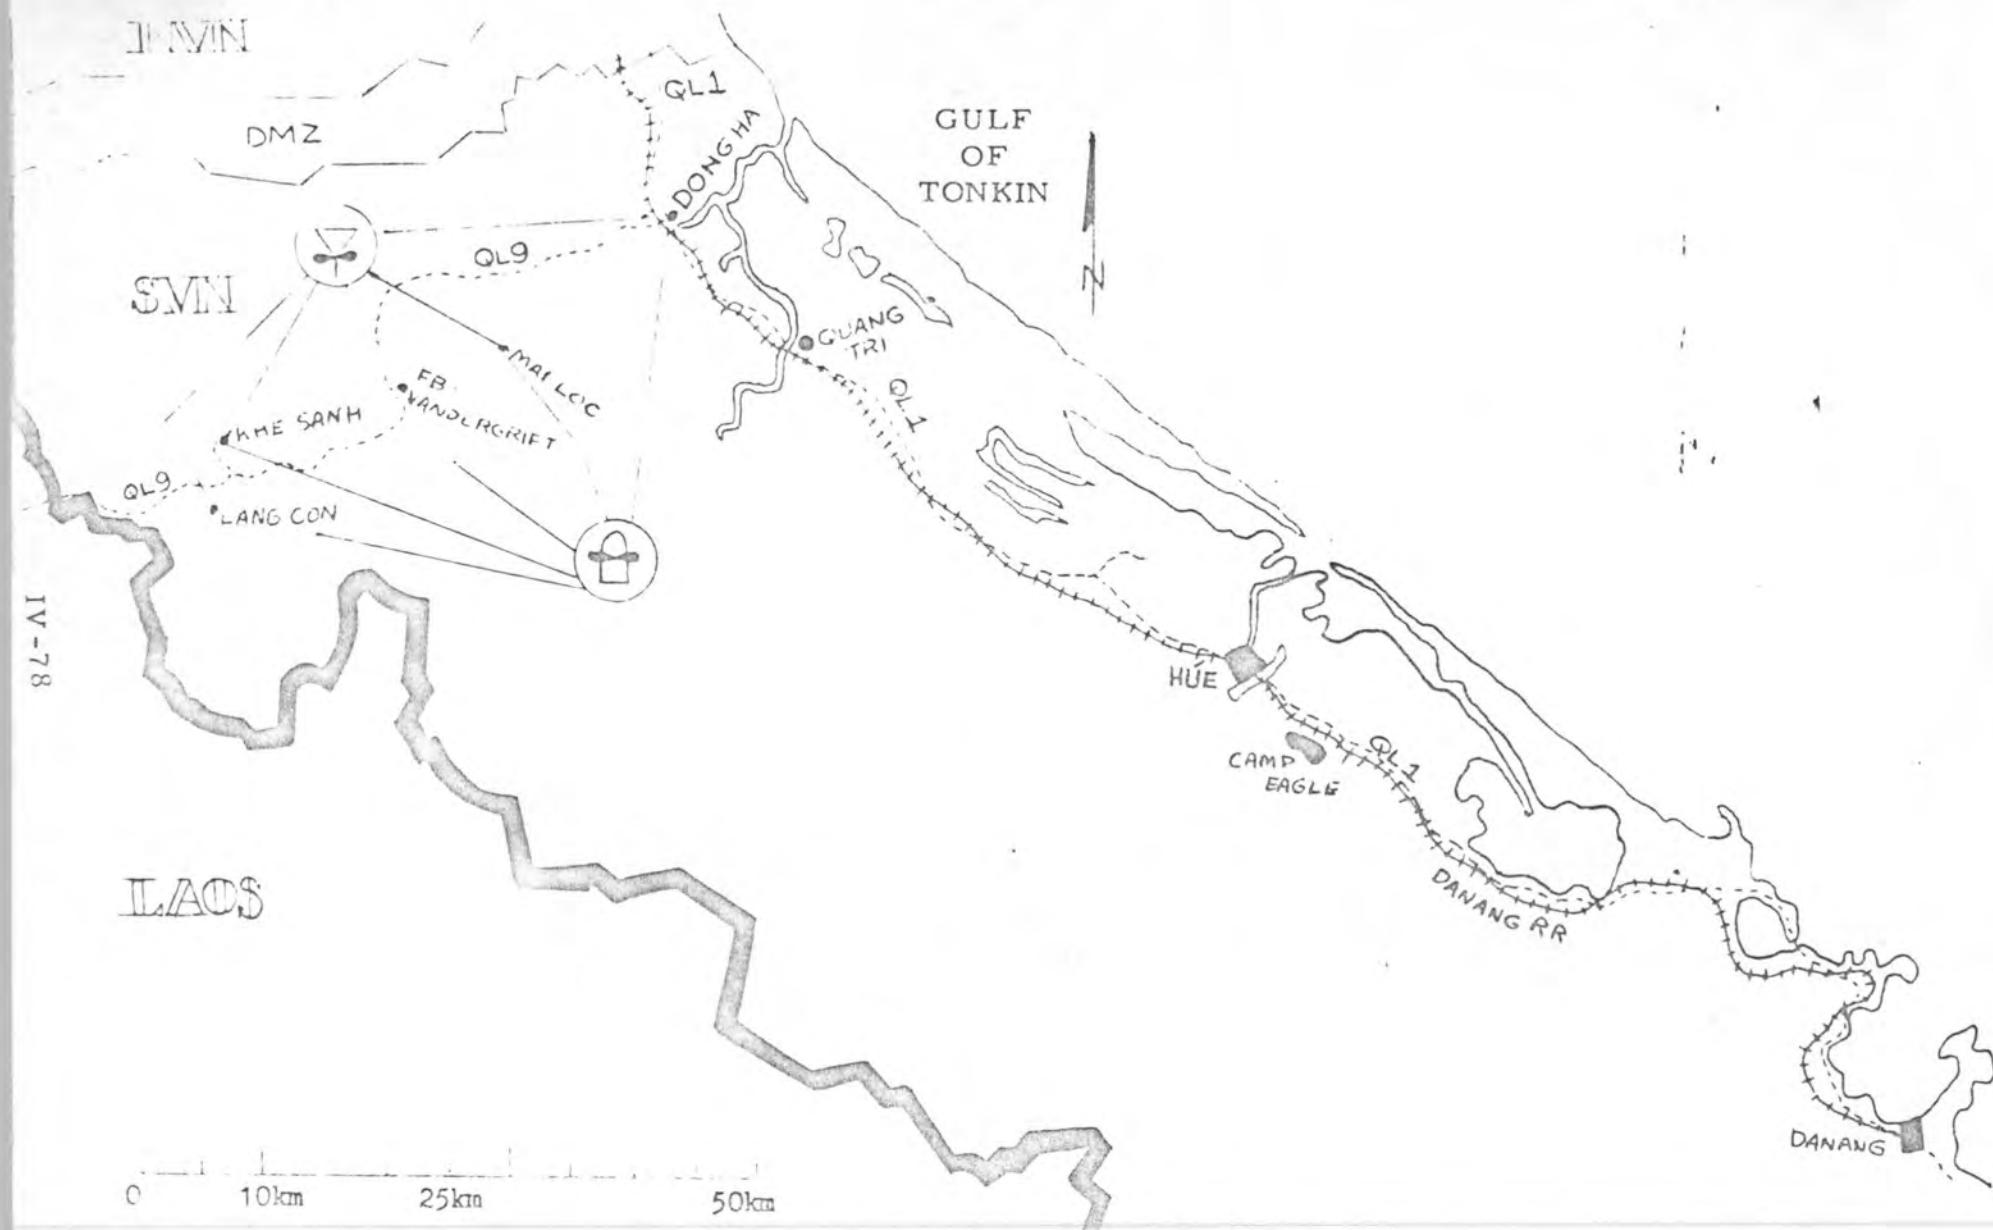
FIGURE IV-11 (U). Rearm/Refuel Points (U)

The rearm points were constructed using earth-filled 2.75 rocket ammunition boxes. A double rearm point was constructed consisting of a central barricade with open rockets pointing into each side. Within each point were three side by side compartments, one for 17 pound HE rockets, one for flechette rockets, and one for 10 pound HE rockets. This large storage capacity was deemed necessary since it was anticipated that as many as six gunships

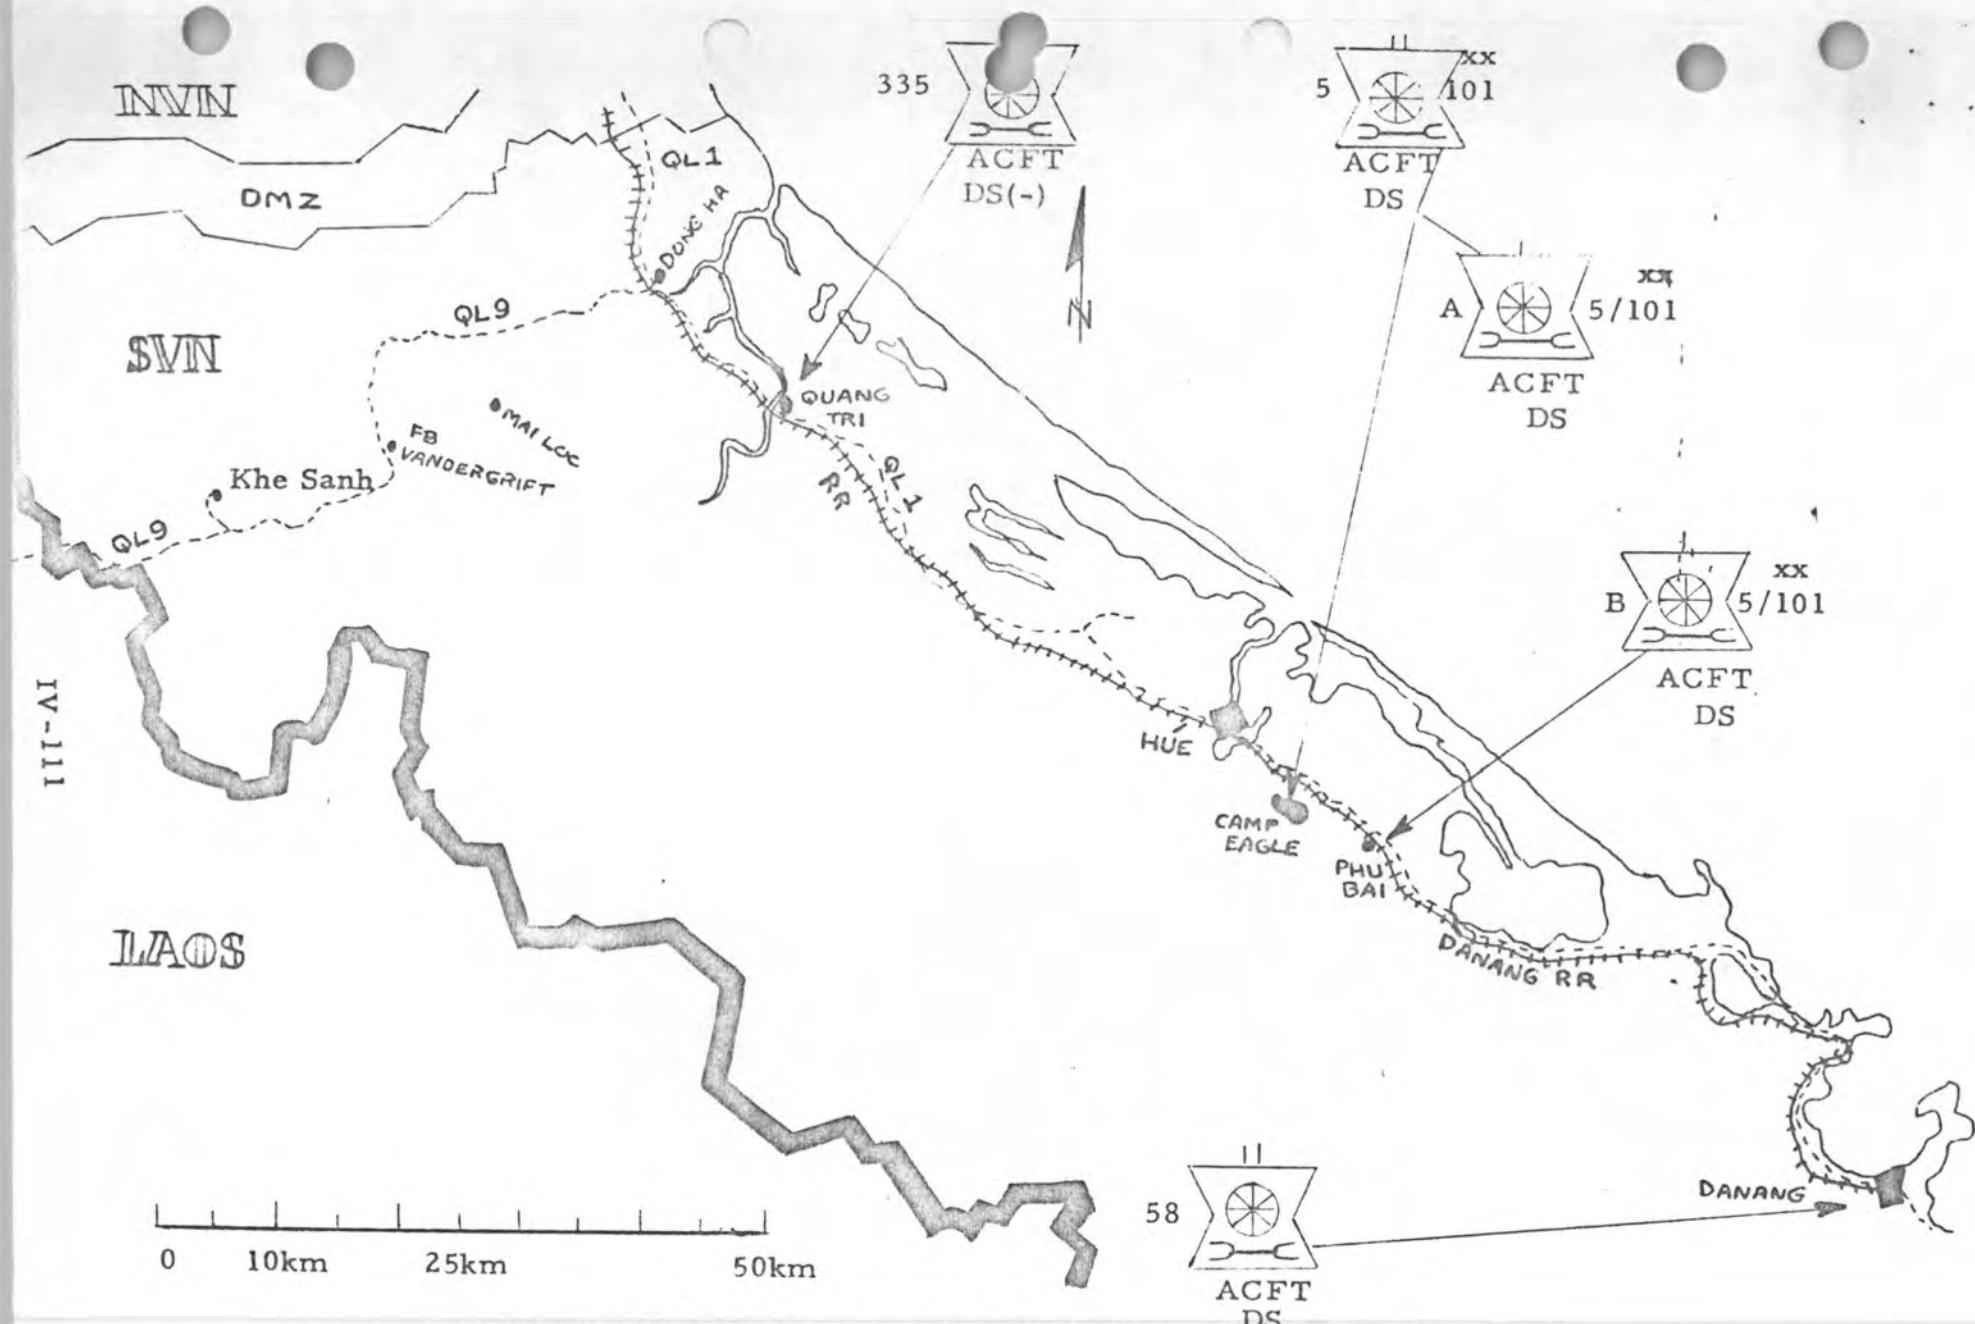
FIGURE IV-24 (U). Aircraft Maintenance Facilities (U).

It was planned that the 335th Direct Support Company (-) of the 23d Inf Div would be attached to the 101st Abn Div (Ambl). It was felt that this addition would provide a capability adequate to support the operation. The units of the 5th Transportation Battalion (AM&S) were scheduled to remain at pre-operation locations at Camp Fagle and Phu Bai. The 335th, augmented as necessary would operate at Quang Tri for about 90 days. Mission alignment

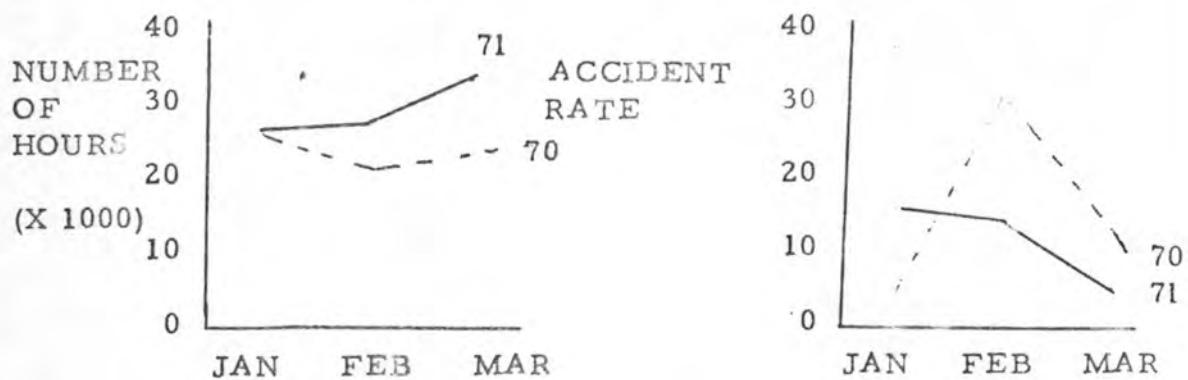
FIGURE IV-32 (U) 101st Avn Gp Hours Flown and Accident Rate, 3rd Qtr FY 70 and 71 (U).

c. An examination of hours and rates in the 101st Aviation Group shows that the Group flew 8,188 hours more during the month of February and March 1971 than during the same period in 1970, experiencing an average rate reduction of 13.8 accidents per 100,000 flying hours. See Figure IV-32 below:

d. The increase in flying hours is a result of the operational requirements of LAMSON 719 and also the requirement to support troops in the Division area of operations. When flying hours are increased, the rate will drop if the number of accidents remains relatively stable or decreases.
