First, I want to take this opportunity to thank you for giving us your time, insight and information in regard to the ongoing investigation of incident of the F-111A Aircraft (refno 1948), piloted by USAF Captain **RONALD D. STAFFORD** and EWO Captain **CHARLES J. CAFFARELLI**.

SUBJECT: Request for Information Regarding Loss of F-111A Piloted by Ronald D. Stafford (Your Ltr, 18 Oct 88)

- 2 Atch
1. SMAMA Service Engineering  
Report No. 73-511
  2. Operation Sequence Times

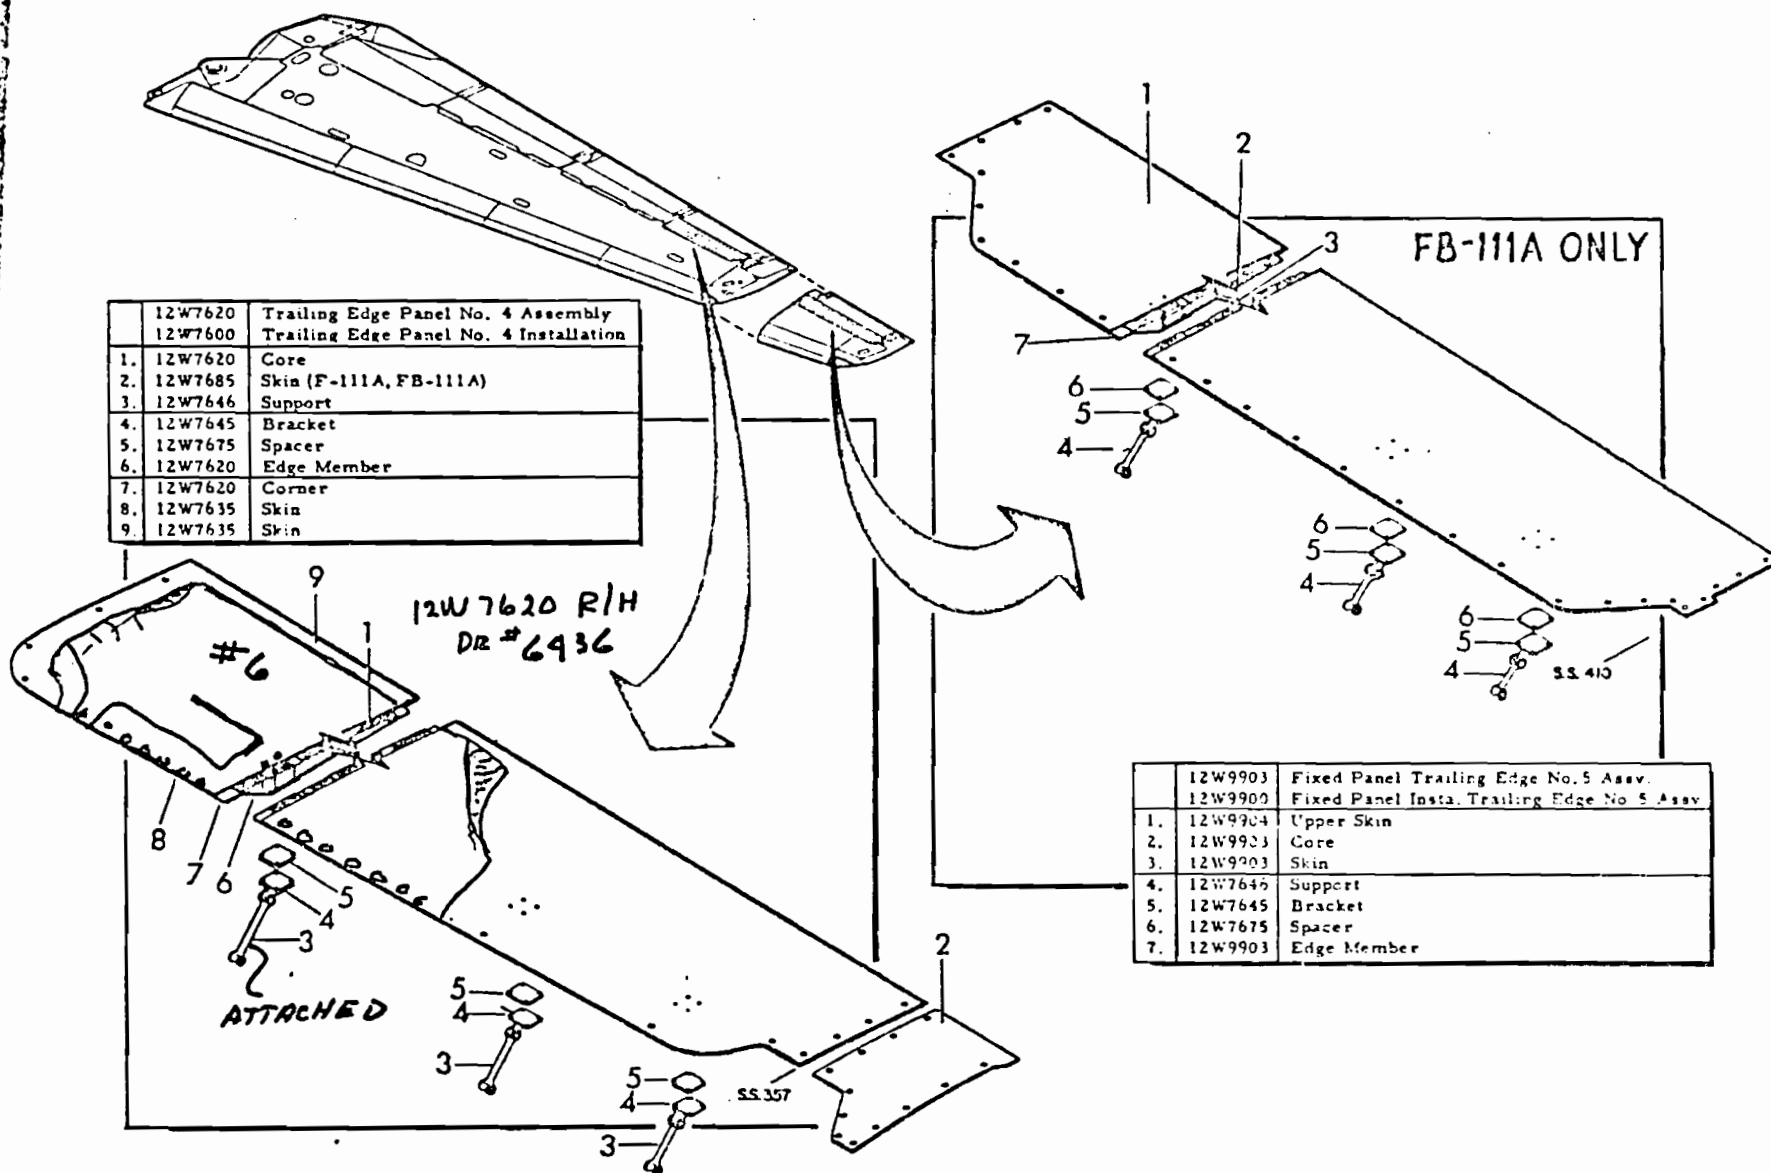
FIGURE 15. FAILURE DESCRIPTION OF PART 6.

# PART MARKED #6

R/H 6436 panel, DWG 12W7620.

Panel is severely bent (damaged) in multiple directions

No fire damage observed.

Fracture is overload (tear). 45° fracture planes were reversing directions.

Cause of failure is impact damage.

6. 6436 Panel - RH upper False Spoiler measure approx 22" span. Both the inbd and outbd section is missing. The section has the support link and fitting was attached. Lower end was broken at the clevis. Panel is severely bent in several directions with the inner skin is peeled and buckled in a down and aft direction.
