COMMUNICATIONS**NAVSHIPS****900,000.1****SERVICE NOTES****AN/SYA-1(V); AN/SYA-4(V); MAINTENANCE INSTRUCTION—DATA DISPLAY CONSOLES, CATHODE RAY TUBE (CRT) VARIANCE**

SERVICE NOTES

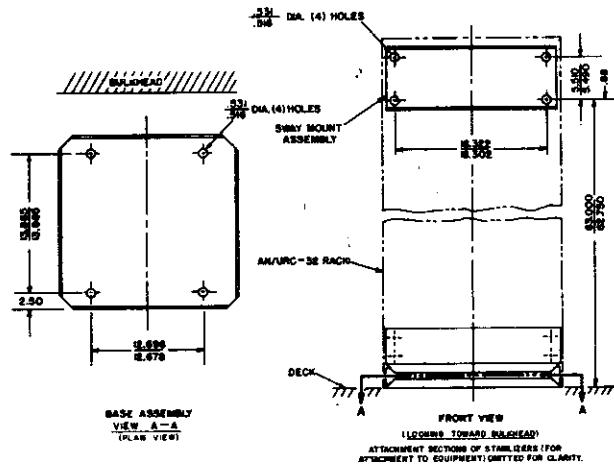
Figure 1.

The major difference in the assemblies is the location of the bolt holes used in installing the equipment. The newer unit requires only 4 bolts in the base assembly and 4 bolts in the sway brace assembly. The earlier units required 8 bolts in each assembly. Figure 1 provides mounting hole locations for the newer assembly. Figure 2 provides mounting hole locations for the earlier AN/URC-32 version.

When a new AN/URC-32() equipment is received, detailed step-by-step instructions are provided and packed with the supplied shock and vibration mount assembly.
