COMSTSINST 3541.5B  
13 Sep 1965

## Section 7.12

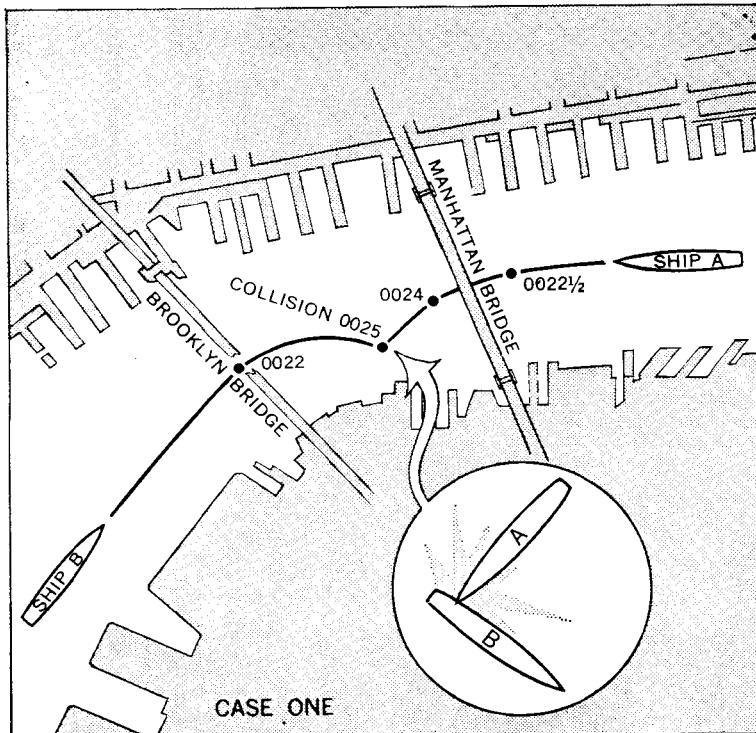
The principal cause of this collision was the improper alteration of course by *Ship A* to her own port upon sounding a two-blast invitation to pass. Within the meaning of the Pilot Rules for Inland Waters, the two vessels were *clearly meeting* and each recognized the situation as such. Accordingly, a port-to-port passing was indicated, and the circumstances did not warrant an assumption by the pilot of *Ship A* that *Ship B* might desire a starboard-to-starboard passing

without a proper exchange of whistle signals.

Additionally, this collision serves to emphasize an effect of excessive speed. In a meeting situation, with a consequently high relative speed, the time available for maneuvering to avoid collision is so drastically reduced that there is insufficient time left to evaluate and resolve confusing situations. Consequently, early reductions in speed are absolutely necessary when there is any uncertainty over the other ship's intentions. Reductions in speed will provide the additional time to clarify a situation.

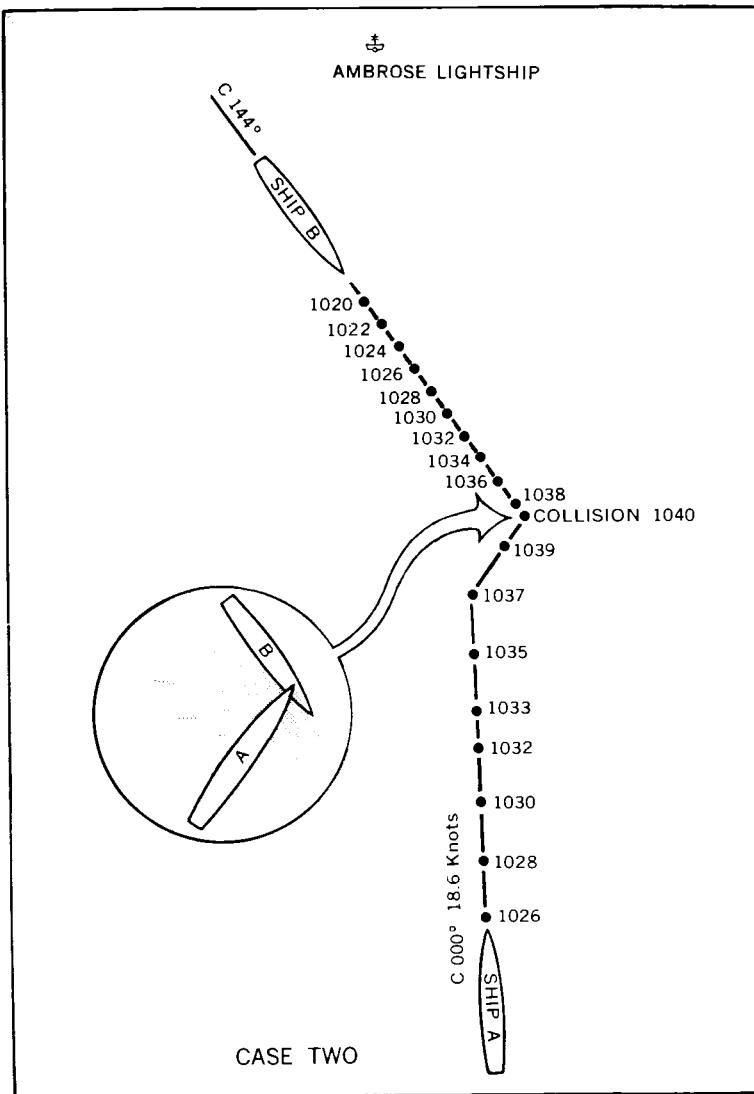
At approximately 0955 EST, 1 March, *Ship A* encountered fog about 25 miles north of Barnegat Lightship. The engine order telegraph was placed on "Standby" and operation of the fog whistle commenced under automatic control, sounding a prolonged blast at intervals of not more than 2 minutes. On course 004° and making a speed of 18.6 knots, the master took charge of the vessel's movements and placed

himself at the radar, which was located on the starboard side of the wheelhouse. With him in the wheelhouse were the staff captain and a helmsman. The second officer and a messenger were stationed on the port wing of the bridge, and the third officer was stationed on the starboard wing. A lookout was on the bow.
