AR 1101

18-CYLINDER ENGINE
LOW-TENSION IGNITION SYSTEM
P & W R-2800
OR
WRIGHT R-3350

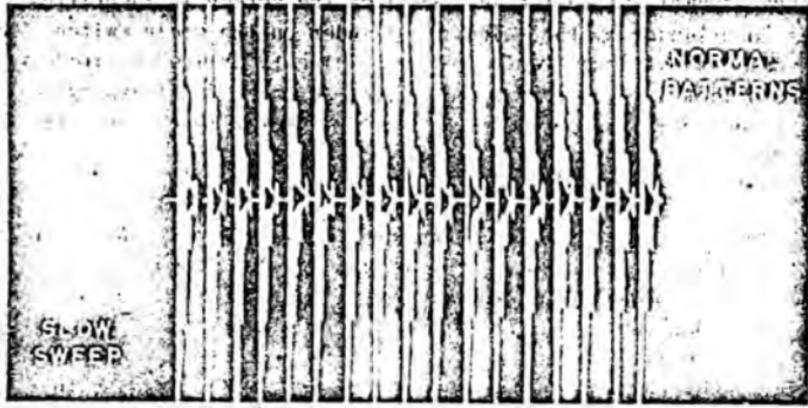
NORMAL PATTERNS - SLOW SWEEP - 18-CYLINDER ENGINE, LOW-TENSION IGNITION SYSTEM - The picture observed on slow sweep presents the patterns of 18 spark plugs fired by two magnetos in one complete engine cycle, or 720 crankshaft degrees. The normal polarity reversal of consecutive firings of one magneto is indicated by patterns appearing alternately above and below the trace line. It will also be noted that because of the magneto arrangement for this engine, successive firings of the same spark plug are alternately positive and negative. The first pattern appearing from the left edge of the screen is identified as to cylinder by the selected cylinder on the Cycle Switch. The remaining patterns are for the remaining 17 cylinders fired by the selected magneto in firing order and are identified by the cylinder number appearing on the cycle switch face in clockwise order.

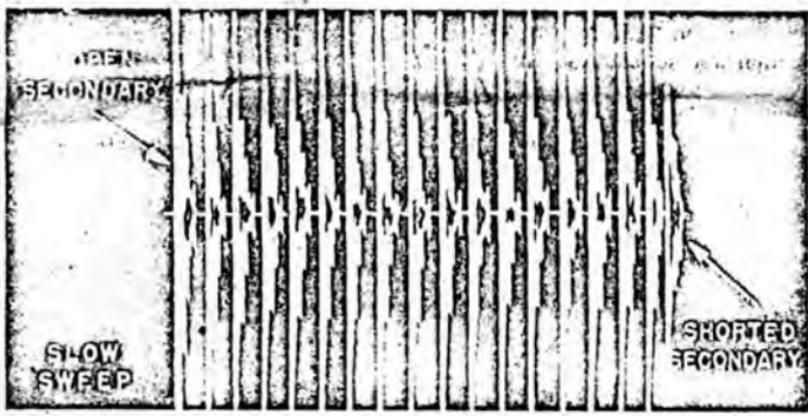
MALFUNCTION PATTERNS - SLOW SWEEP - 18-CYLINDER ENGINE, LOW-TENSION IGNITION SYSTEM - Malfunction patterns such as an open high-tension circuit (open secondary) can be identified as a much higher than normal pattern with complete lack of high-frequency oscillation, a shorted high-tension circuit (shorted secondary) appears as a pattern slightly lower in height than a normal pattern with complete lack of second high-frequency oscillation. The lack of second high-frequency oscillation appears as a bright spot on the tail of the pattern. An open secondary, a shorted secondary, and 16 normal patterns are shown.

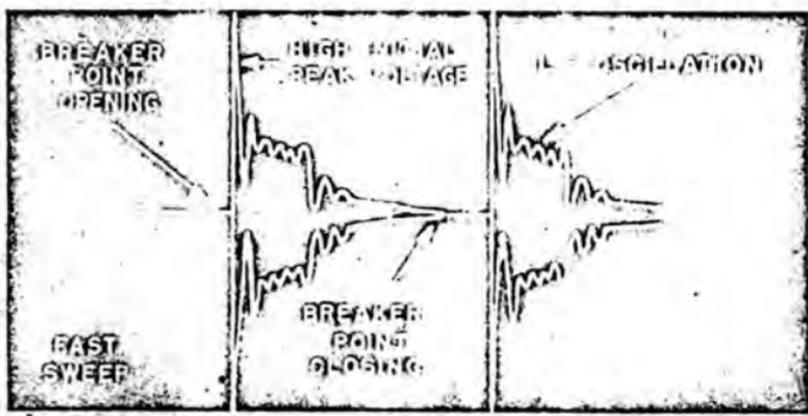
NORMAL PATTERN - FAST SWEEP - 18-CYLINDER ENGINE, LOW-TENSION IGNITION SYSTEM - The two patterns that appear in fast sweep are for the cylinder selected by the Cycle Switch and for the next cylinder fired by the selected magneto. The pattern at the left end is the cylinder selected by the Cycle Switch. Both patterns appear above and below the trace line as successive firings of the same spark plug are alternately positive and negative. The normal pattern has the following basic characteristics; breaker point opening, an initial high-amplitude excursion, second high-frequency oscillation which extends to form a "saddle" in that portion of the pattern between the second excursion of the trace and the abrupt negative slope toward the zero signal line, a "hook" following the "saddle", and a low-frequency tail until the breaker points close.

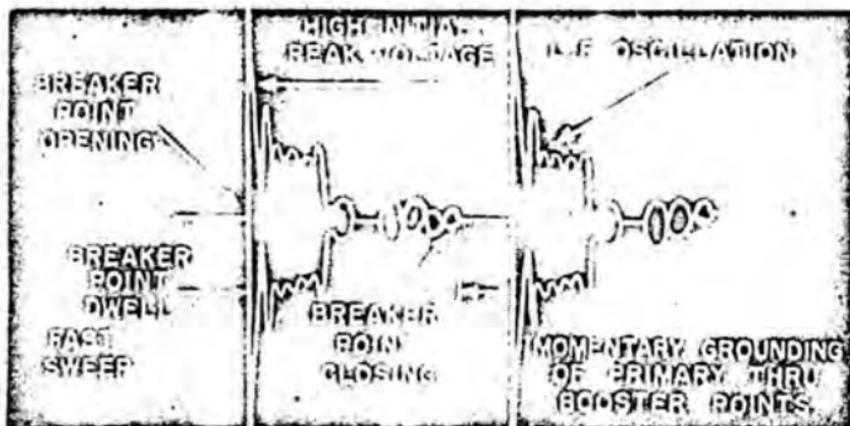
NORMAL PATTERNS - FAST SWEEP - 18-CYLINDER ENGINE, LOW-TENSION IGNITION SYSTEM - The normal patterns pictured at the left end will be observed on certain cylinders and is attributed to the magneto booster points closing prior to the normal breaker point closing. This pattern differs from the other pictured normal pattern during the time the booster points are closed. Between the time the booster points open again and the normal breaker point closing, there appears low-frequency oscillation. Although not completely normal, all of the characteristics of a normal pattern are present so the pattern is considered normal.

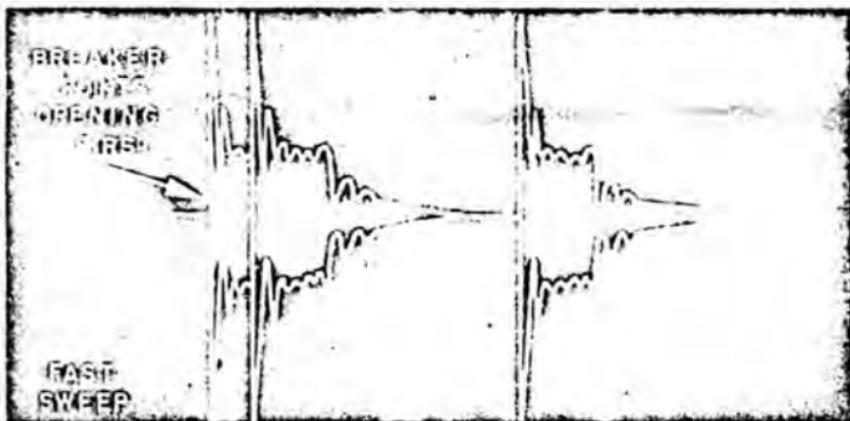
BREAKER POINT NON-SYNCHRONIZATION PATTERN - FAST SWEEP - 18-CYLINDER ENGINE, LOW-TENSION IGNITION SYSTEM - The magneto breaker point synchronization check is made to determine that both spark plugs in each cylinder are fired simultaneously. The Condition Switch is set to "B" (both magnetos) of the selected engine to display on the Indicator the patterns from both left and right magnetos superimposed on each other. If the breaker points are not synchronized, the breaker points associated with the patterns appearing to the left are opening before those associated with the patterns on the right. By measuring the distance on the screen between the points of breaker point opening and allowing 1/32 inch to equal one degree of crankshaft rotation, the amount of synchronization error may be determined. The breaker point non-synchronization check should be made on the cylinders to which the magnetos are installed and timed.

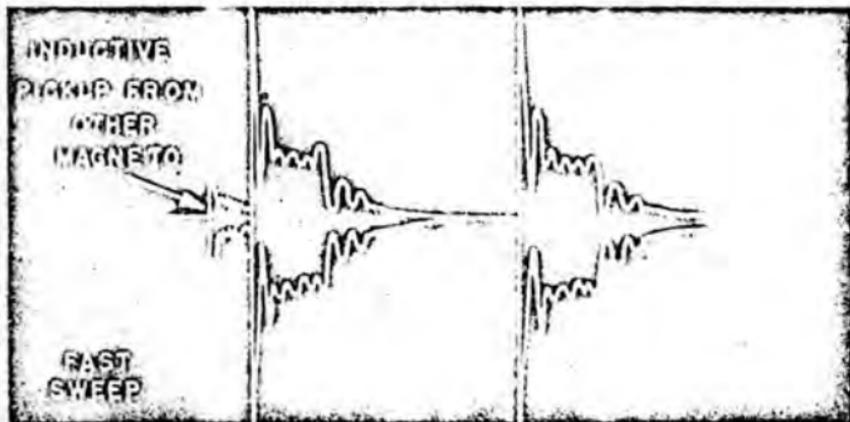
BREAKER POINT NON-SYNCHRONIZATION PATTERN - FAST SWEEP - 18-CYLINDER ENGINE, LOW-TENSION IGNITION SYSTEM - The magneto breaker point synchronization check is made to determine that both spark plugs in each cylinder are fired simultaneously. With the Condition Switch set to "L" (left magneto), if activity of small magnitude is observed ahead of the breaker point opening, that activity is caused by the right magneto breaker point opening early. Switching the Condition Switch to "R" should eliminate this activity. By measuring the distance on the screen between points of breaker point opening and allowing 1/32 inch to equal one degree of crankshaft rotation, the amount of synchronization error may be determined. The breaker point non-synchronization check should be made on the cylinder to which the magnetos are installed and timed.

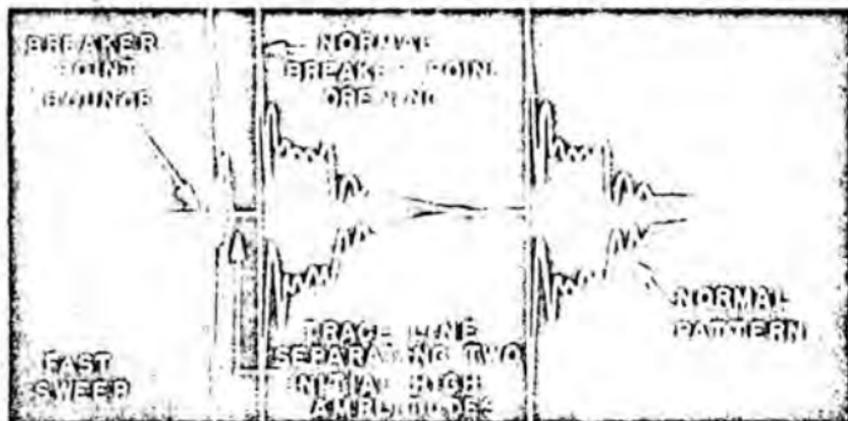
BREAKER POINT BOUNCE PATTERN - FAST SWEEP - 18-CYLINDER ENGINE, LOW-TENSION IGNITION SYSTEM - This pattern resembles that for magneto breaker point mistiming. The marked difference, however, is the short trace line separating the two initial high-amplitude oscillations and the appearance of the pattern with the Condition Switch set for only a single magneto position. Breaker point bounce may occur both before the normal breaker point opening and after the normal breaker point closing.

Probable Causes: A weak breaker point spring or damaged cam with rough spots on it. A weak spring should cause bounce on all spark plug positions of the affected magneto while for a damaged cam the bounce should occur on only one spark plug position.

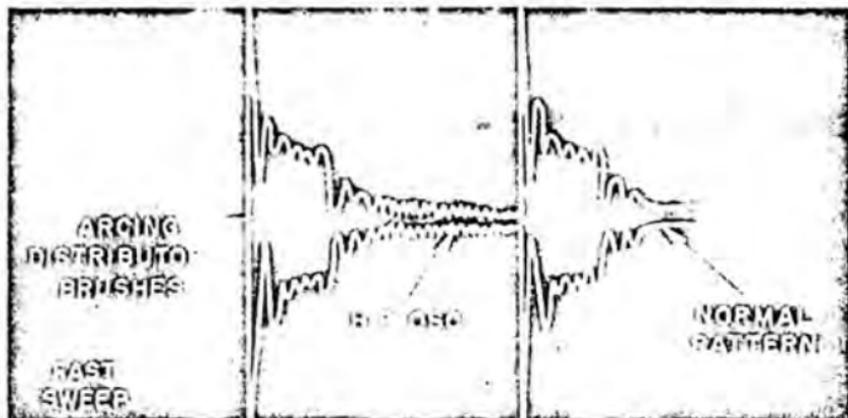
ARCING DISTRIBUTOR BRUSH PATTERN - FAST SWEEP - 18-CYLINDER ENGINE, LOW-TENSION IGNITION SYSTEM - This pattern appears normal except for an unusual amount of activity in the sloping tail of the pattern between the hook and breaker point closing. Early stages of brush arcing appear on isolated cylinders. As the malfunction progresses more cylinders are affected; the oscillations become larger and cover a greater portion of the pattern. Severe arcing has been observed as excessive activity throughout the entire length of the pattern.

Probable Causes: Burned or dirty distribution segments, concaved segment surfaces causing the brushes to jump, weak brush springs, feathered segment edges, or excessive distributor vibration may cause the brushes to arc.

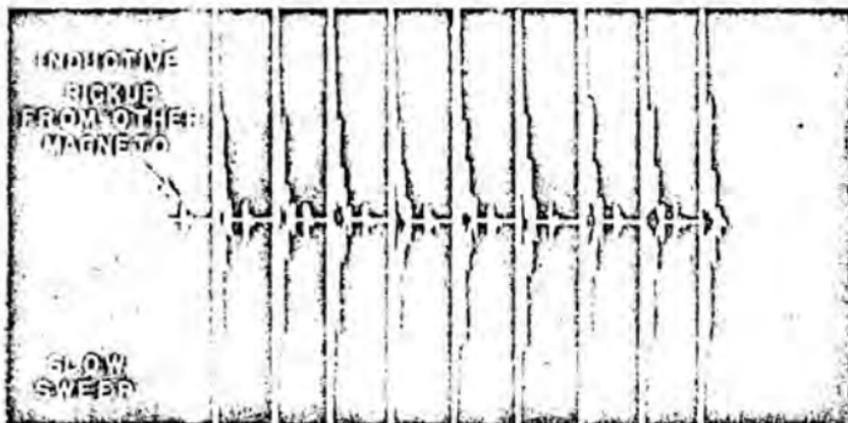
SHORTED PRIMARY CIRCUIT PATTERN (MAGNETO TO DISTRIBUTOR) - SLOW SWEEP - 18-CYLINDER ENGINE, LOW-TENSION IGNITION SYSTEM - A completely shorted primary circuit in the grounding system or between the magneto and the distributor produces no pattern; only the horizontal trace line will be seen. Nine very small pips which are inductive pickup from the other magneto are sometimes visible. All spark plugs fired by the affected magneto will display this pattern. The nine additional patterns appearing at the left are from the other magneto and are visible because of the Analyzer tie-in to the magneto grounding system.

Probable Causes: Faulty magneto grounding switch or system, the breaker points not opening, a grounded primary coil or condenser, or a ground between the magneto and distributor.

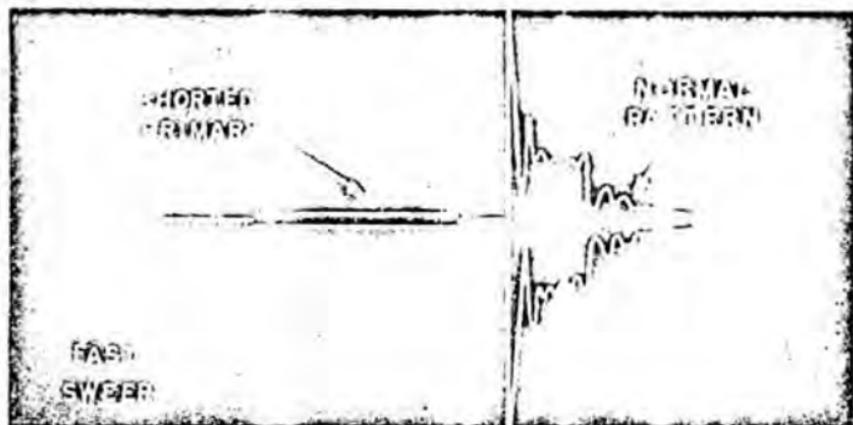
SHORTED PRIMARY CIRCUIT PATTERN (DISTRIBUTOR TO COIL) - FAST SWEEP - 18-CYLINDER ENGINE, LOW-TENSION IGNITION SYSTEM -
A shorted primary circuit between the distributor and cylinder mounted coil produces no pattern for the cycle switch selected spark plug position; only the horizontal trace line will be seen. The pattern will appear on only the selected cylinder position, but the pattern for the next cylinder to be fired by the selected magneto will generally be distorted because of the reaction of this malfunction on the system.

Probable Causes: A ground in the primary lead from the distributor to the cylinder mounted coil or a short in the primary winding of this coil.

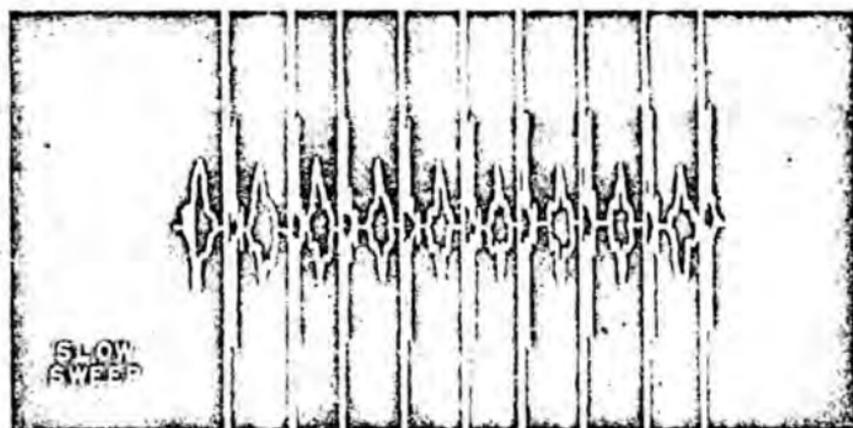
OPEN PRIMARY CIRCUIT PATTERN (MAGNETO TO DISTRIBUTOR) - SLOW SWEEP - 18-CYLINDER ENGINE, LOW-TENSION IGNITION SYSTEM -
This pattern can best be described as nine pips superimposed on a distorted sine wave. The pips occur at approximately the breaker point closing points of the affected magneto. The sine wave voltage variation is the normal voltage variation induced in the primary coil by the magneto rotor. The nine normal patterns are for the unaffected magneto, but are generally distorted because of the malfunction present on the one magneto.

Probable Causes: The breaker points are not closing either mechanically or electrically because of excessive point clearance or a foreign substance insulating electrical contact between the point. The pattern can also be caused by an open in the primary coil or distributor.

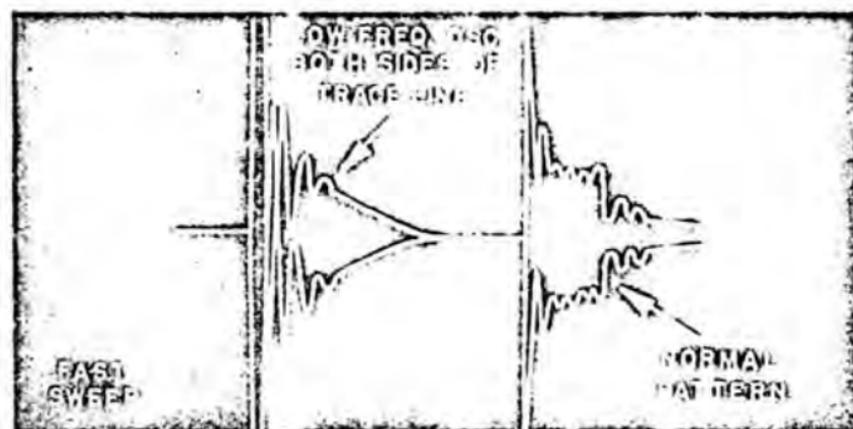
OPEN PRIMARY CIRCUIT PATTERN (DISTRIBUTOR TO COIL) - FAST SWEEP - 18-CYLINDER ENGINE, LOW-TENSION IGNITION SYSTEM -
This pattern produces a very high initial peak voltage, the second excursion of the trace extends below the horizontal trace line, and the remainder of the pattern consists of low-frequency oscillations until the breaker points close. The pattern will only appear for the Cycle Switch selected cylinder position.

Probable Causes: An open in the lead from the distributor to the cylinder mounted coil or in the primary winding of this coil.

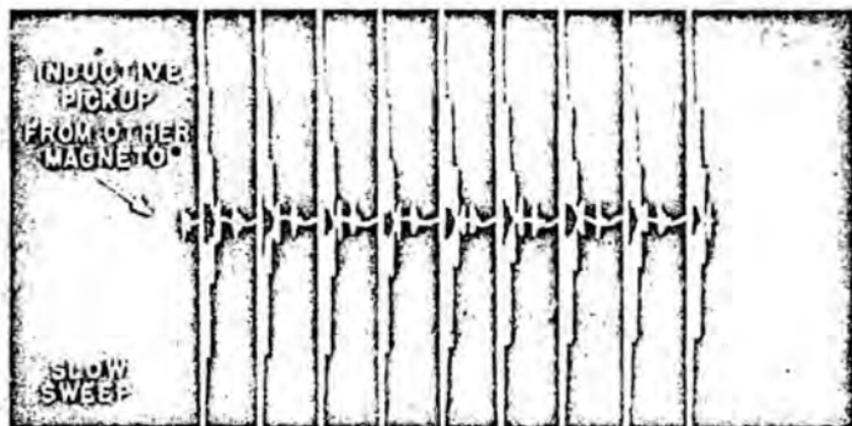
OPEN "P" LEAD PATTERN - SLOW SWEEP - 18-CYLINDER ENGINE, LOW-TENSION IGNITION SYSTEM - This pattern can best be described as nine small pips superimposed on a low-amplitude sine wave. The nine small pips are inductive pickup from the other magneto, the sine wave 400 cycle pickup. The nine normal patterns are for the unaffected magneto, but are generally distorted because of the malfunction present on the one magneto.

Probable Causes: An open in the magneto grounding primary lead either in the magneto, at the AN connector, on the magneto or between the magneto and grounding switch or relay. This open "P" lead acts as an antenna picking up signals from the other magnetos. The defective magneto is not necessarily inoperative. In addition to the above possible causes, the open could be in the ignition cable to the Analyzer.

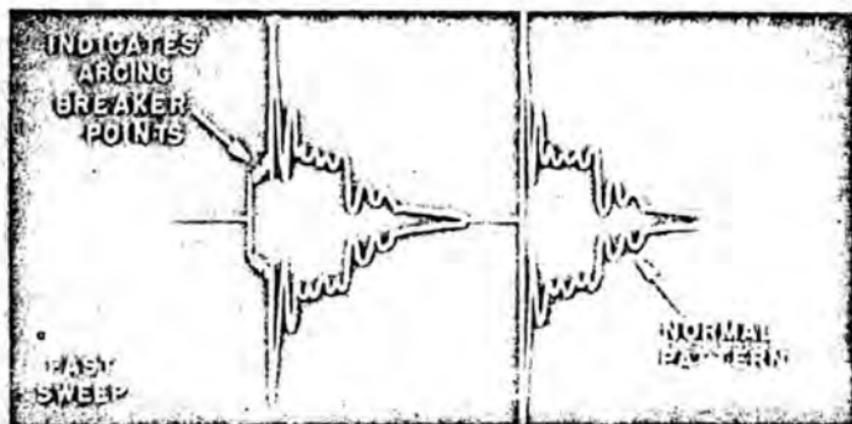
ARCING BREAKER POINTS PATTERN - FAST SWEEP - 18-CYLINDER ENGINE, LOW-TENSION IGNITION SYSTEM - An early stage of arcing breaker points appears as a bright spot just after the breaker point opening; severe arcing is illustrated. The arc is maintained until the points have opened sufficiently to extinguish the arc, at which time primary coil current flow ceases, inducing a surge of energy into the high-tension coil. The activity in the high-tension coil then becomes visible on the Indicator. Since a large percentage of the primary coil energy was dissipated during arcing, the amplitude of the pattern is not as large as normal. The oscillation in the "saddle" portion of the pattern indicates that the spark plug is firing. All spark plugs fired by the affected magneto display this pattern.

Probable Causes: Oil on the breaker points, a defective (open) primary condenser, or the lead from the breaker points to the condenser is disconnected.

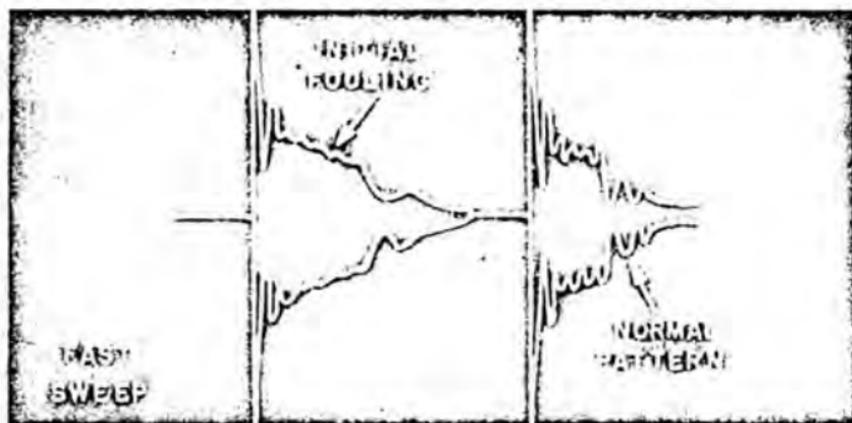
INITIAL FOULING OF SPARK PLUG PATTERN - FAST SWEEP - 18-CYLINDER ENGINE, LOW-TENSION IGNITION SYSTEM - The height of the initial high-amplitude oscillation is less than normal and does not return as close to the zero trace as normal. There is less oscillation in the "saddle" portion of the pattern and the sharp negative slope following the "saddle" is not as pronounced as normal. Some combustion is indicated by the oscillation in the "saddle" portion of the pattern.

Probable Causes: Early stages of spark plug fouling due to a foreign substance (lead or carbon) on the spark plug electrodes. The condition can generally be cleared up by accomplishing the recommended plug de-fouling procedure.

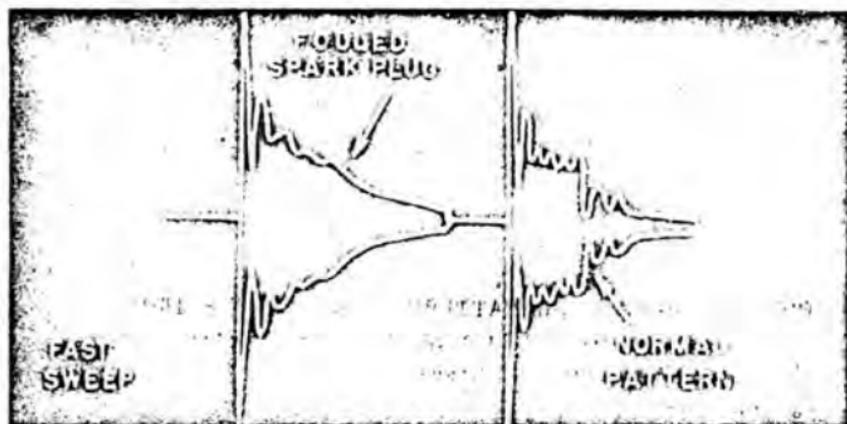
FOULED SPARK PLUG PATTERN - FAST SWEEP - 18-CYLINDER ENGINE, LOW-TENSION IGNITION SYSTEM - This pattern is essentially the same as the shorted high-tension circuit pattern. However, in contrast to the steady appearance of the short, the fouled plug pattern represents a changing resistive short due to fouling, and consequently presents a changing, dancing appearance. A pattern intermittently changing from almost normal to that of a dead short may be classed as an intermittently fouling plug. If the pattern continuously presents characteristics of a fouled plug the pattern may be classed as a badly fouled plug.

Probable Causes: Spark plug fouling due to a foreign substance (lead or carbon) on the electrodes. The condition can sometimes be cleared by the recommended de-fouling procedure.

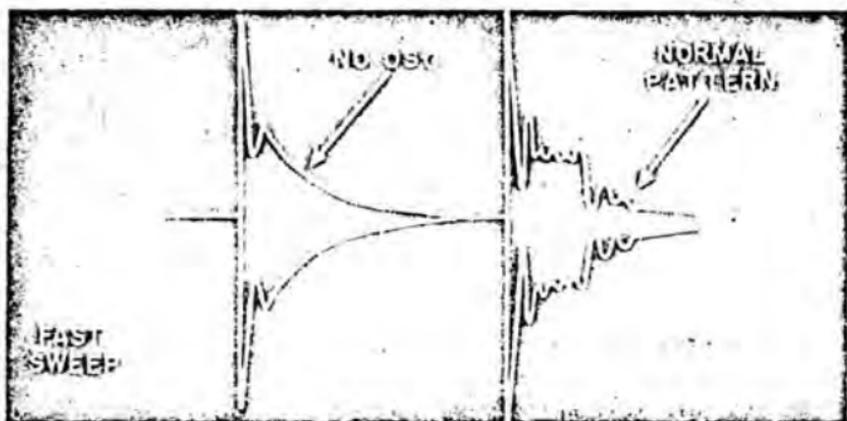
SHORTED HIGH-TENSION CIRCUIT (SHORTED SECONDARY) PATTERN - FAST SWEEP - 18-CYLINDER ENGINE, LOW-TENSION IGNITION SYSTEM - The initial peak voltage amplitude is less than normal. The pattern tail appears as a steady curved line without high-frequency oscillation since the circuit is not dissipating energy in the presence of combustion ionization.

Probable Causes: Badly fouled spark plugs, a short circuit within the spark plugs, such as a cracked ceramic or carbon tracked cigarette well, a short in the high-tension lead or coil, a spark plug lead off and shorted to ground. If the pattern appears on both spark plugs of one cylinder, it generally indicates cylinder failure where metal particles have peened over the spark plug electrodes.

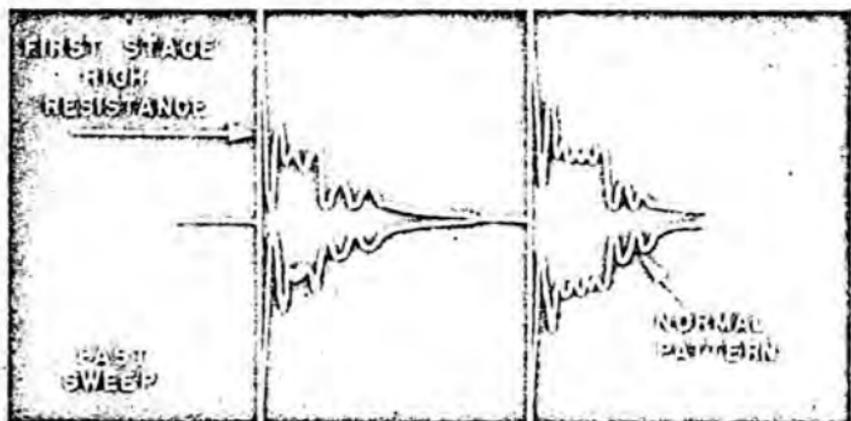
FIRST STAGE OF HIGH-TENSION CIRCUIT (SECONDARY CIRCUIT) HIGH-RESISTANCE PATTERN - FAST SWEEP - 18-CYLINDER ENGINE, LOW-TENSION IGNITION SYSTEM - The initial high peak voltage is higher than normal and this first excursion returns to a point nearer the zero trace line. Following this the "saddle" portion is shorter than normal. The remainder of the pattern, the sharp negative return of the trace toward the zero trace and the low-frequency tail are normal.

Probable Causes: Large plug gap, high resistance within the spark plug, dirty spark plug contact button or cylinder mounted coil contact button, damaged cigarette spring at the spark plug or at the cylinder mounted coil, or any abnormal gap in the secondary circuit.

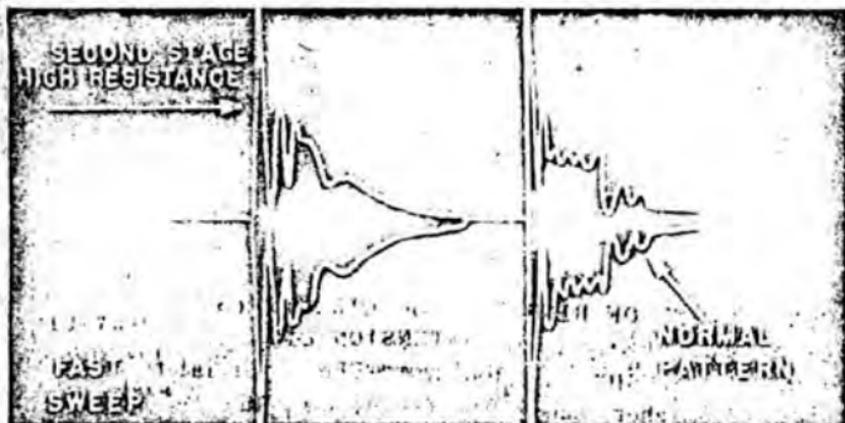
SECOND STAGE OF HIGH-TENSION CIRCUIT (SECONDARY CIRCUIT) HIGH RESISTANCE PATTERN - FAST SWEEP - 18-CYLINDER ENGINE, LOW-TENSION IGNITION SYSTEM - The initial high peak voltage is higher than normal and this first excursion returns to a point very near the zero trace line. Following this the "saddle" portion is much shorter than normal. The "hook" following the "saddle" and the sharp negative return of the trace toward the zero trace are not pronounced.

Probable Causes: Large plug gap, high resistance within the spark plug, dirty spark plug contact button or cylinder mounted coil contact button, damaged cigarette spring at the spark plug or at the cylinder mounted coil, or any abnormally large gap in the secondary circuit.
