PROCEEDINGS OF THE MERCHANT MARINE COUNCIL

UNITED STATES COAST GUARD

Vol. 23, No. 12 • December 1966

SHIPPING TRAFFIC SAFETY:

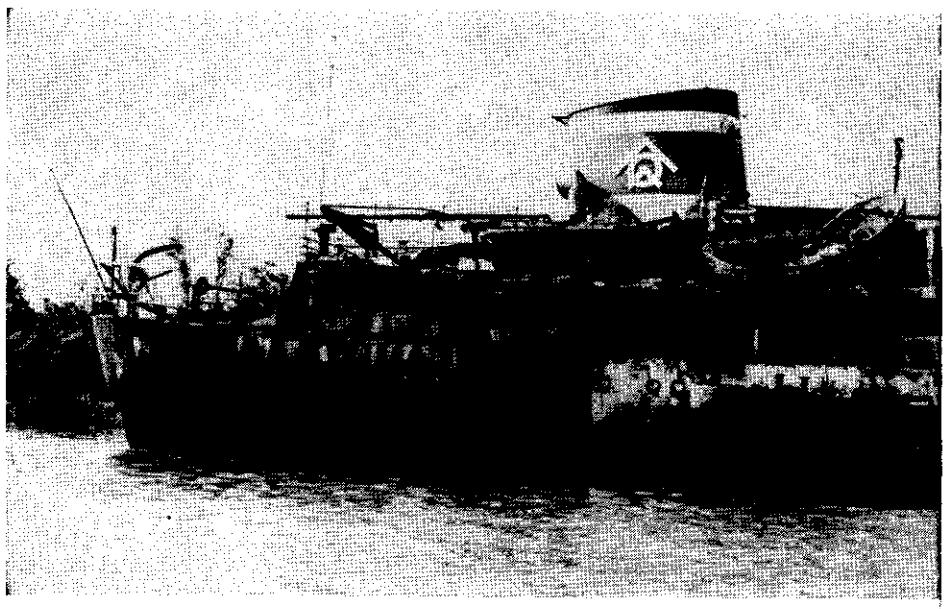
The blackened Boheme shows results of collision and fire.

Collisions were also the cause of heavy vessel damage during fiscal 1966. Some of the circumstances surrounding them are worthy of review. During a period of thick fog an outbound tanker and an inbound freighter collided in the channel leading to one of our major ports. Both vessels were steaming at greater than

moderate speed and were too close to the center of the channel. Neither made full use of her radar. One of them was equipped with a VHF radio-telephone capable of operating on the navigational information frequency. Since the collision was the result of a misunderstanding as to intent, it appeared that it might have been avoided if both vessels had been so equipped and had established direct contact. In another collision in fog off one of our ports two vessels approached in the vicinity of the sea buoy. Each had radar, but did not plot the other's approach. The outbound vessel assumed the other would pass the sea buoy on her own port side, while the inbound vessel planned a starboard-to-starboard situation. The value of radar was clouded by slight course changes, which gave the navigators a false impression. The failure to navigate with caution, and the failure to use radar information properly, contributed heavily to the cause of this collision; however, it might have been avoided by the establishment of sealanes in the area. Here again, direct radio contact between the bridges of the vessels might also have been helpful.

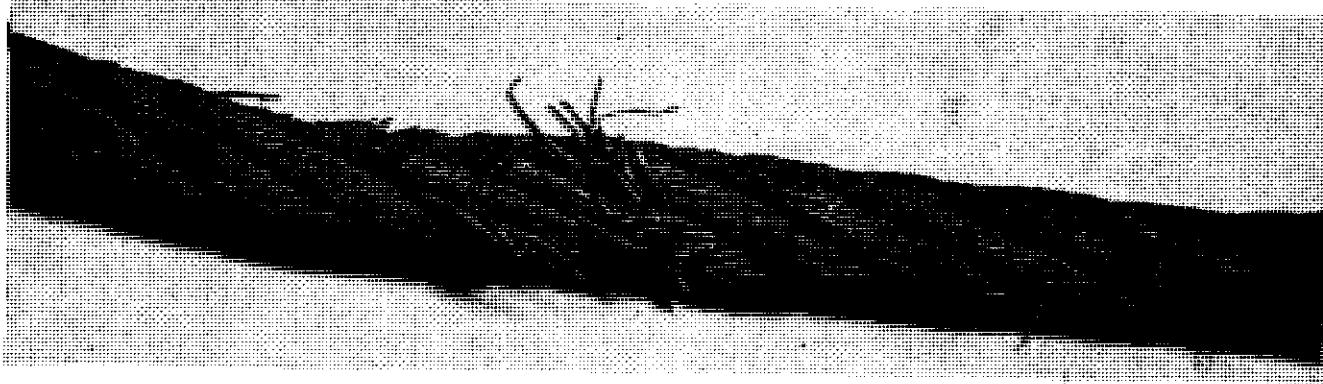
And this was the wire rope fall that didn't break!!

Subsequent examination of visible areas revealed that the wire rope which failed appeared to have been properly maintained since there were no fishhooks or obvious pitted areas. The wire which was the proper size was obtained and installed in a foreign port and no test data concerning the capacity of the wire was available.

Aside from lack of maintenance in hidden areas, this casualty might have been avoided if other precaution-

ary measures had been taken. Prior to installation, the actual strength or capacity of the wire should have been ascertained in order to insure that it would support the required load.
