VA3-137 LONG THANH NORTH 1050N 10658E
(YS145982)

VFR3/NC48-7 K10D (VVLTL/LTH)

BINH THUY AB

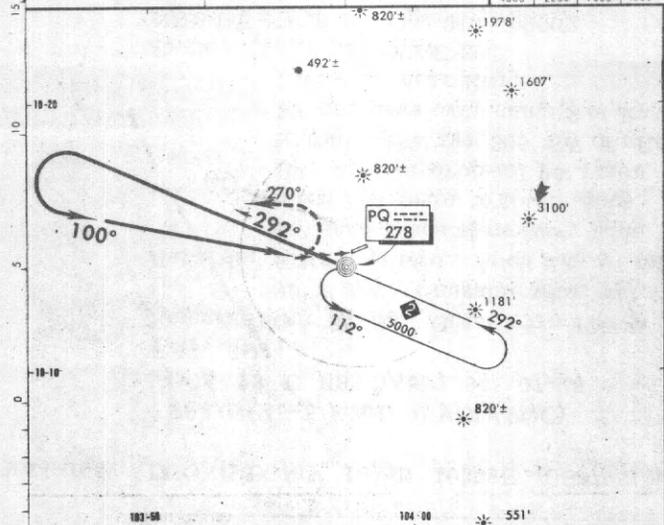
DUONG DONG
 NDB (ADF) Rwy 7
 NDB 278 PQ
 (OP NOT CONTINUOUS)
 MSA
 160°-090° - 180° - 270°-360°
 4500 | 2200 | 1000 | 4300

NOTE: Descent rate 600' per minute.

DESCENDING LEFT 15 NM to 2000' (1993')

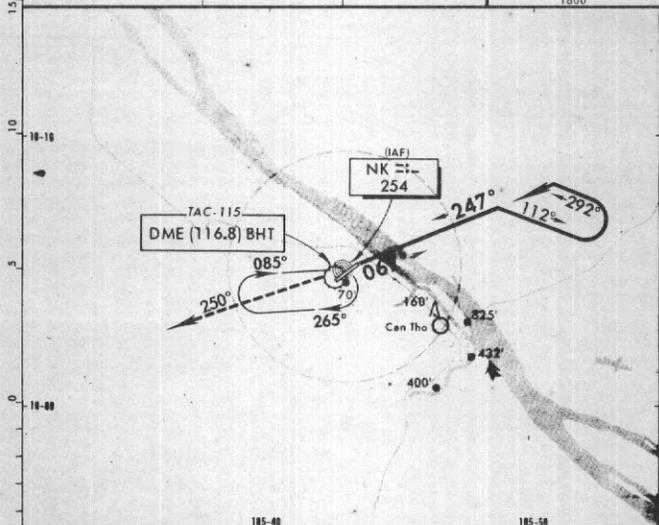
BINH THUY Tower 118.1	Apt. Elev 7'	BINH THUY, VIET-NAM
SIGON Control (R) 120.9	Var 01°E	NDB Rwy 24
	Class HW	NDB 254 NK 254
	Ground 118.7	MSA 1800

NOTE: For use by U.S. aircraft only.

Altimeter Setting in MILLIBARS (INCHES on Request)
