III MAF "VC Attack of Marble
Mountain Airfield &
Chudai Airfield"

Subj: Viet Cong Attack of Marble Mountain Air Facility and
Chu Lai Airfield of 28 October 1965; report of (U)

From: Commanding General
 To: Commanding General, Fleet Marine Force, Pacific
 Subj: Viet Cong Attack of Marble Mountain Air Facility and Chu Lai Airfield
 of 28 October 1965, report of

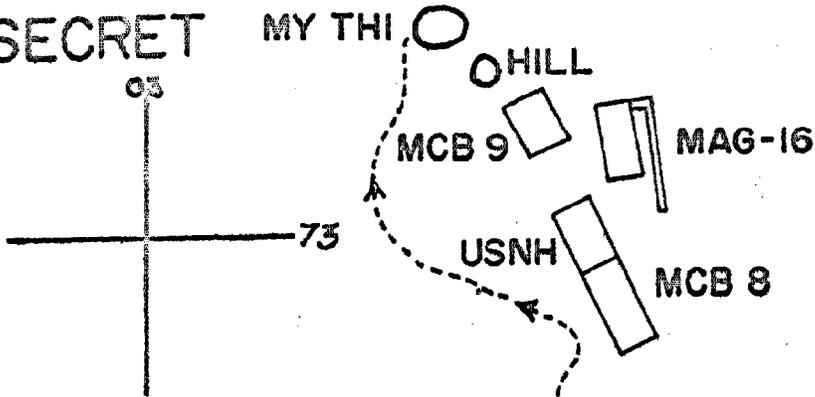
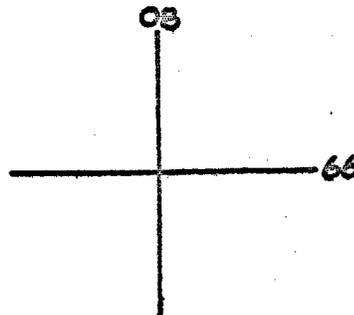
SCALE: 1:50,000
TAB B TO ENCLOSURE (2)

PROBABLE VC APPROACH ROUTE TO MARBLE MOUNTAIN AIR FACILITY

GROUP NO. 1
IN SAMPANS
TO MY THI

GROUP NO. 2 OVER
BRIDGE TO POINT
SOUTH OF MARBLE
MOUNTAIN

ed; the Naval Advisory Group reported no suspicious activity in this area during this period. A more probable method of infiltration, and one which more realistically supports the VC attack, is contained in a report received by the Hoa Vang District Chief from an agent he rates B/2. This report indicates that at 0830 27 October, approximately 300 men, plus 200 porters, were sighted coming from the direction of Thanh Quit, BT 053635, moving towards Khue Dong, BT 056705. At Khue Dong they split into two groups. The first group embarked in sampans and went up the river to My Thi, BT 054743, just northwest of MCB-9. The second group crossed the bridge just southwest of Marble Mountain, BT 072702, and were equipped with one AA machine gun, which fired at the flare ship. (See TAB B)

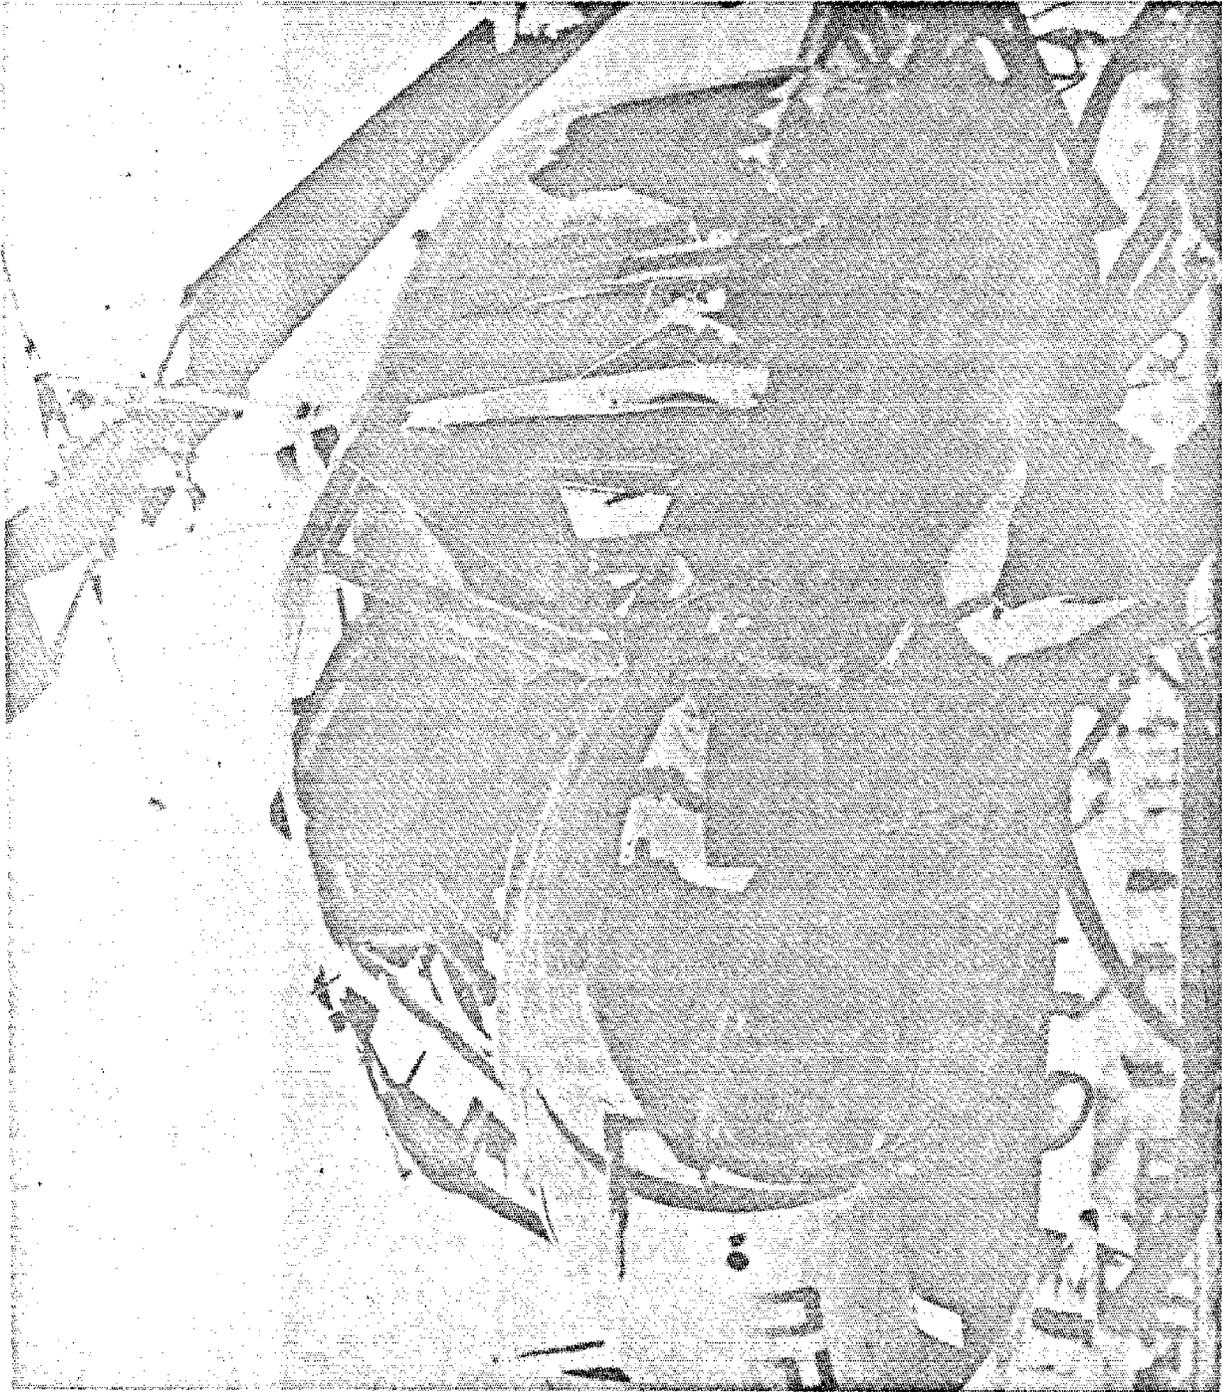
DESTROYED UHIE - MARBLE MOUNTAIN
FIGURES 8 TO TAB J TO ENCLOSURE (1)

<u>a. Aircraft</u>	<u>Destroyed</u>	<u>Major Damage</u>	<u>Minor Damage</u>
UH 1 B	13	2	2
UH 34	6	9	17
OH 37	0	0	5
<u>b. Vehicles:</u>			
M50 Water Truck	1	0	0
M422 Truck (Nighty Mite)	1	0	1
M35 Crash Truck	0	1	2
M63 Gas Truck	0	1	0

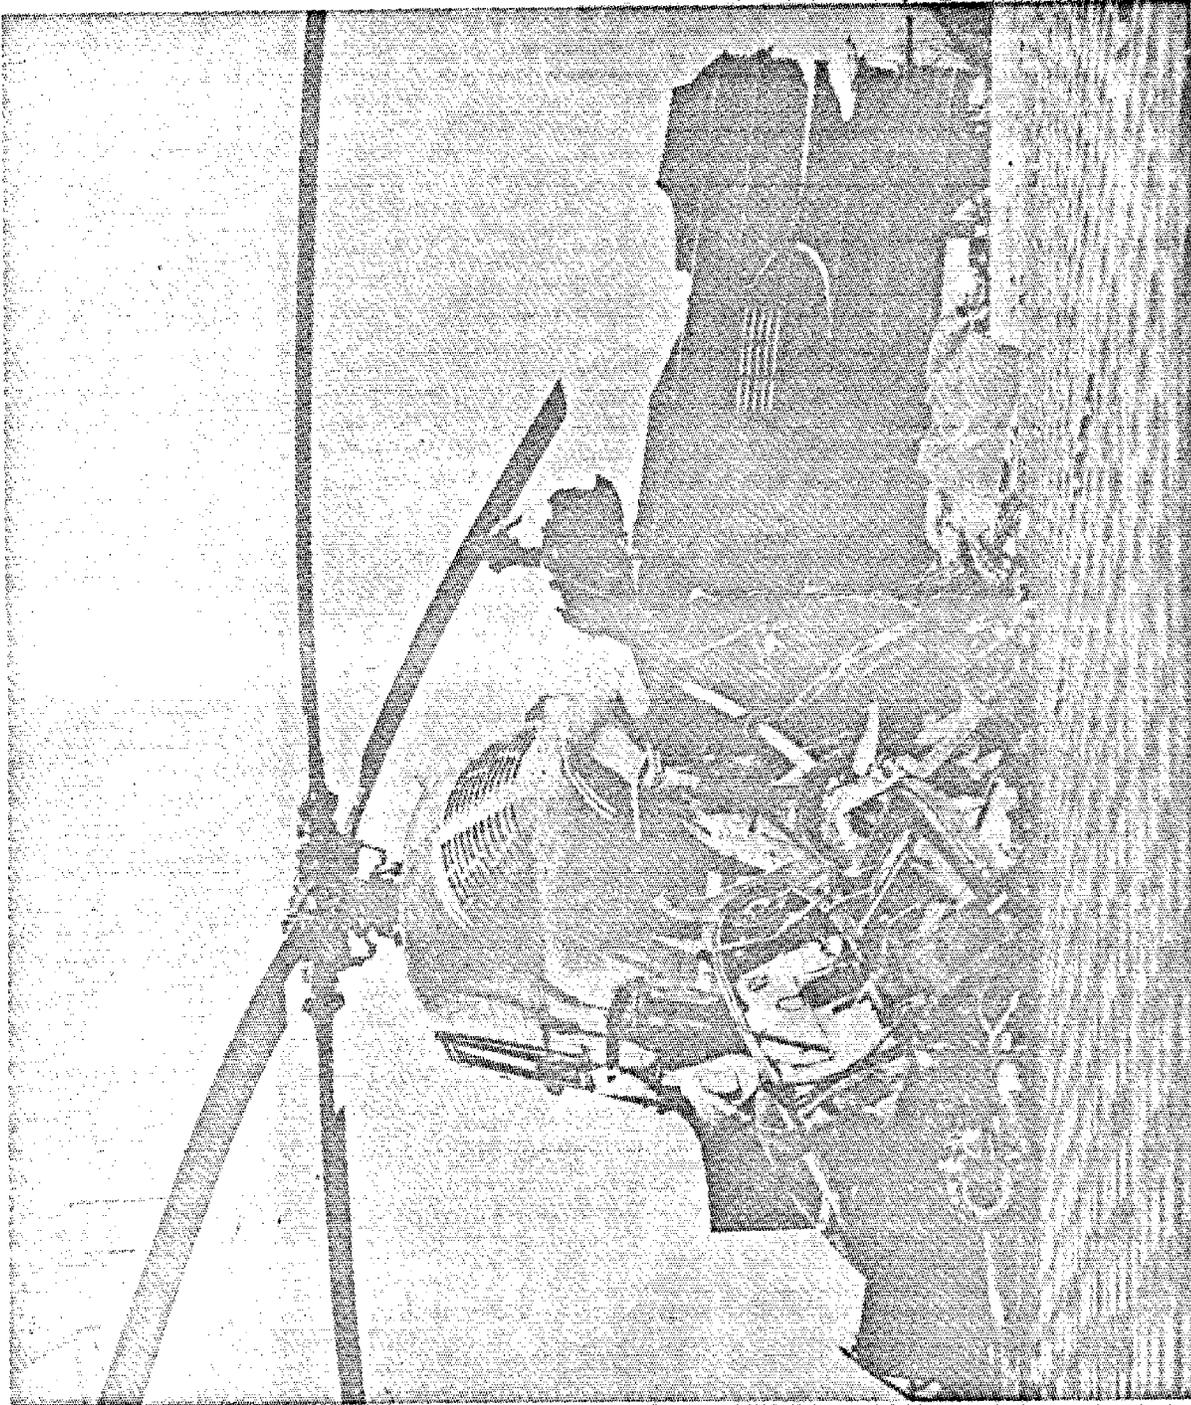
DESTROYED H-34 - MARBLE MOUNTAIN
FIGURE 10 TO TAB J TO ENCLOSURE (1)
