101ST AIRBORNE DIVISION (AIRMOBILE)

FINAL REPORT

AIRMOBILE OPERATIONS IN SUPPORT OF
OPERATION LAMSON 719
8 February - 6 April 1971

VOLUME II

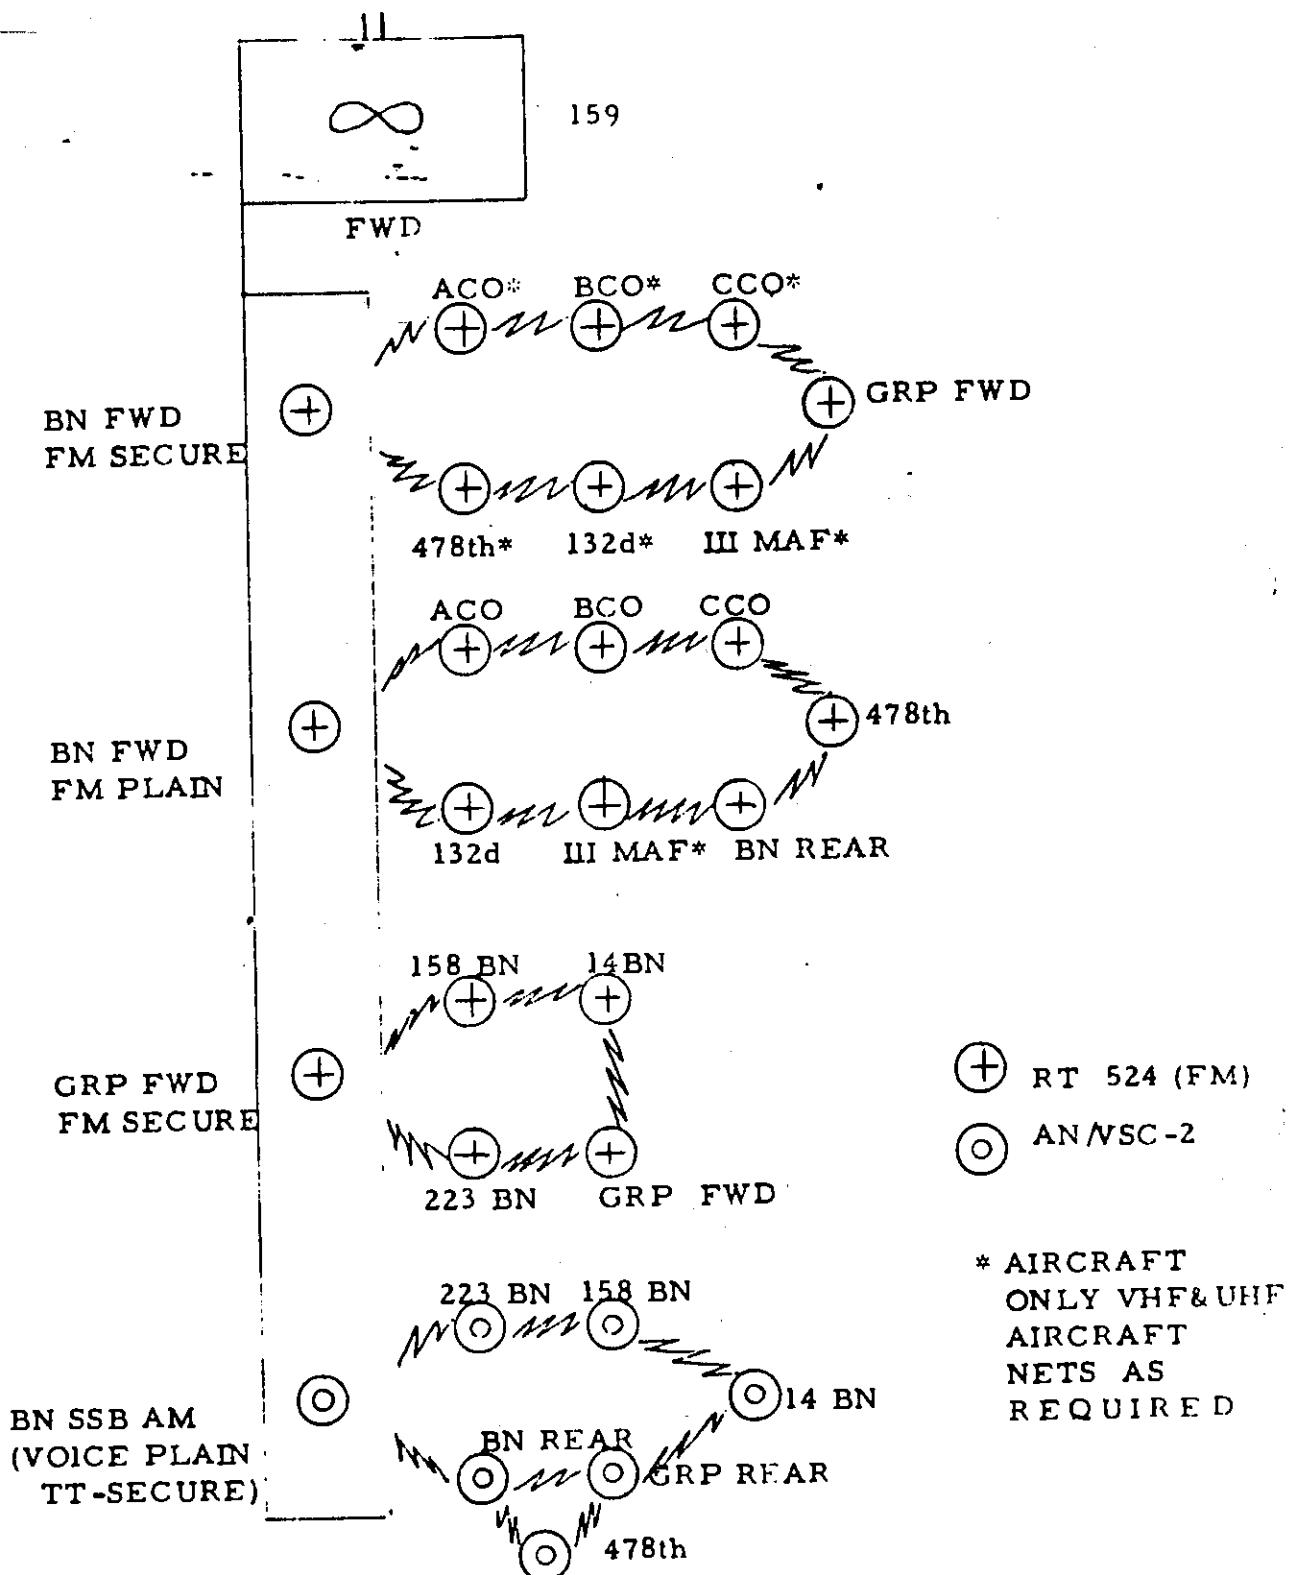
FIGURE IV-1 (U) Radio Net Diagram for 159 Avn Bn (ASHB) (U).

The primary means of voice communications on this operation was FM radio. Three RT-524 radios were set up at a forward operations tent, providing a battalion secure net, a battalion plain net and a station in the group secure net. The secure capability was achieved by using two KY-8 secure sets. Power for this FM configuration was supplied initially by two 1.5 KW DC generator sets and four 12 volt DC batteries. Later on, because of generator failure and battery problems, a 3 KW DC generator set was used in conjunction with an RA-91C rectifier. A net diagram of the FM radio system is shown at Figure IV-1. The battalion (fwd) plain net was originally designed to communicate with the rear area by means of an FM retrans site. Because of equipment shortages, this retrans site was not installed and bad atmospheric conditions nullified the possibility of communicating to the rear without it. The battalion (fwd) plain net was then used, as was the battalion (fwd) secure net, primarily for contact with aircraft in the area of operations. Aircraft VHF and UHF radios were also employed as required.

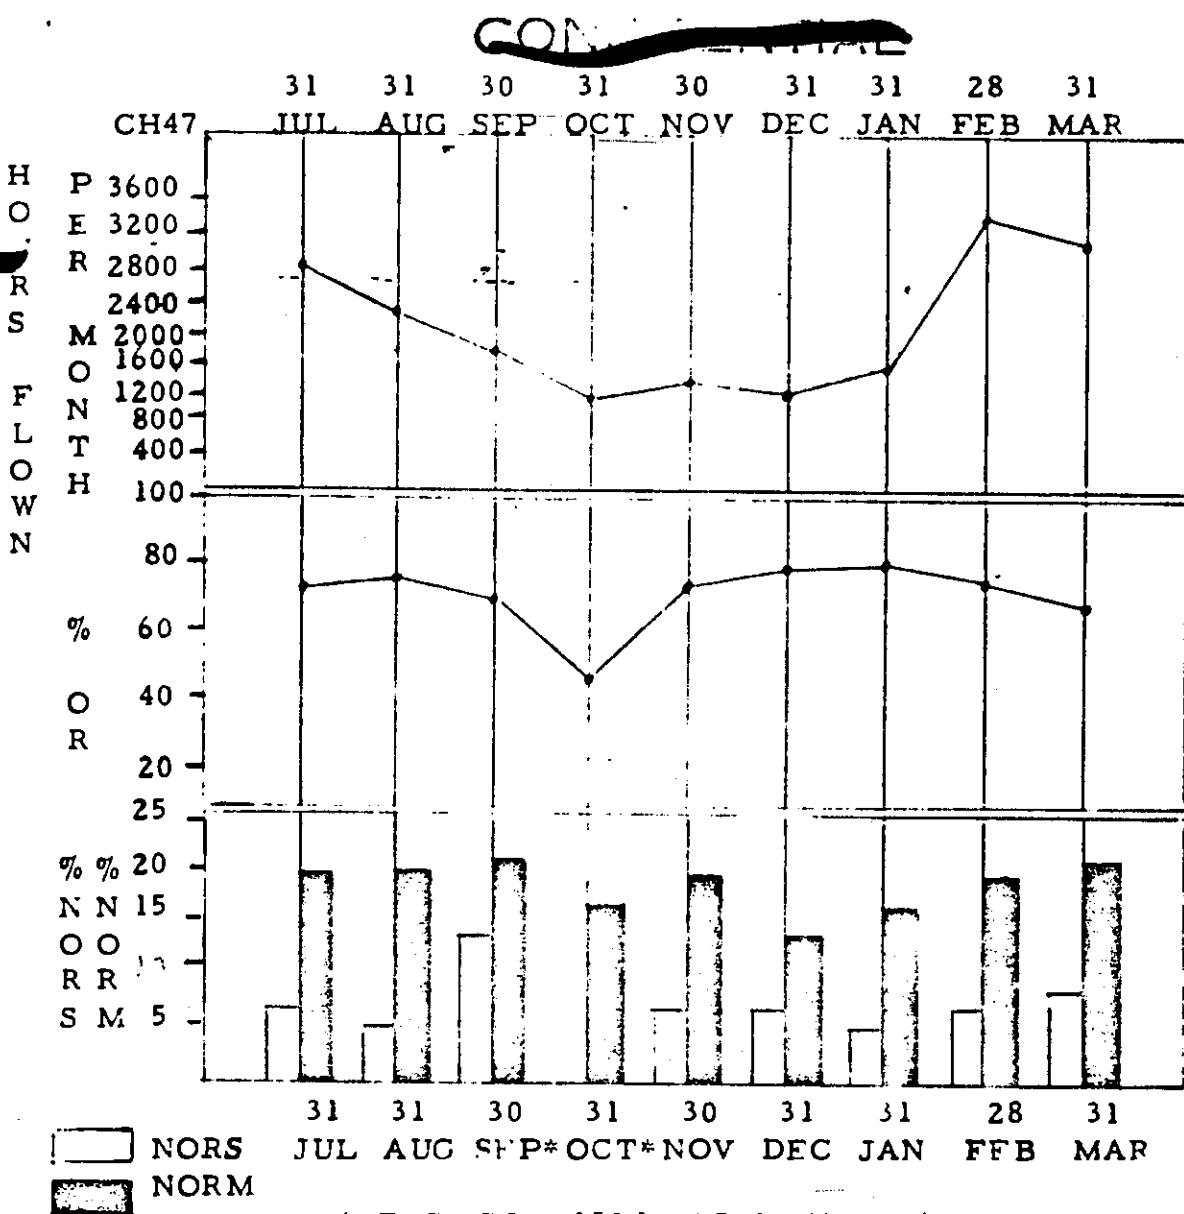
A, B, C, CO., 159th ASHB (AMBL)
48 ASSIGNED CH-47's

DEPICTING COMBINED MONTHLY FLYING HOUR
PROGRAM AVG OPERATIONAL READY RATES & AVG
MONTHLY NORM/NORS RATES FOR MONTHS SHOWN
DURING 1970-1971

* DURING THIS PERIOD, THE 159th ASHB WAS
UNDERGOING SUPER "C" CONVERSION

FIGURE IV-4 (U) Monthly Flying Hours, CH-47 (U)

The three primary indicators for determining the efficiency of the maintenance effort during this period were the operational ready rate (OR), and the NORM/NORS rates. At Figures IV-4, 5, and 6 are charts which graphically depict these indicators with relation to the associated flying hour program of the CH-47's and CH-54's. As the flying hour program increased abruptly in February, the NORM rates, and in the case of the CH-47's, the NORS rates, also increased. It is significant to note that the NORS rate, although increasing slightly, remained relatively constant when compared with the previous seven month period. This was due primarily to the amount of command interest and emphasis on the aviation repair parts supply system. A forward liaison element of the 34th General Support Group, operating out of Quang Tri, was in a large measure responsible for insuring that the necessary repair parts were made available to the requesting units in an absolute minimum of time. This element also maintained close liaison with the civilian PMP teams, and determined where their assistance was most urgently required. One of the primary reasons for the slight increase in the NORS rates was that some of the repair parts for which there was a sudden demand were items that had acquired little if any demand data in previous operations. Many of the parts damaged by enemy fire were rarely required under normal operating conditions. It must be emphasized at this point, that a major factor in keeping NORS/NORM rates at an acceptable level was the prior planning done by the units of the 159th Assault Support Helicopter Battalion, and the aircraft scheduling program which they used. They were able to adequately forecast, in most cases, the repair parts which would be required based on the increased flying hour program. A major area of concern to the maintenance activities during the operation was the conditions under which the aircraft were operating in the forward areas. The dust in which the CH-47's and CH-54's were forced to operate on a continuous basis was a critical factor in increased wear on engines and rotor blades. As a result of the battalion policy of flushing each CH-47 engine with water after every flying day, the damage to engines remained negligible. The wear on CH-54 engines was also negligible because of their Engine Air Particle Separators (EAPS). Most of the damage done by the dust was to the aircraft rotor blades. The abrasive nature of the dust coupled with the extremely high winds generated by the rotor wash, resulted in abnormally rapid deterioration of the leading

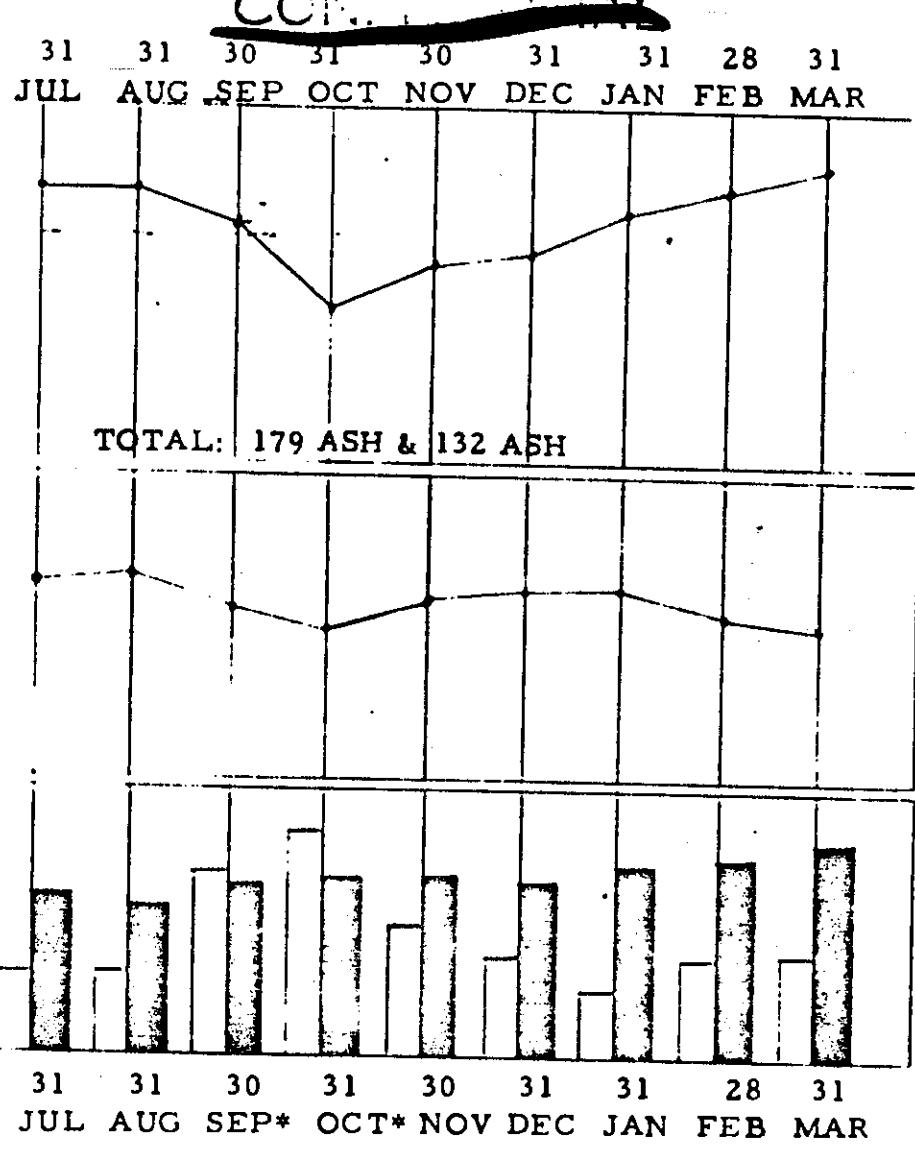
* DURING THIS PERIOD
179 ASH CO UNDERWENT
SUPER "C" CONVERSION

179 ASH CO & 132 ASH CO OPCON TO 159 ASHB
(AMBL) 32 ASSIGNED CH47 DEPICTING COM-
BINED MONTHLY FLYING HOUR PROGRAM,
AVG. OPERATIONAL READY RATES & AVG.
MONTHLY NORMS/NORS RATES FOR
MONTHS SHOWN DURING 1970-1971

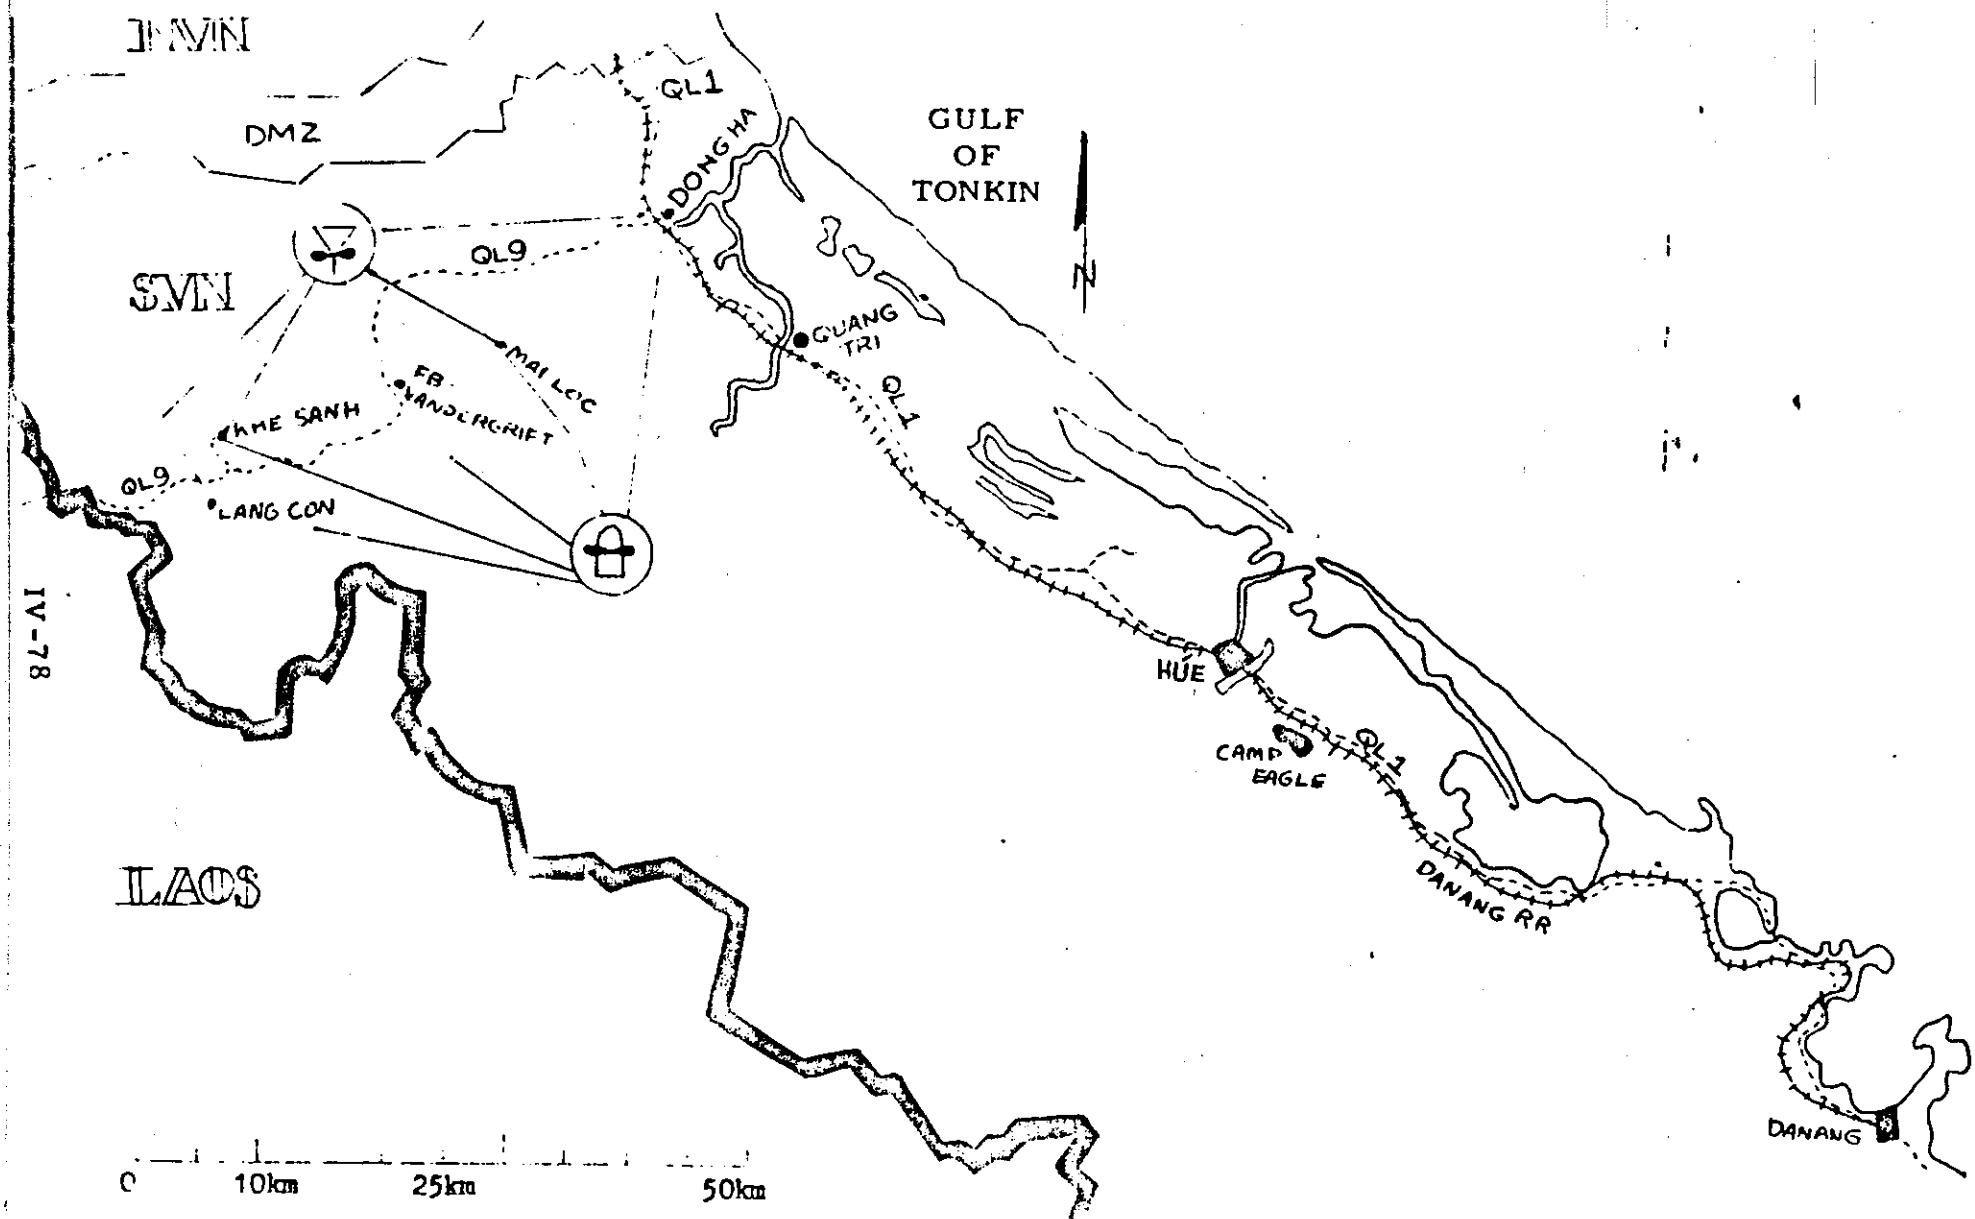
FIGURE IV-11 (U). Rearm/Refuel Points (U)

The rearm points were constructed using earth-filled 2.75 rocket ammunition boxes. A double rearm point was constructed consisting of a central barricade with open rockets pointing into each side. Within each point were three side by side compartments, one for 17 pound HE rockets, one for flechette rockets, and one for 10 pound HE rockets. This large storage capacity was deemed necessary since it was anticipated that as many as six gunships

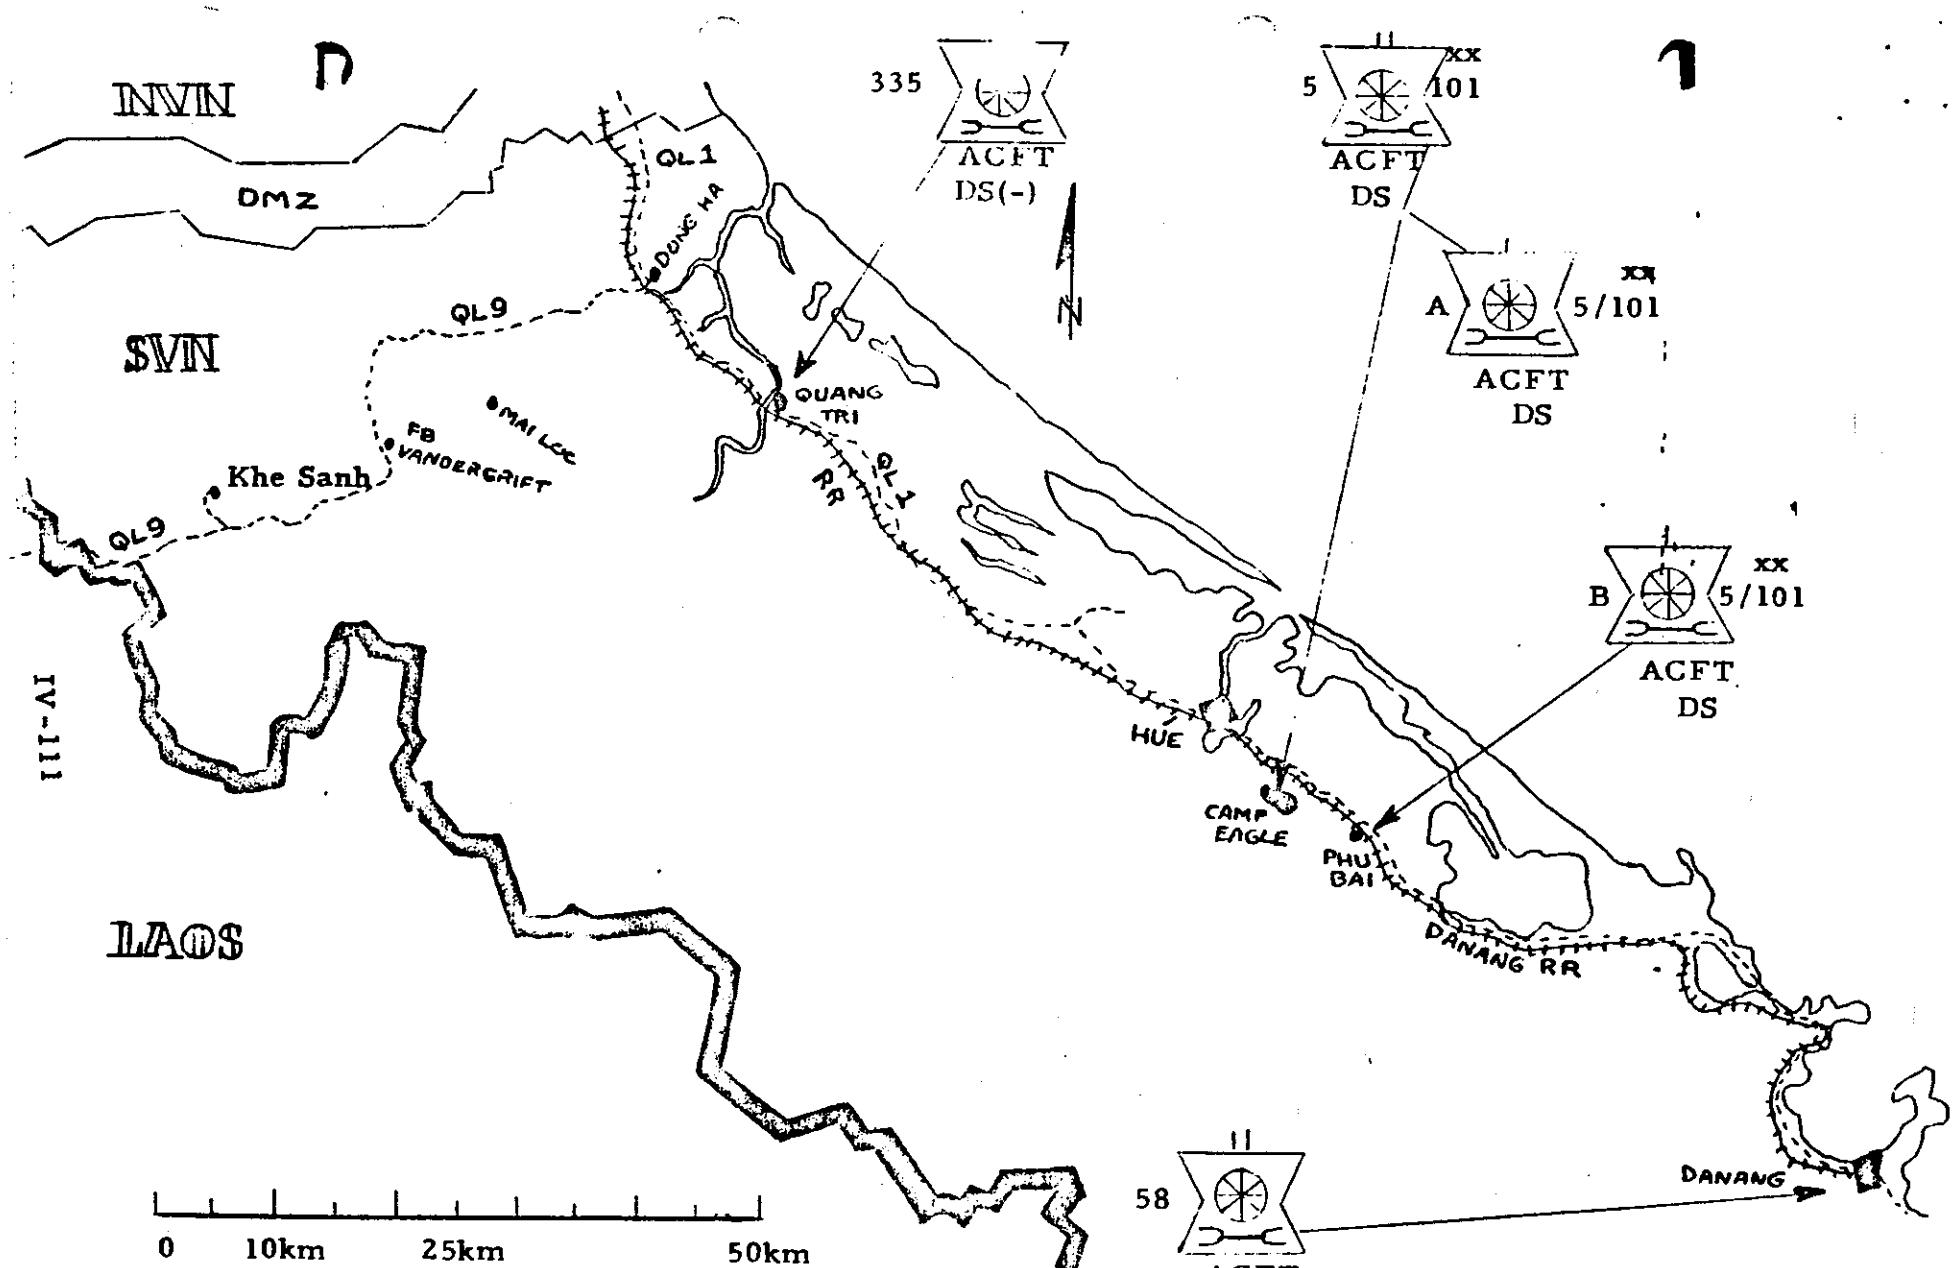
FIGURE IV-24 (U). Aircraft Maintenance Facilities (U).

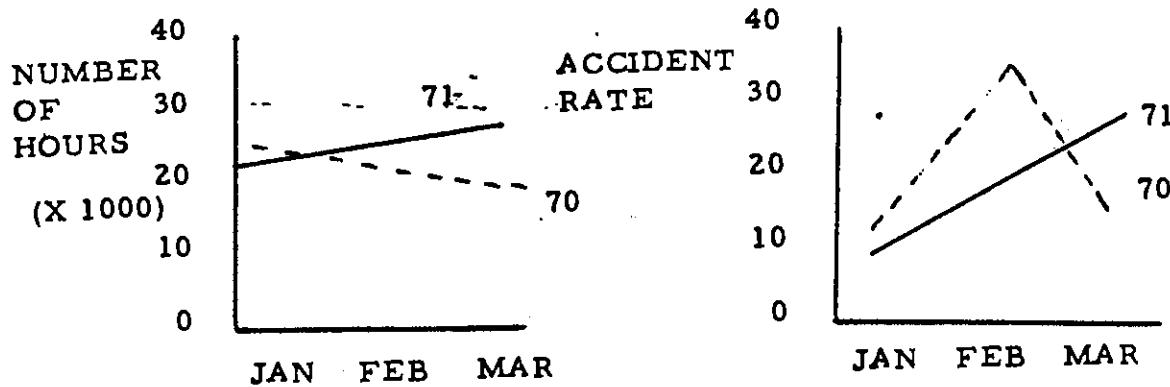
FIGURE IV-31 (U). 101st Abn Div (Armb) Hours Flown and Accident Rate, 3rd Qtr FY 70 and 71 (U).

b. The division flew 7,548 hours more during the month of February and March 1971 than during the same time period in 1970. See Figure IV-31 below:

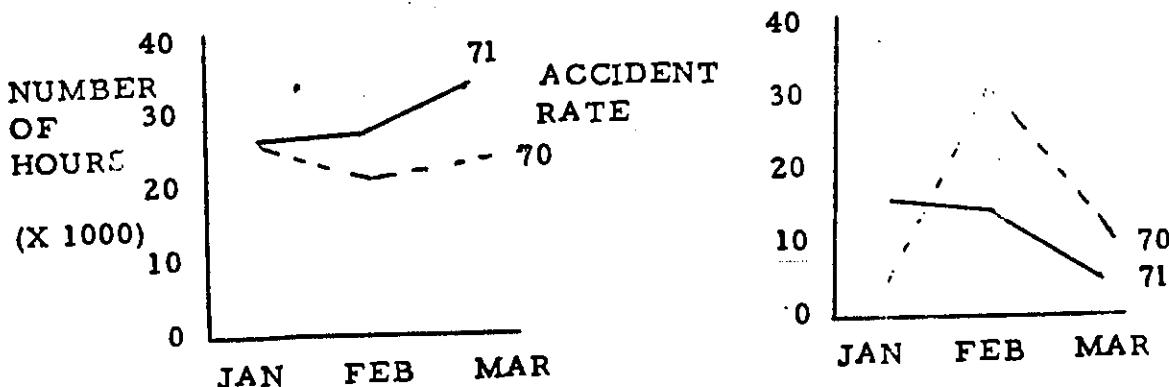
FIGURE IV-32 (U) 101st Avn Gp Hours Flown and Accident Rate, 3rd Qtr FY 70 and 71 (U).

c. An examination of hours and rates in the 101st Aviation Group shows that the Group flew 8,188 hours more during the month of February and March 1971 than during the same period in 1970, experiencing an average rate reduction of 13.8 accidents per 100,000 flying hours. See Figure IV-32 below:

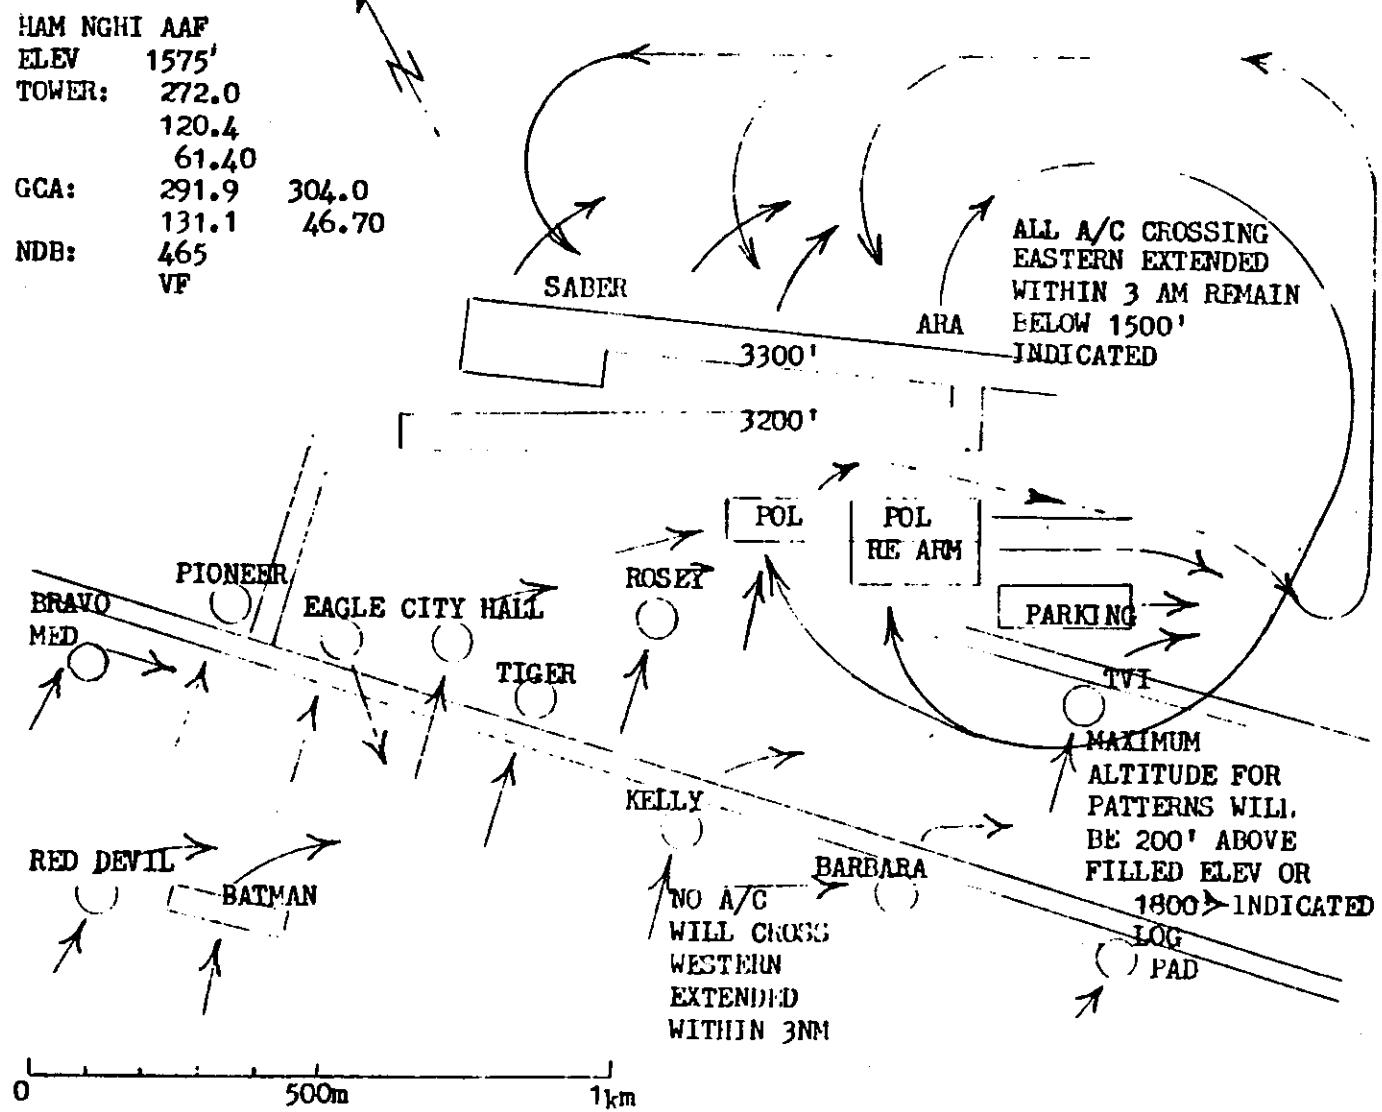
FIGURE IV-33 (U). Khe Sanh Air Facility and Flight Routes (U).

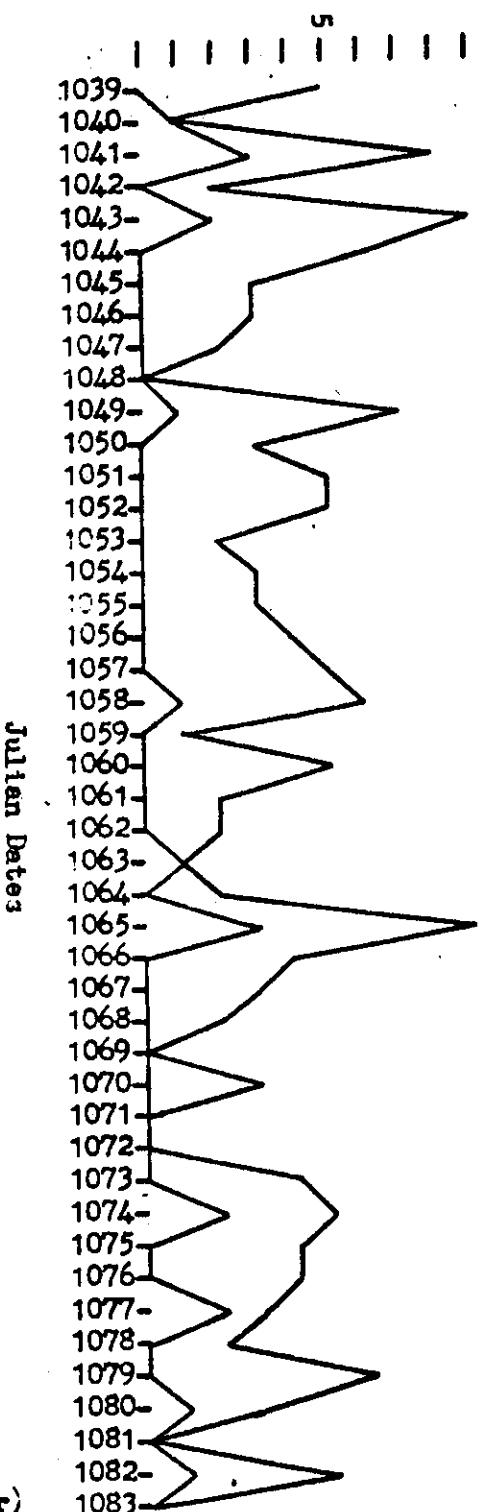
FIGURE IV-147 (U) AL-1G, Hit versus Lost (U).

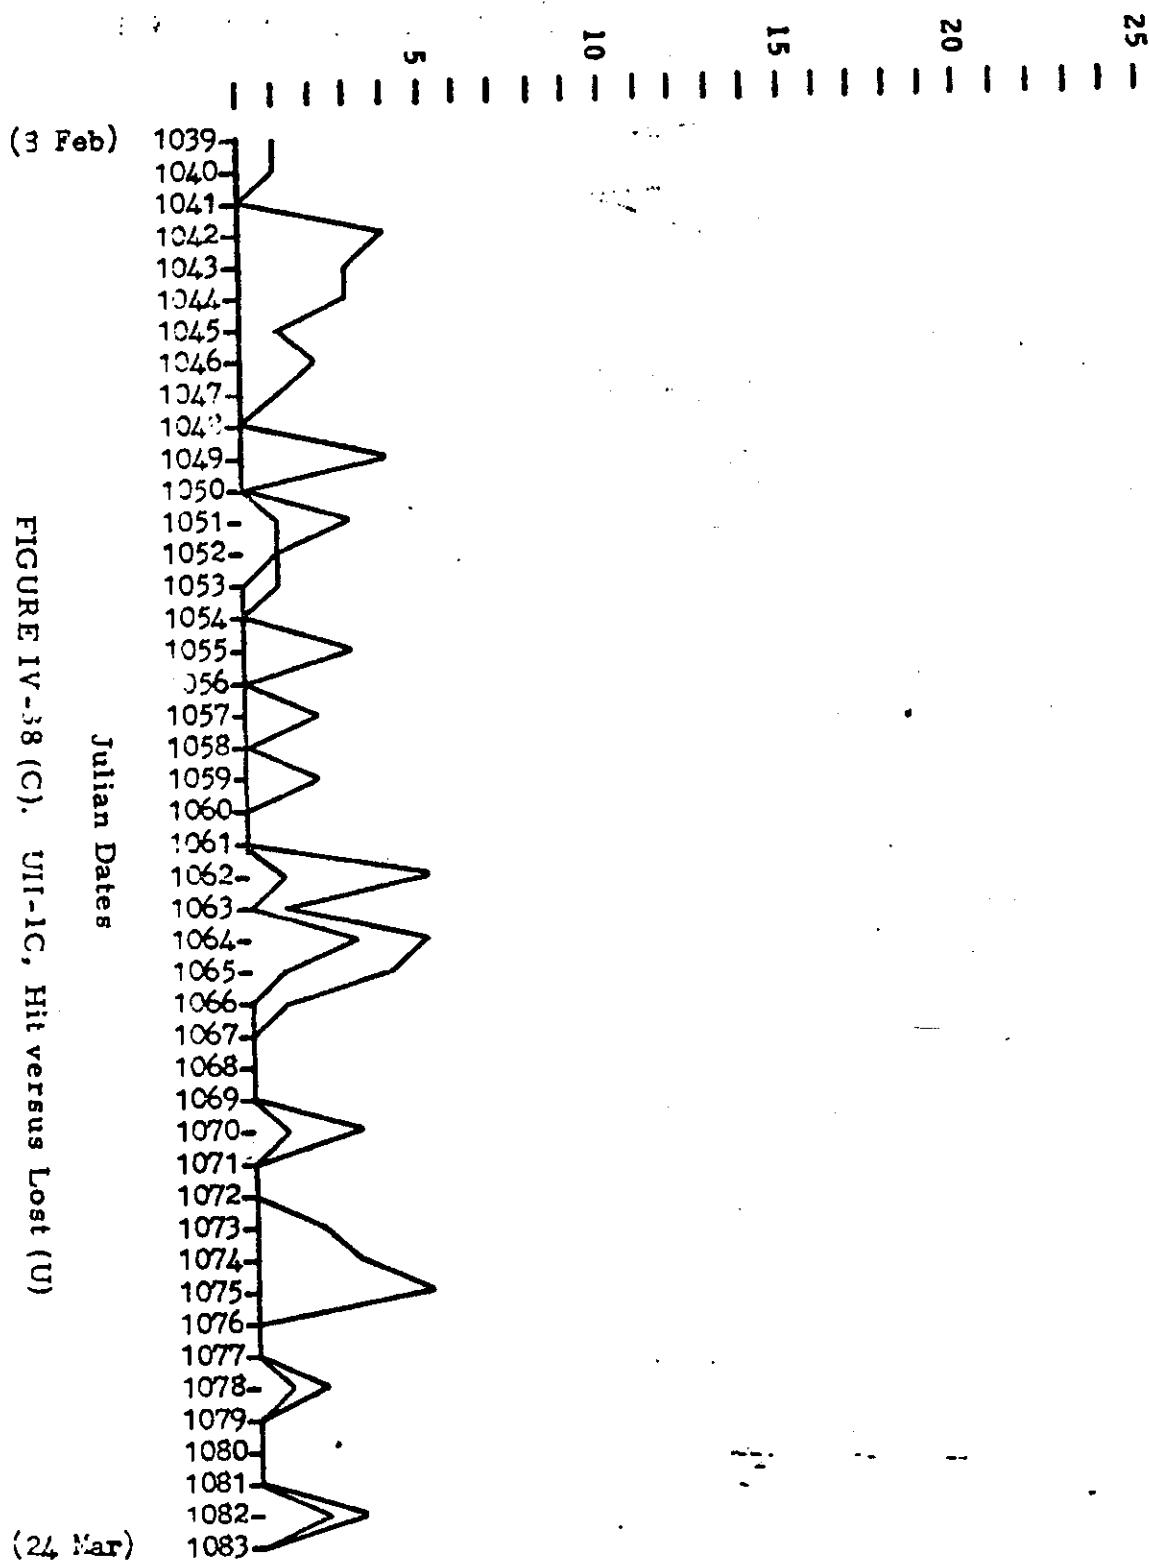
FIGURE IV-38 (C). UH-1C, Hit versus Lost (U)

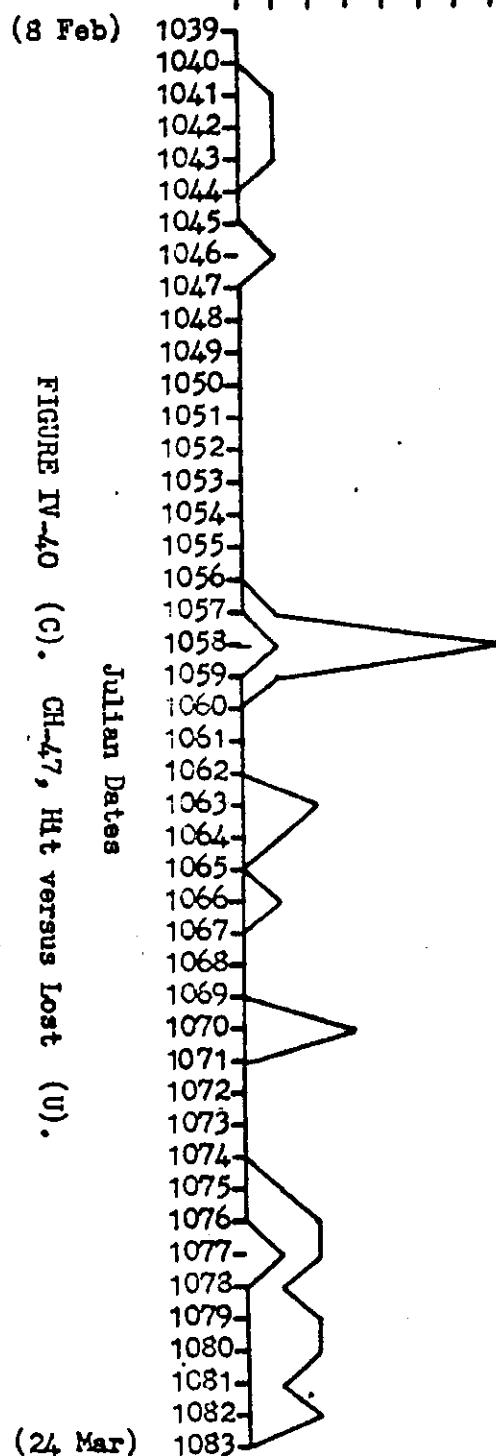
FIGURE IV-40 (C). CH-47, Hit versus Lost (u).
