101ST AIRBORNE DIVISION (AIRMOBILE)

FINAL REPORT

AIRMOBILE OPERATIONS IN SUPPORT OF
OPERATION LAMSON 719
8 February - 6 April 1971

VOLUME II

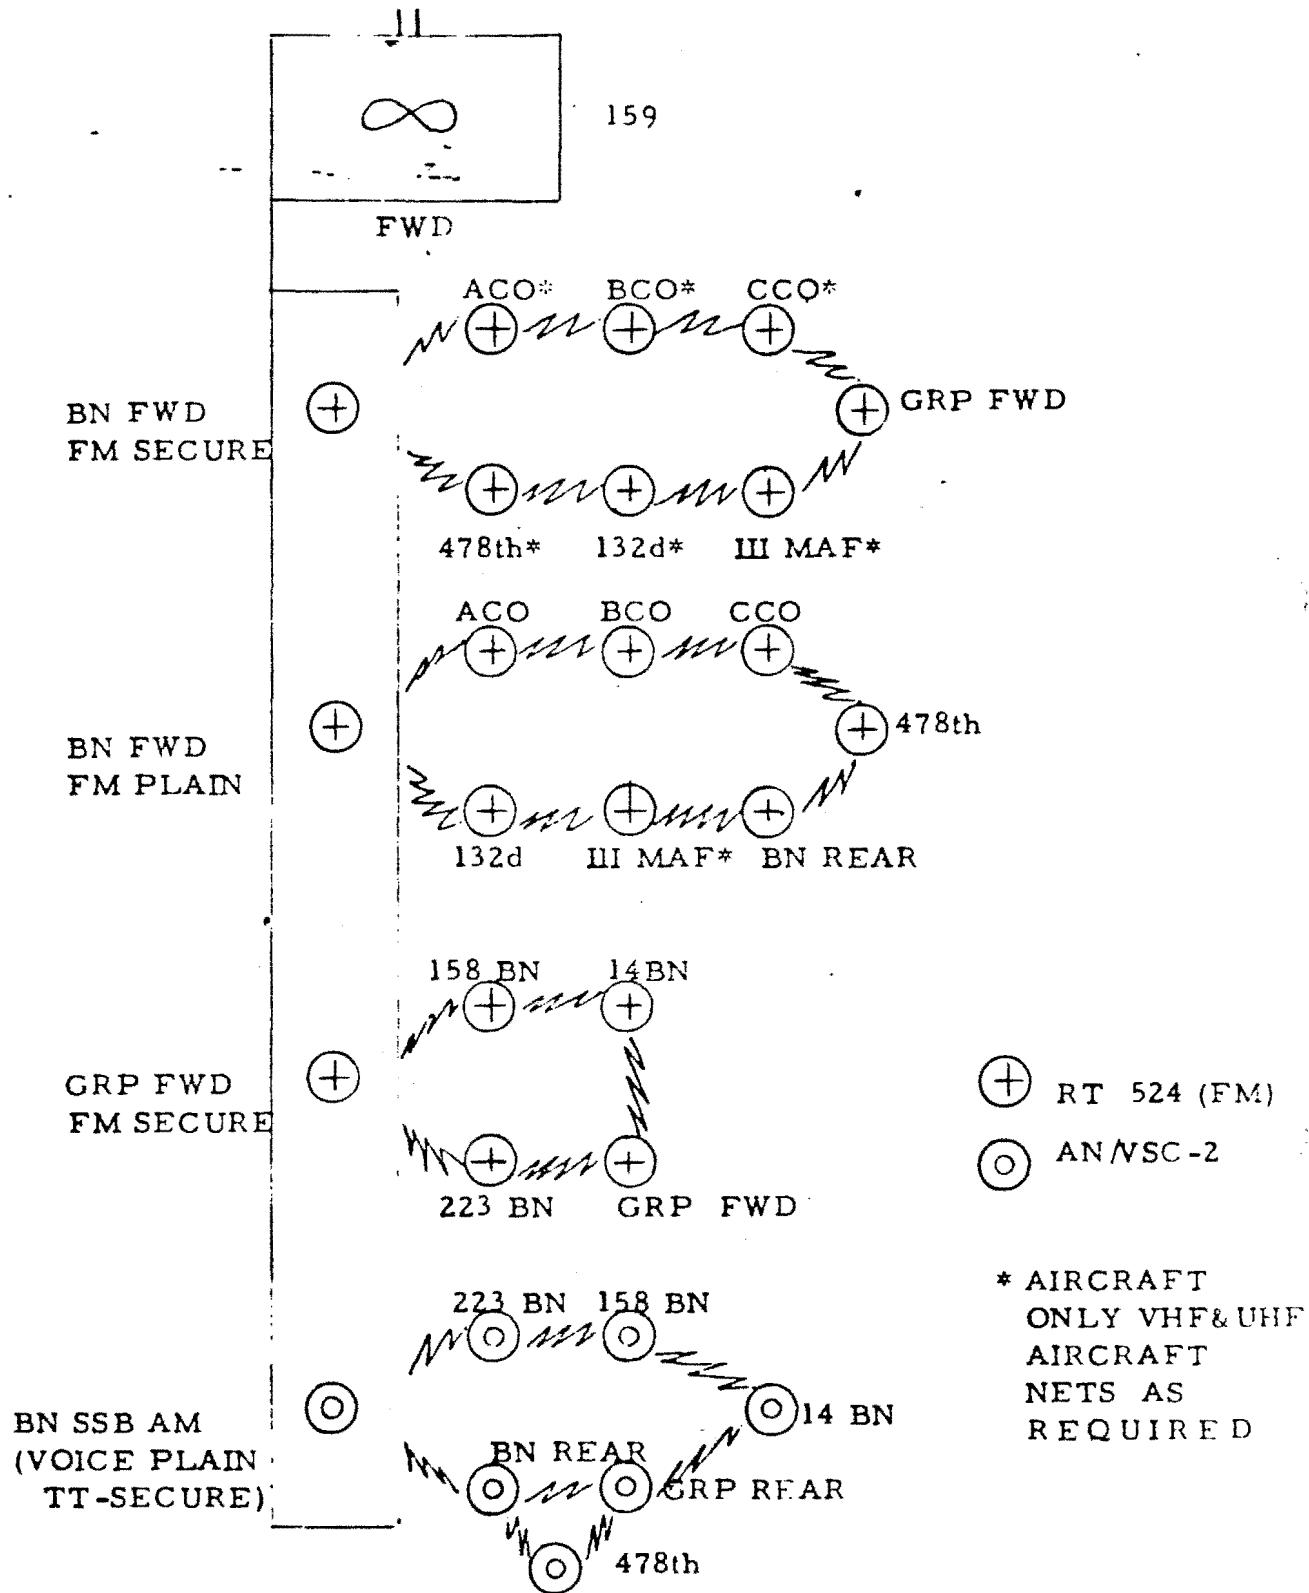
FIGURE IV-1 (U) Radio Net Diagram for 159 Avn Bn (ASHB) (U).

The primary means of voice communications on this operation was FM radio. Three RT-524 radios were set up at a forward operations tent, providing a battalion secure net, a battalion plain net and a station in the group secure net. The secure capability was achieved by using two KY-8 secure sets. Power for this FM configuration was supplied initially by two 1.5 KW DC generator sets and four 12 volt DC batteries. Later on, because of generator failure and battery problems, a 3 KW DC generator set was used in conjunction with an RA-91C rectifier. A net diagram of the FM radio system is shown at Figure IV-1. The battalion (fwd) plain net was originally designed to communicate with the rear area by means of an FM retrans site. Because of equipment shortages, this retrans site was not installed and bad atmospheric conditions nullified the possibility of communicating to the rear without it. The battalion (fwd) plain net was then used, as was the battalion (fwd) secure net, primarily for contact with aircraft in the area of operations. Aircraft VHF and UHF radios were also employed as required.

WD-1 wire and field telephones were used for local land

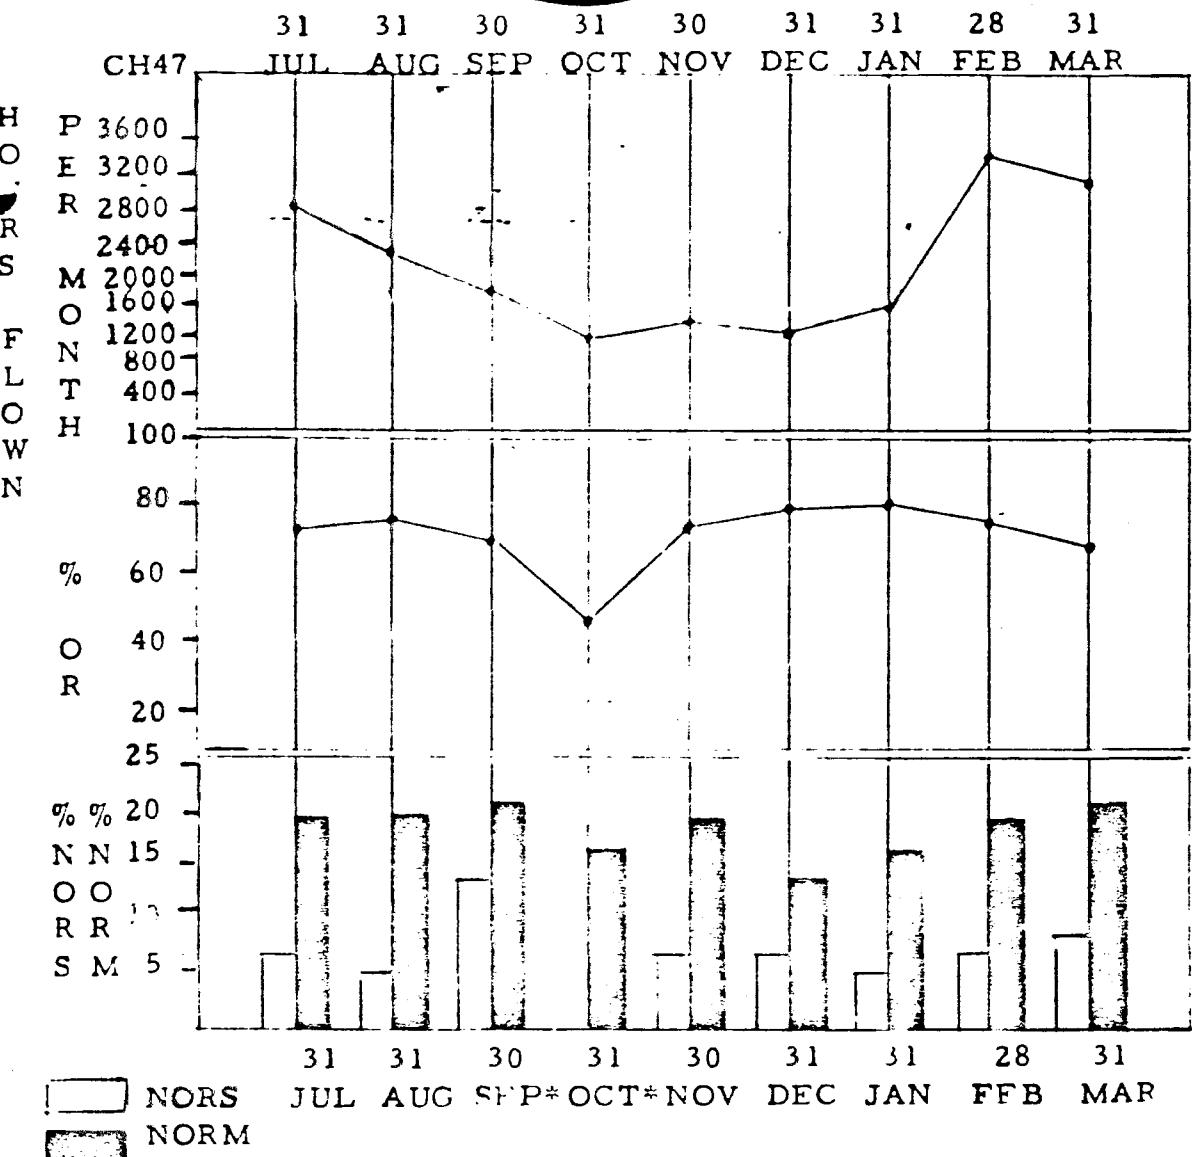
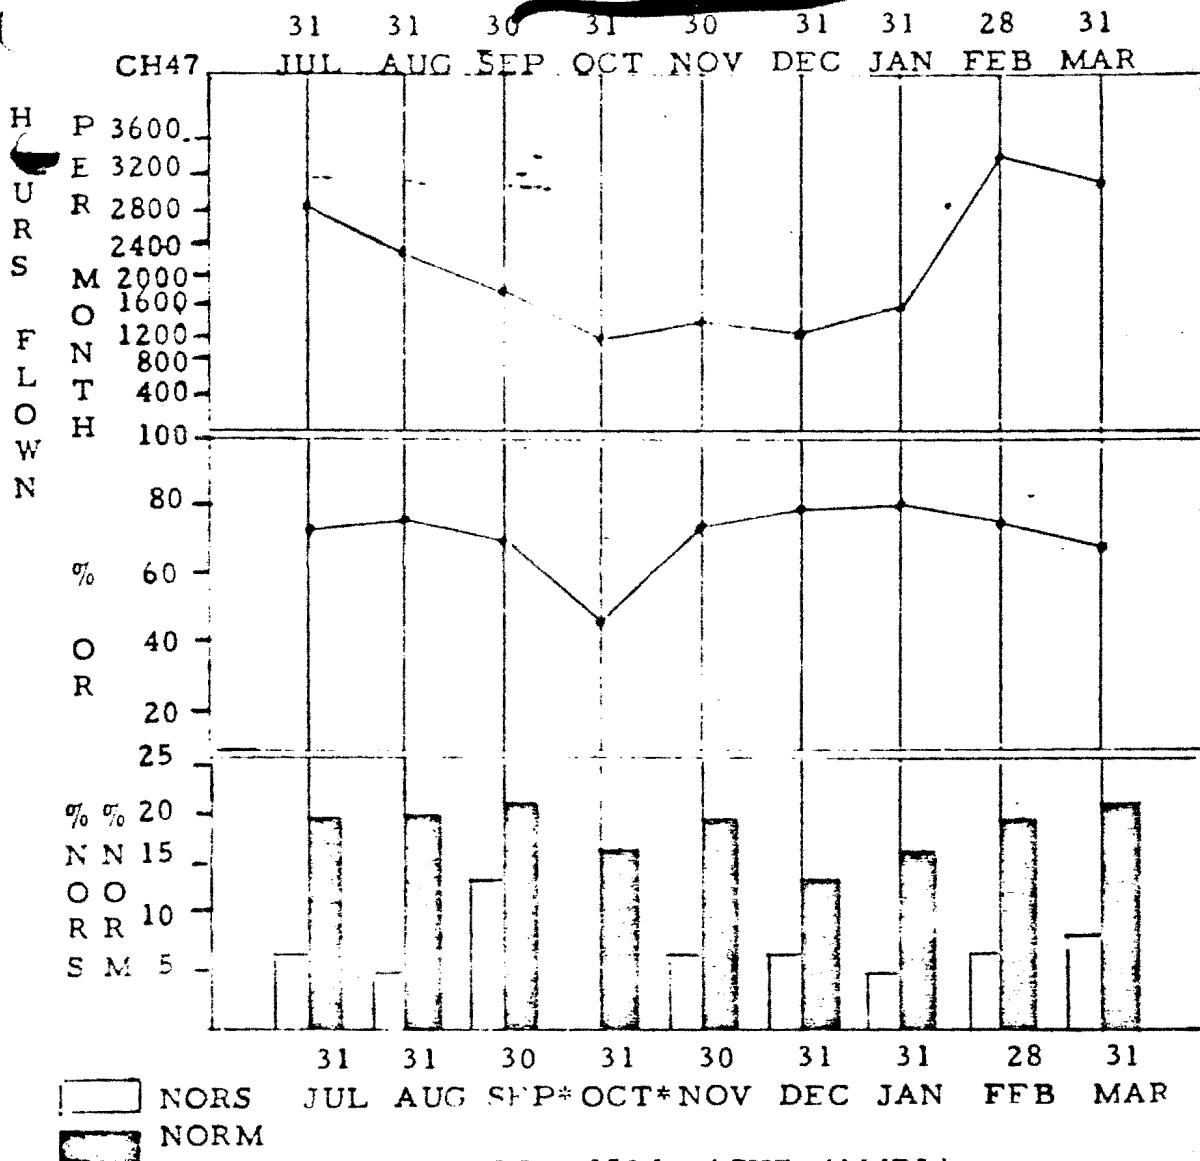
FIGURE IV-4 (U) Monthly Flying Hours, CH-47 (U)

A, B, C, CO., 159th ASHB (AMBL)
48 ASSIGNED CH-47's

DEPICTING COMBINED MONTHLY FLYING HOUR
PROGRAM AVG OPERATIONAL READY RATES & AVG
MONTHLY NORM/NORS RATES FOR MONTHS SHOWN
DURING 1970-1971

The three primary indicators for determining the efficiency of the maintenance effort during this period were the operational ready rate (OR), and the NORM/NORS rates. At Figures IV-4, 5, and 6 are charts which graphically depict these indicators with relation to the associated flying hour program of the CH-47's and CH-54's. As the flying hour program increased abruptly in February, the NORM rates, and in the case of the CH-47's, the NORS rates, also increased. It is significant to note that the NORS rate, although increasing slightly, remained relatively constant when compared with the previous seven month period. This was due primarily to the amount of command interest and emphasis on the aviation repair parts supply system. A forward liaison element of the 34th General Support Group, operating out of Quang Tri, was in a large measure responsible for insuring that the necessary repair parts were made available to the requesting units in an absolute minimum of time. This element also maintained close liaison with the civilian PMP teams, and determined where their assistance was most urgently required. One of the primary reasons for the light increase in the NORS rates was that some of the repair parts for which there was a sudden demand were items that had acquired little if any demand data in previous operations. Many of the parts damaged by enemy fire were rarely required under normal operating conditions. It must be emphasized at this point, that a major factor in keeping NORS/NORM rates at an acceptable level was the prior planning done by the units of the 159th Assault Support Helicopter Battalion, and the aircraft scheduling program which they used. They were able to adequately forecast, in most cases, the repair parts which would be required based on the increased flying hour program. A major area of concern to the maintenance activities during the operation was the conditions under which the aircraft were operating in the forward areas. The dust in which the CH-47's and CH-54's were forced to operate on a continuous basis was a critical factor in increased wear on engines and rotor blades. As a result of the battalion policy of flushing each CH-47 engine with water after every flying day, the damage to engines remained negligible. The wear on CH-54 engines was also negligible because of their Engine Air Particle Separators (EAPS). Most of the damage done by the dust was to the aircraft rotor blades. The abrasive nature of the dust coupled with the extremely high winds generated by the rotor wash, resulted in abnormally rapid deterioration of the leading

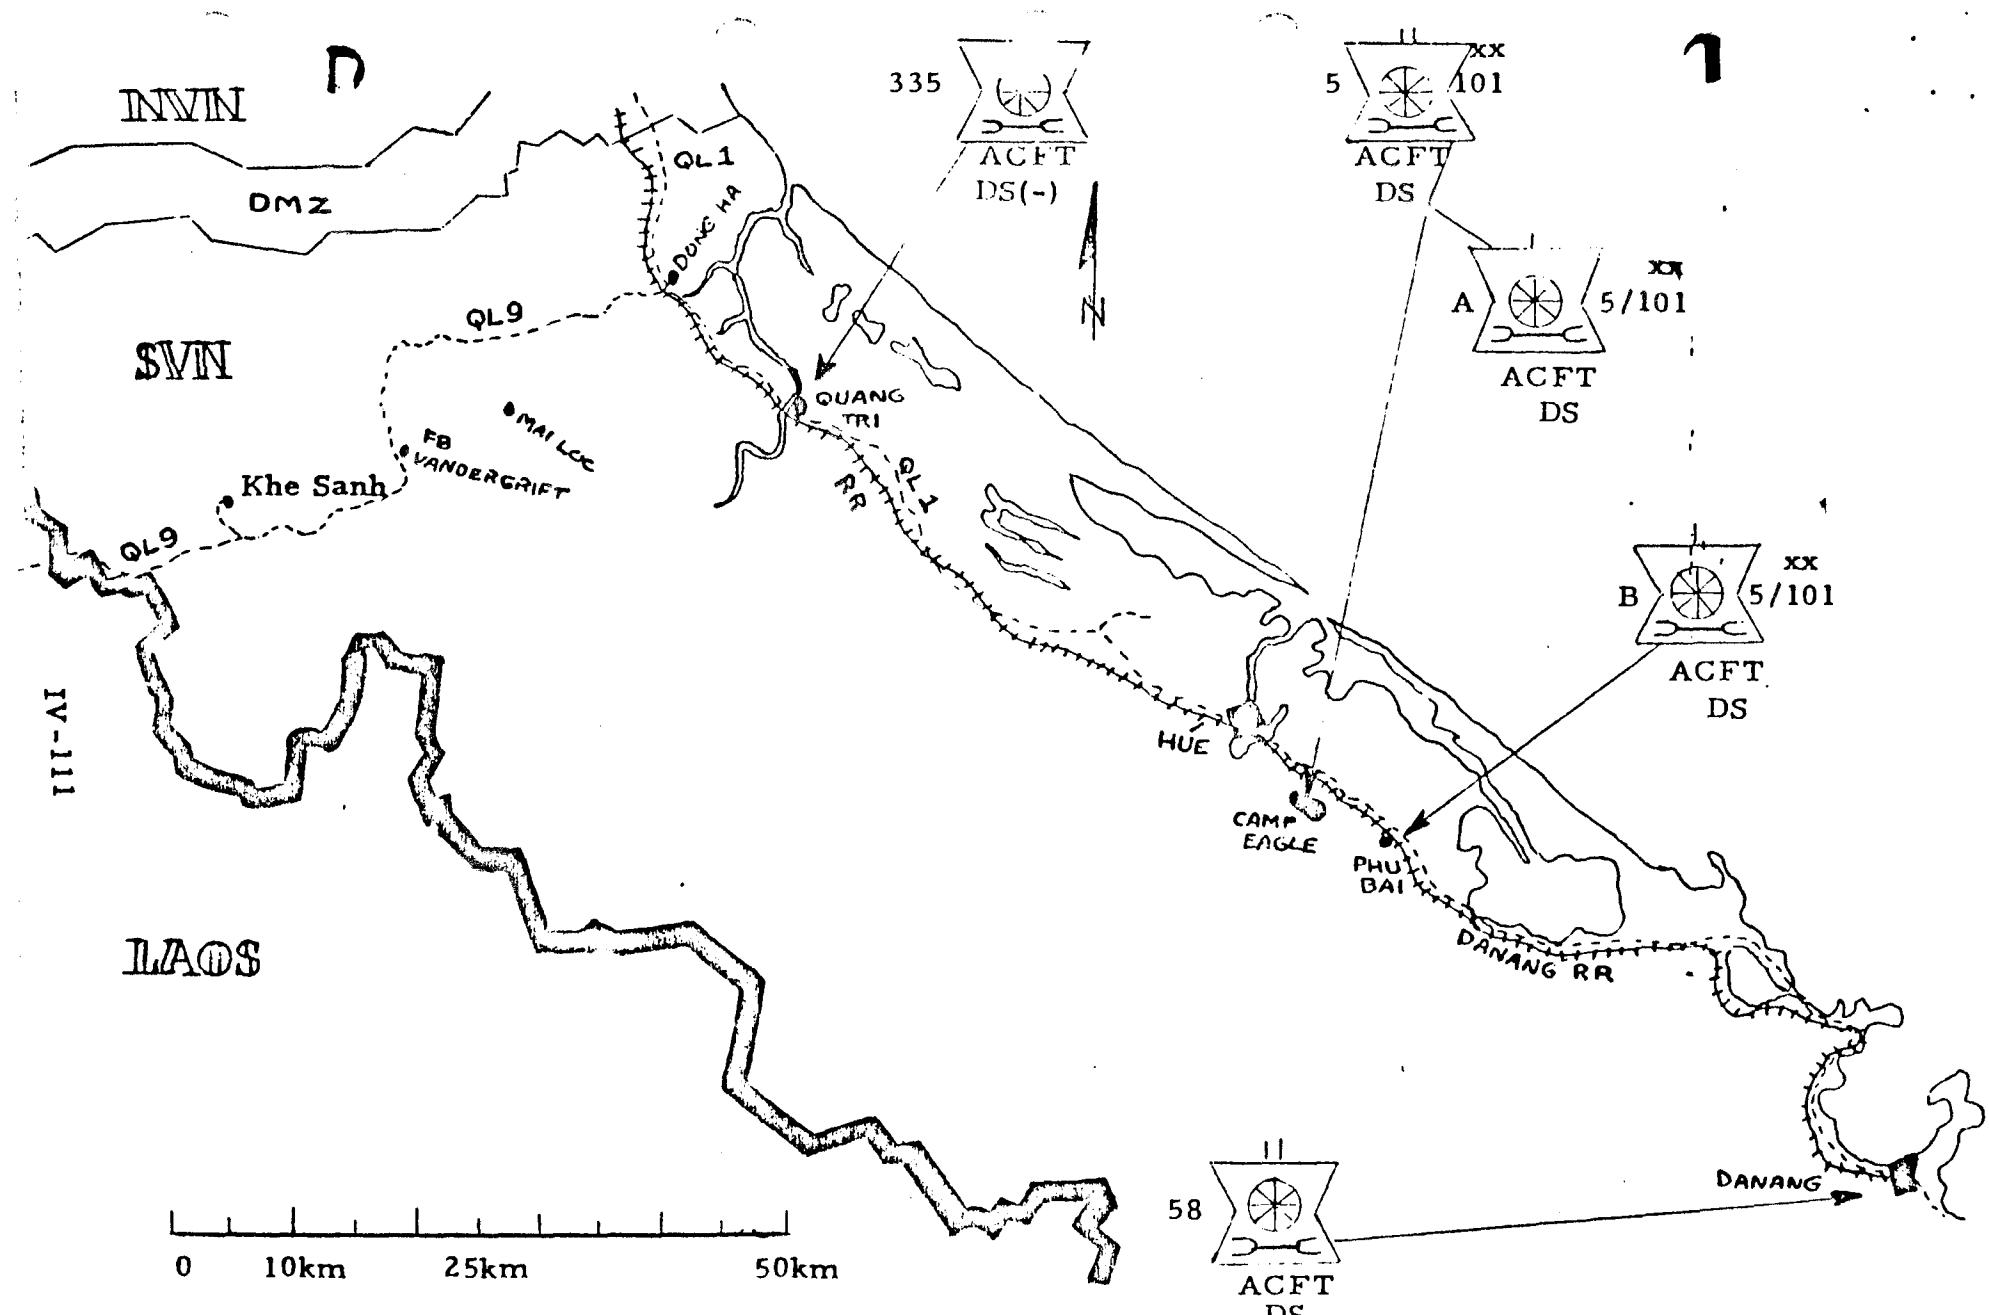
FIGURE IV-24 (U). Aircraft Maintenance Facilities (U).

It was planned that the 335th Direct Support Company (-) of the 23d Inf Div would be attached to the 101st Abn Div (Ambl). It was felt that this addition would provide a capability adequate to support the operation. The units of the 5th Transportation Battalion (AM&S) were scheduled to remain at pre-operation locations at Camp Fagle and Phu Bai. The 335th, augmented as necessary would operate at Quang Tri for about 90 days. Mission alignment

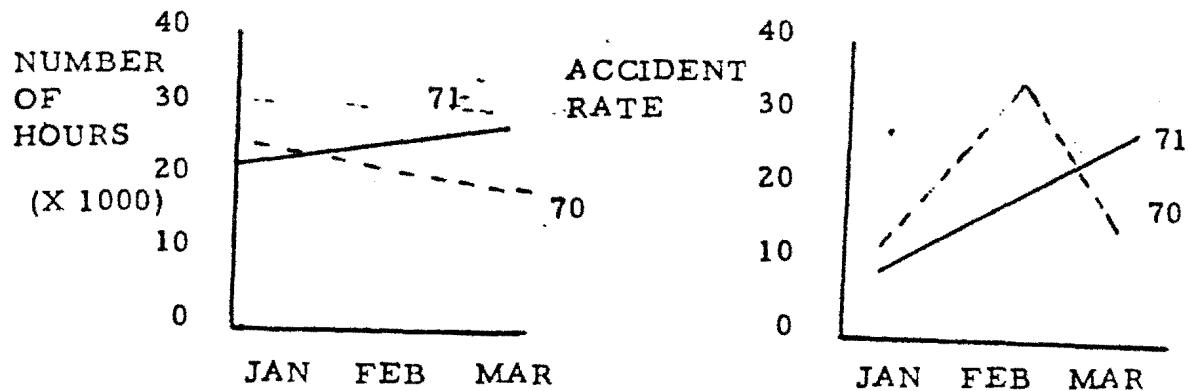
FIGURE IV-31 (U). 101st Abn Div (Ambl) Hours Flown and Accident Rate, 3rd Qtr FY 70 and 71 (U).

b. The division flew 7,548 hours more during the month of February and March 1971 than during the same time period in 1970. See Figure IV-31 below:

d. The increase in flying hours is a result of the operational requirements of LAMSON 719 and also the requirement to support troops in the Division area of operations. When flying hours are increased, the rate will drop if the number of accidents remains relatively stable or decreases.

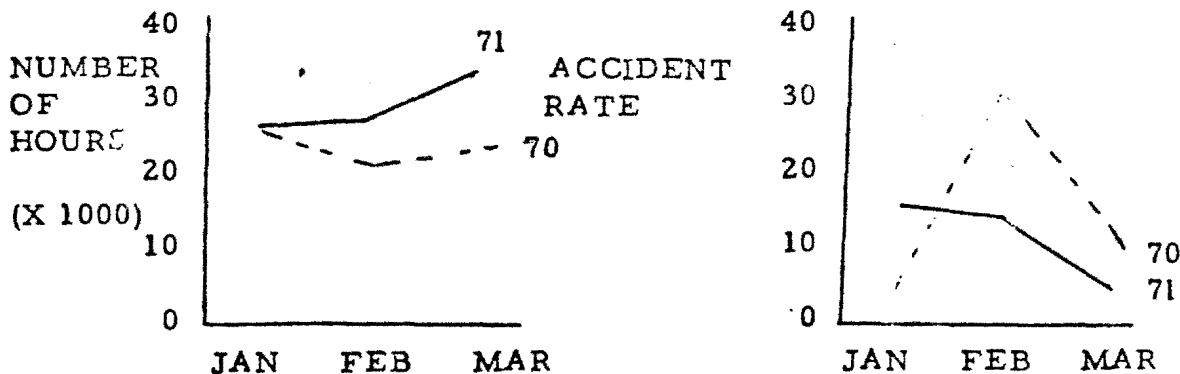
FIGURE IV-32 (U) 101st Avn Gp Hours Flown and Accident Rate, 3rd Qtr FY 70 and 71 (U).

c. An examination of hours and rates in the 101st Aviation Group shows that the Group flew 8,188 hours more during the month of February and March 1971 than during the same period in 1970, experiencing an average rate reduction of 13.8 accidents per 100,000 flying hours. See Figure IV-32 below:

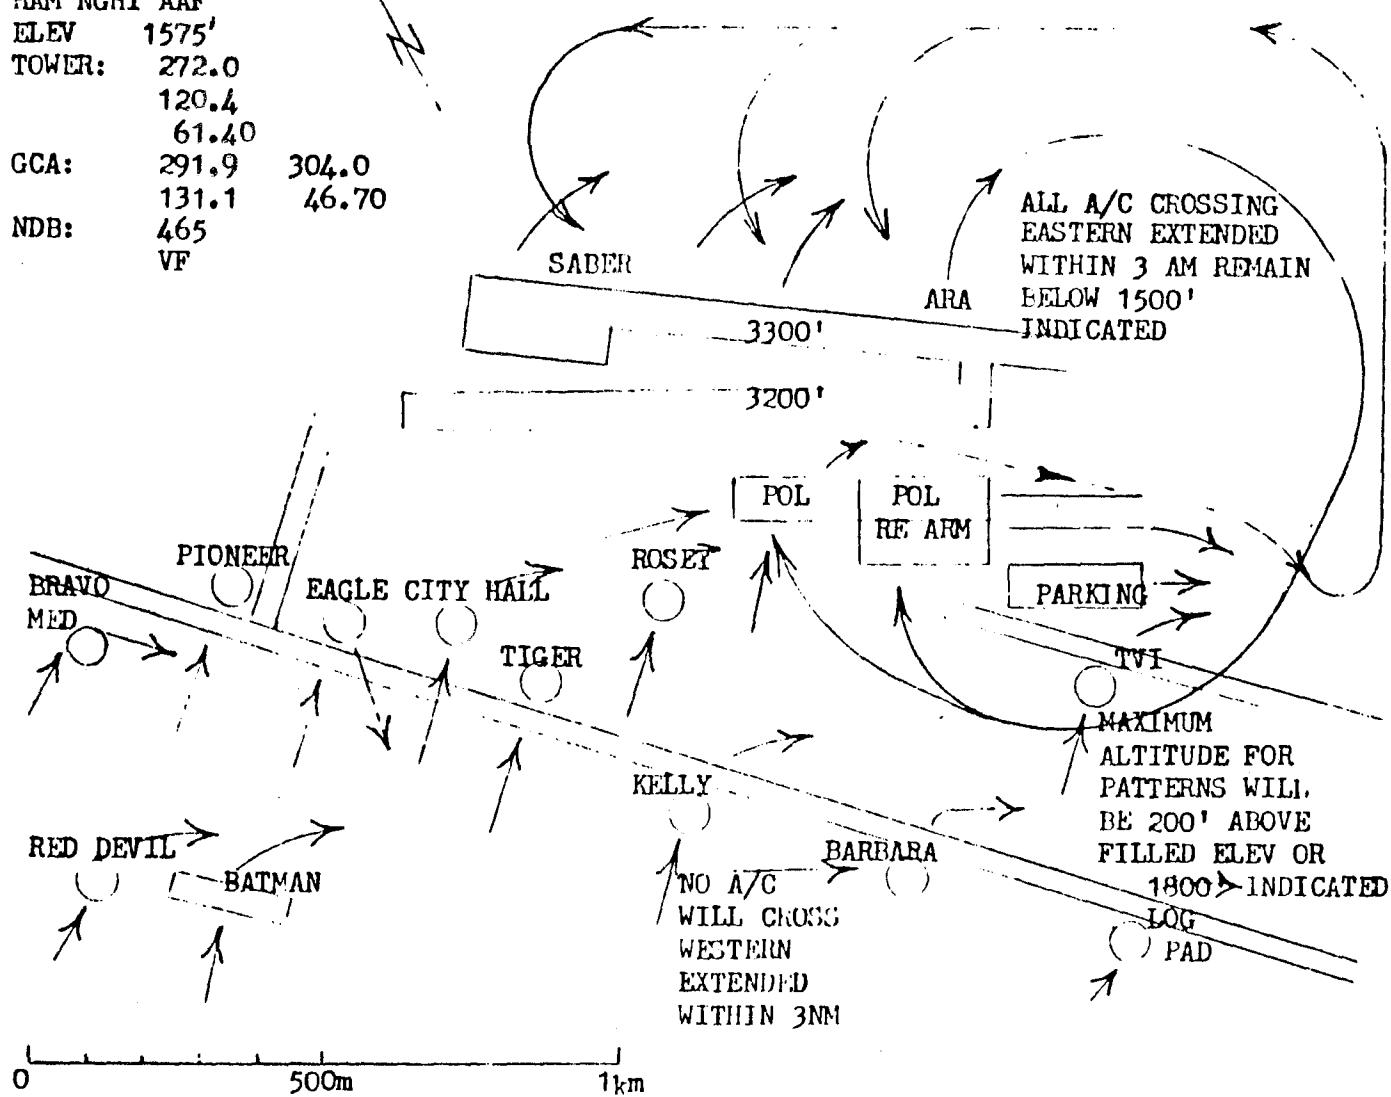
FIGURE IV-33 (U). Khe Sanh Air Facility and Flight Routes (U).

HAM NGHI AAF
ELEV 1575'
TOWER: 272.0
120.4
61.40
GCA: 291.9 304.0
131.1 46.70
NDB: 465
VF
