MANC (Metallurgical Laboratory)

Right #4 Bellcrank (ASA 7075 T-6 Aluminum Alloy Forging)

Task #1128, Attachment #7

Metallurgical Analysis

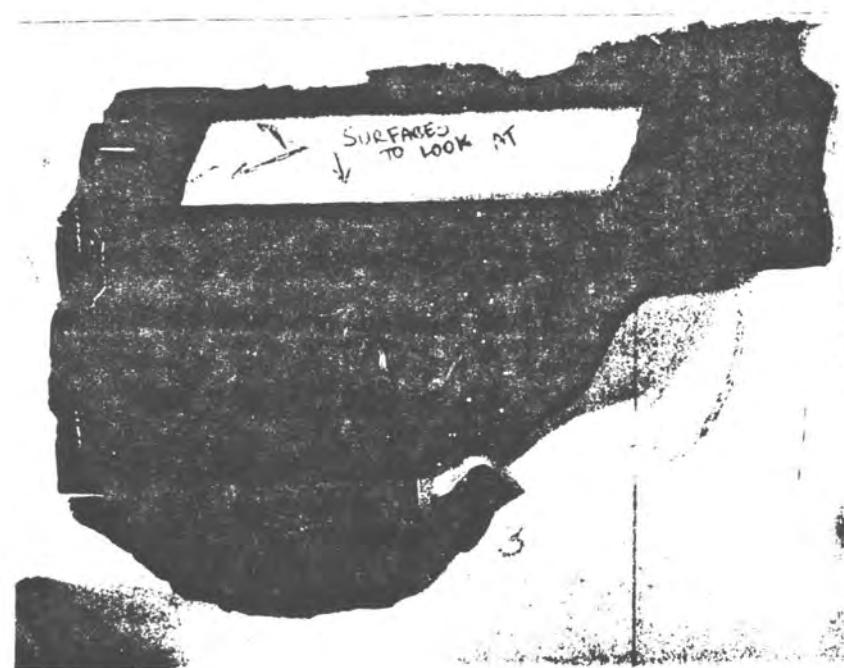
Photo 3
Specified fractured areas
identified as #1 - #2 - #3.

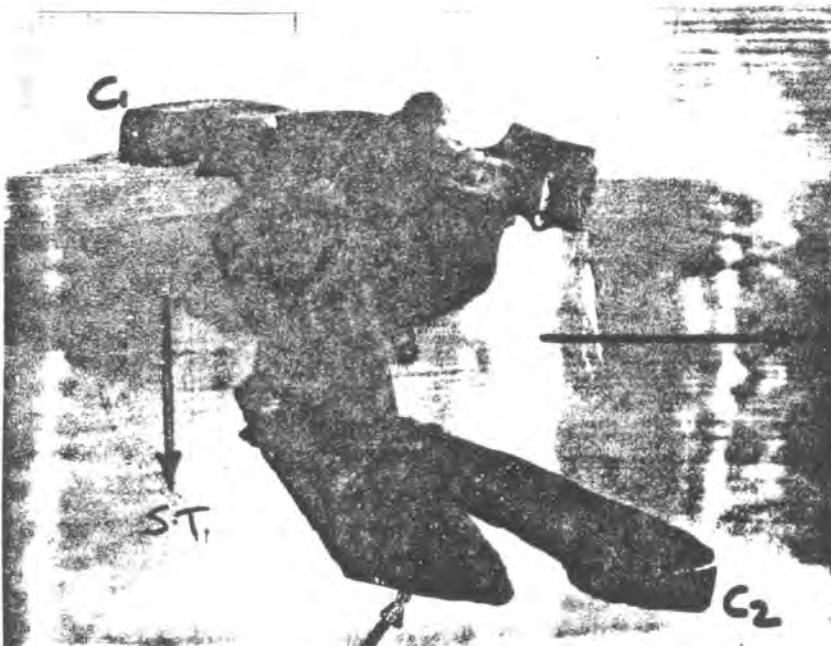
Photos 1 & 2

1. An additional analysis on the massive failure zone of this Bellcrank, Photos 1 & 2, was requested for the determination of the direction of final separation. Final separation was in the direction of the red arrow, as shown in these photos and explained in the caption. Additional separation of the flange segments C1 & C2 at the laboratory revealed discolored corrosion zones on the fractures, Photo 3. These zones were similar to corrosion zones found previously on the cracks at the other areas of the Bellcrank previously examined in the original analysis.

4. Conclusion: Failure direction of this end of Bellcrank #4 RH is indicated and explained in Photos 1 & 2. The presence of "stress corrosion type" separation zones was also observed on longitudinal fracture areas of flange segments C1 & C2, (Photos 1-4), as verified by fractographs analysis. The short transverse direction of the original item material may possibly constitute the thickness direction on these fracture surfaces, and depending on the orientation of the item with respect to the original material would increase the feasibility of stress corrosion characteristics there.

Corresponding views of segment exhibiting major failure & separation zone of #4 RH Bellcrank. View B is in direction of green arrow shown in Photo A. All exposed fracture surfaces revealed rapid overload characteristics. Curvature of web portion of Bellcrank, aitensile shearlip at A and compressive mash zone at B (Photo 1), and separation of flanges segments C1 & C2 away from web all suggest final separation in direction of red arrow. Heavy blue arrow denotes possible short transverse direction of wrought stock item was machined from.

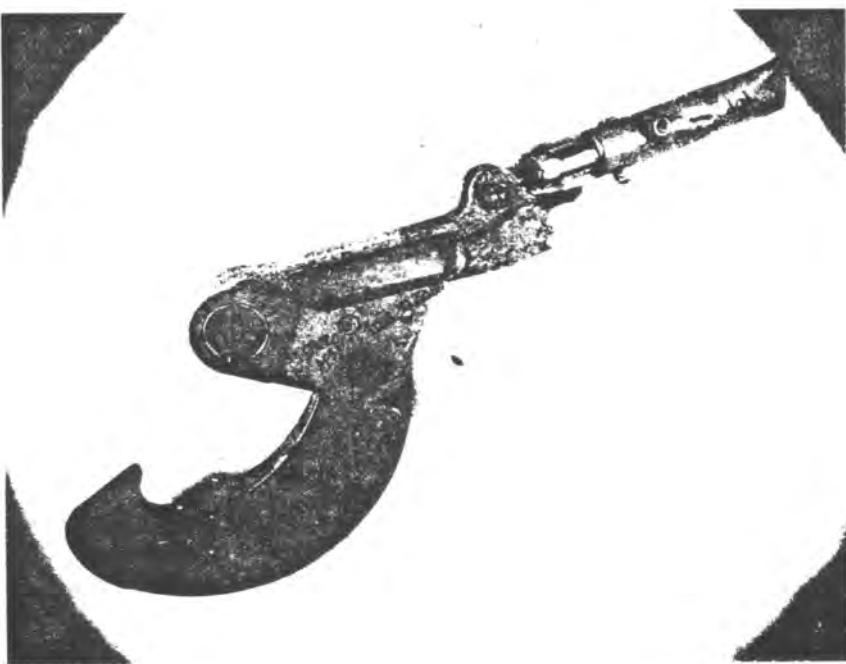
Photos 1 & 2. Right or Left #3 Hook, Bellcrank and Pushrod Assy Submitted for Analysis. Crack was Evident at Junction of Crank Lobe and Flange, as Shown in Photo 2. See Photos 3 and 4.

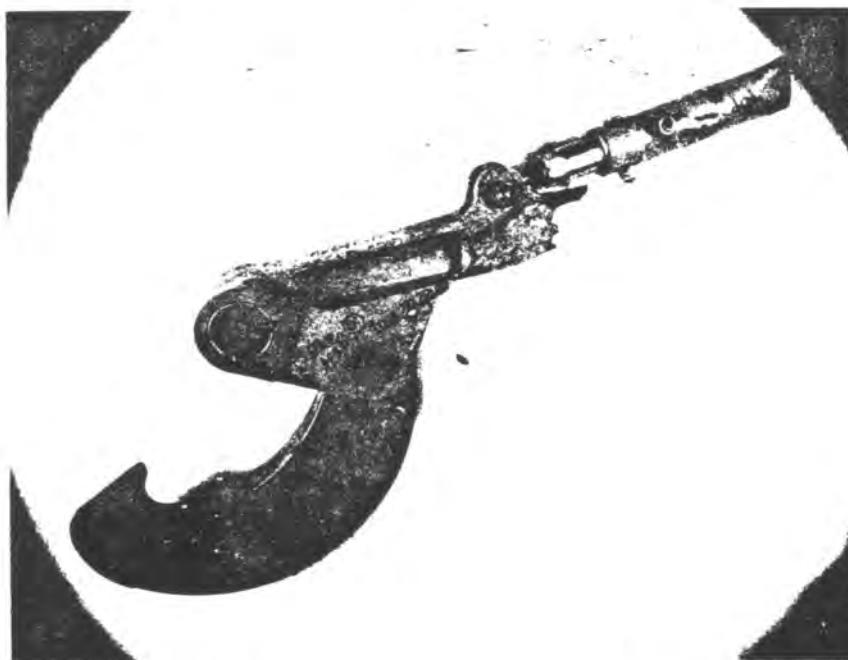
Photos 1 & 2. Right or Left #3 Hook, Bellcrank and Pushrod Assy Submitted for Analysis. Crack was Evident at Junction of Crank Lobe and Flange, as Shown in Photo 2. See Photos 3 and 4.

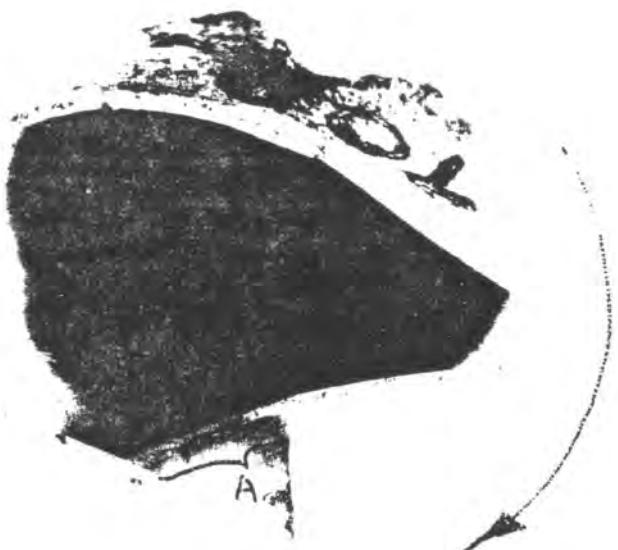
3. Examination of the pushrod fracture surface (Photo 10) indicated failure by a combination of rapid bending and torsional shear. Final separation of the mating portion is believed to have occurred in the direction indicated by the arrow. This is suggested by crimping of the rod at the right side and "fluting in" of the appending segment "A".

Photo 10. Failed Pushrod Tube Attached to #3 2 1/2X Bellcrank. Arrow Indicated Direction of Separation of Mating Portion of Tube. Fluting of Appending Segment "A" and its Bending in a Downward Direction Suggest Final Separation in this Vicinity.

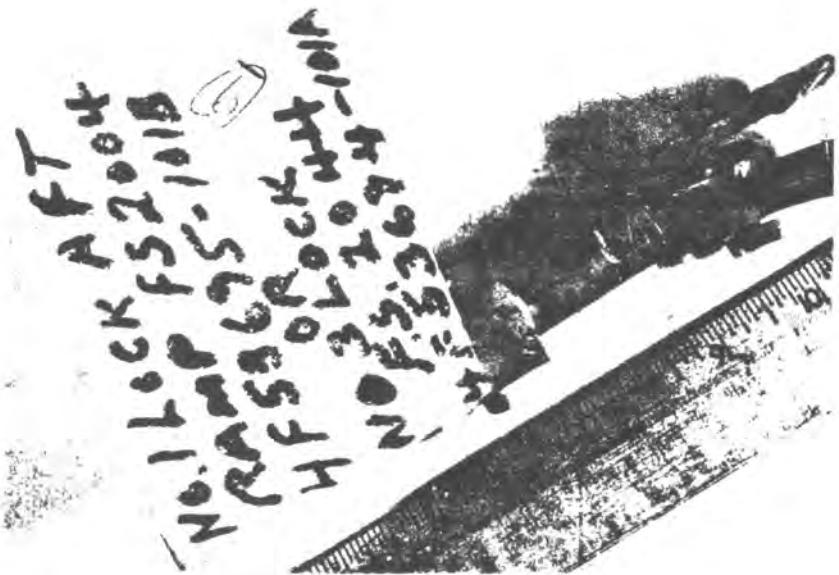
Photo 1
Pushrod as received.

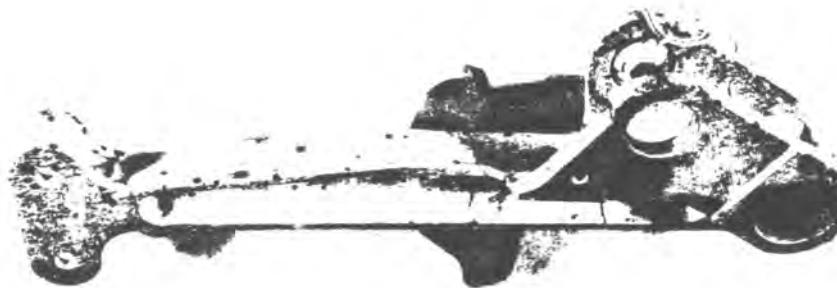
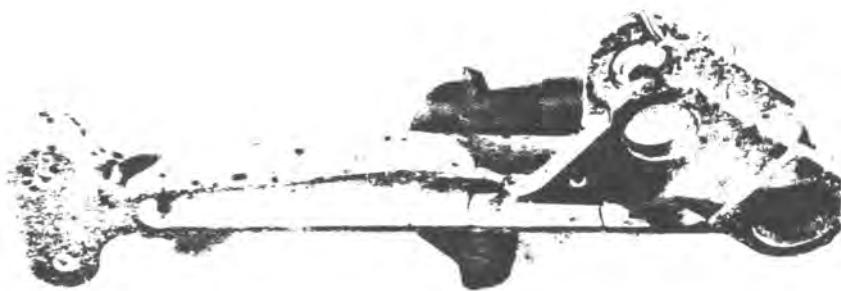
3. The crack indication as reported by Nondestructive Test Report, Lab Control #75-76 was investigated under the microscope. The suspected crack was forced open. A replica was made of the fractured surface, for observation under the Electron Microscope. Photo #2. In forcing the crack open, the suspected crack did not propagate under load. The bellcrank cracked in another location adjacent to the initial crack. Then the suspected crack was opened to obtain the initial crack face.

Photo #2
Identifies suspected crack.

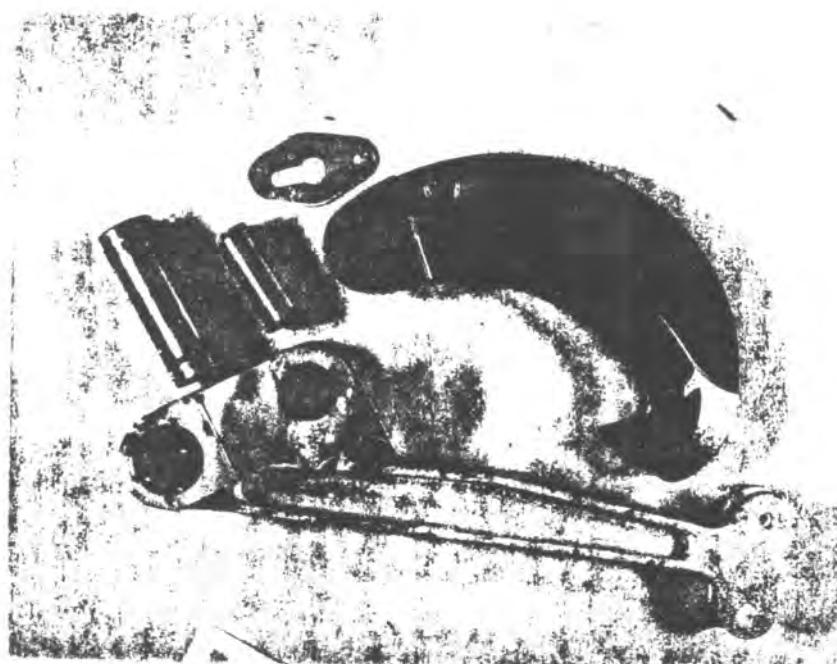
2. Photo #1 identifies the hook and bellcrank assembly. The corrosion pitting of the bellcrank should not be taken into consideration in this investigation. This was the result of the cleaning operation, in the stripping of the part.

Photo 1. Hook and Bellcrank Assy after stripping and cleaning.

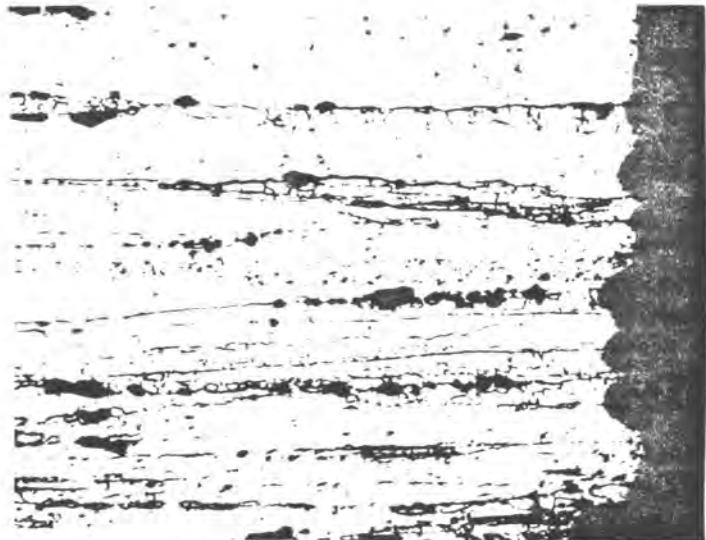
Photo 3 200X

#5 Pressure Door Roller Bracket - Showing the top side of the exhibit, and how the corrosion has attacked the surface along with intergranular corrosion in the grain boundaries.

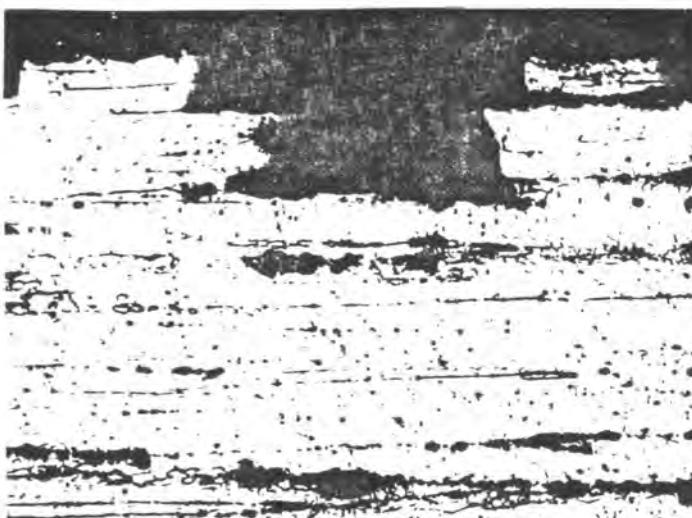
Photo 6 200X

#5 Pressure Door Roller Bracket - Showing the fractured surface at a different location, with the same condition as the above photograph.

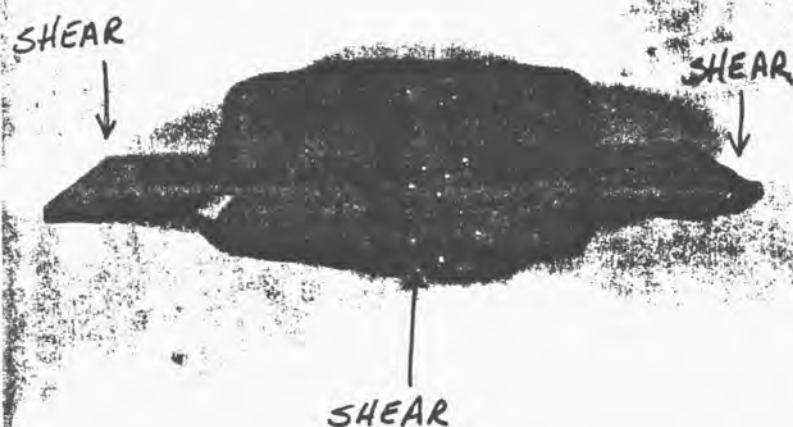
Photo 4

Mode of Failure - Tensile shear by overload.

Arrows indicate direction of bending action.

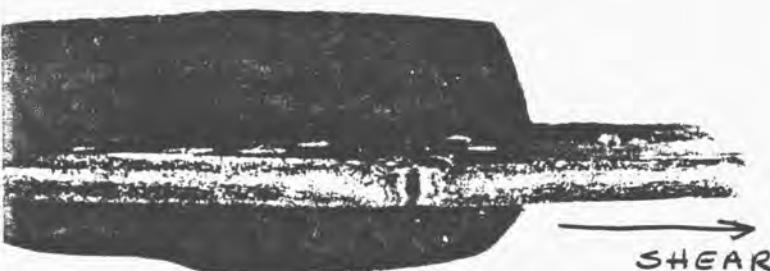
Photo 5

Mode of Failure - Tensile shear by overload.

Arrows indicate direction of shear.

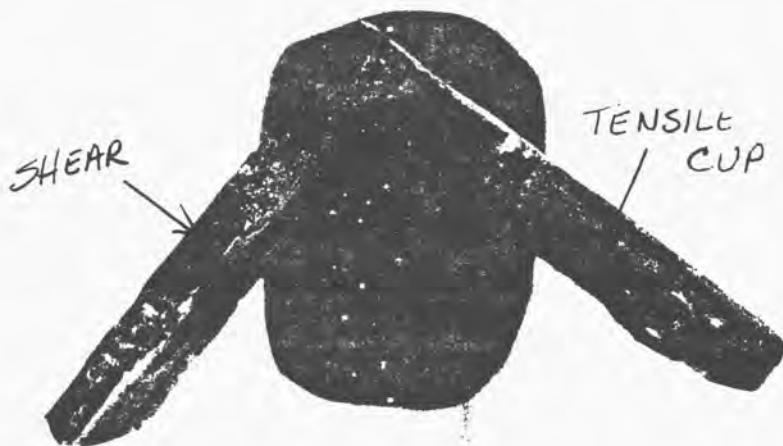
Photo 6

Mode of Failure - Tensile cup & shear by overload.

Arrows indicate direction of shear.

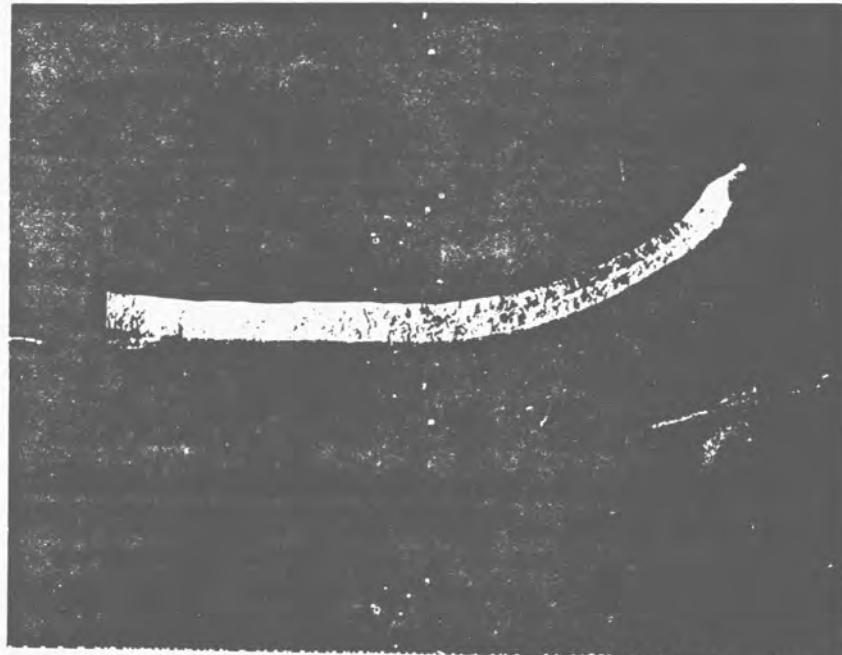
Photo 12

Mode of Failure - Tensile shear by overload.

Arrow indicates shear direction.

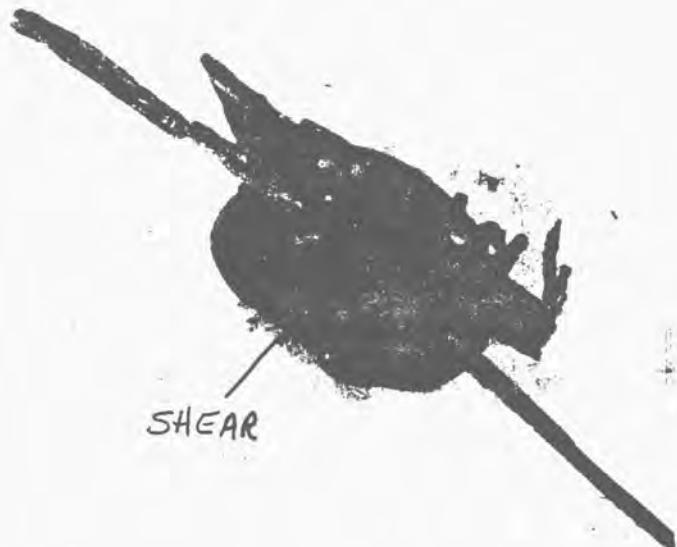
Photo 21

Sample 19

Mode of Failure - Tensile shear by overload.

Arrow indicates shear direction.

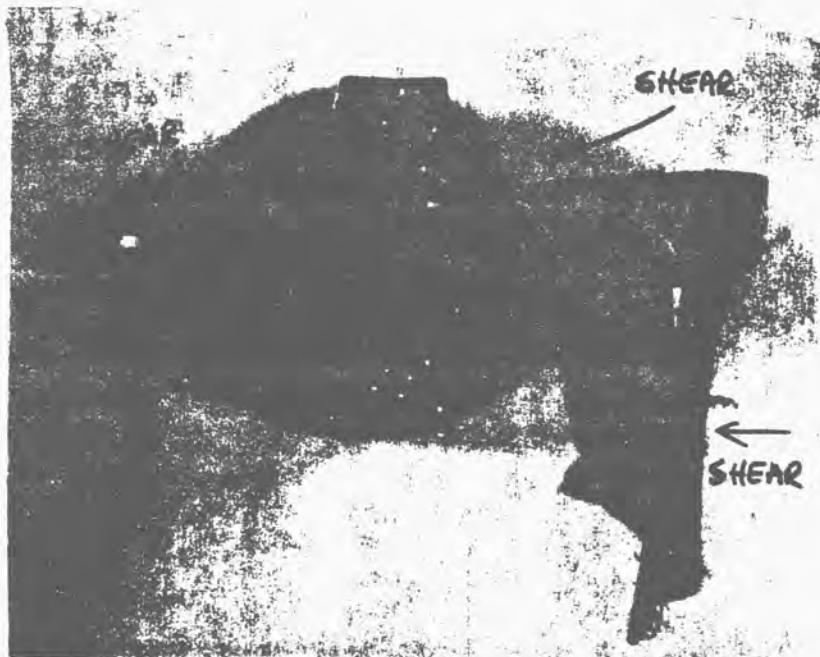
Photo 23

Sample 21

Mode of Failure - Tensile shear with a reversing shear.

Arrows indicate shear direction.

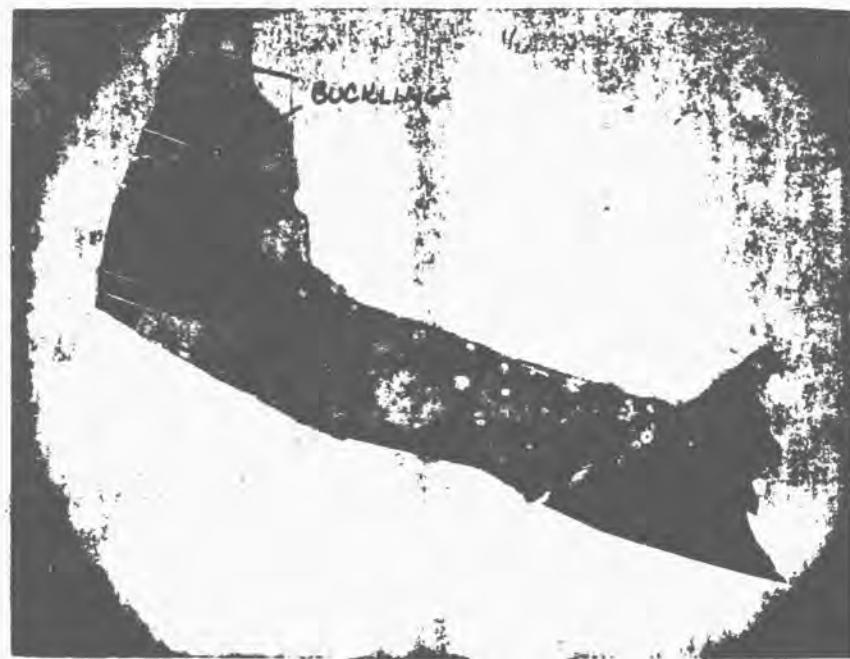
Photo 2

Sample #1
Shows buckling area.

Tensile shear right to left
compression & tearing by
impact.
